Vol. 39 No. 1 June 2022

FE Analysis and Visual Presentation Methodology of Mechanical Systems

By David A. Danaher, PE, DFE (NAFE 703F) and Sean M. McDonough, PE (NAFE 1146M)

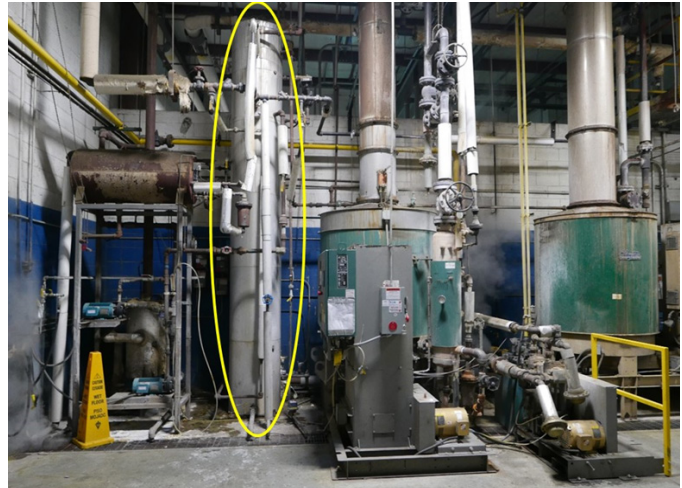
Figure 1
Exemplar SCR highlighted by the yellow circle
(photograph taken by Kineticcorp).

The incident, which occurred in April 2017, involved a storage tank that stored steam condensate, which was used in a commercial manufacturing process. The tank measured 30 inches in diameter and 17.5 feet tall and weighed approximately 2,000 pounds. At the time of the incident, the tank contained approximately 510 gallons of condensed steam at a temperature of 330°F and pressure of 100 psig⁴. The tank, which is referred to as a "semi-closed receiver" or SCR, received surplus steam from the plant, and allowed additional hot water makeup from an external reservoir with a vent to the environment. **Figure 1** shows an exemplar tank highlighted with a yellow circle.

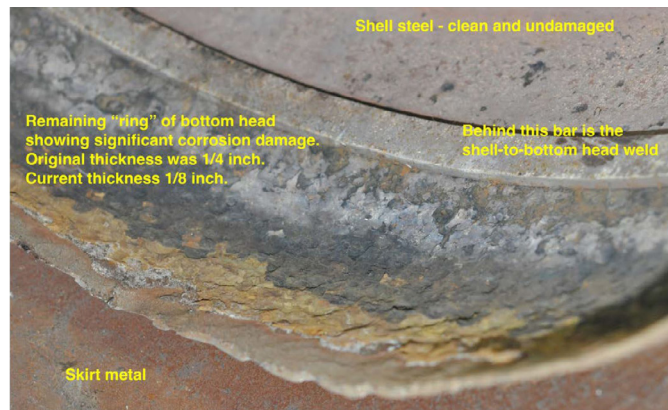
incident and found that “the vessel failed due to corrosion of the 6-inch ring of the original bottom head, resulting in the circumferential split of the ring and subsequent separation of the entire tank circle from the SCR.”⁴ The CSB found the original 6-inch ring that was left in place during the repair was heavily corroded, and the reduced thickness of the material provided an inherent circumferential weakness that allowed the patch to separate from the tank.

Figure 10
An image from the CSB report showing
the corrosion of the 6-inch ring.
