Vol. 39 No. 1 June 2022

Forensic Engineering Research and Testing of Building Copper Tube Water Piping System Freeze Failures

By Joseph G. Leane, PE, DFE (NAFE 524F)

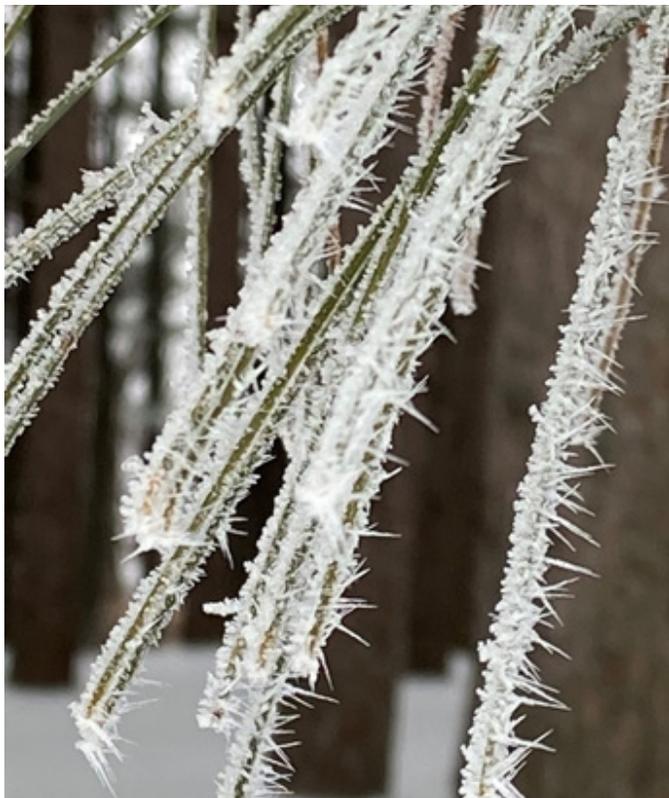
Figure 2

Photo of dendritic ice formation on needles on a tree.

on the inner surface of the tube wall, growing in the dendritic form^{12,13}. Ice nucleation is the point where the phase change begins when water freezes to ice. When ice begins to form, the temperature abruptly increases to the phase change equilibrium temperature and remains there during the freeze process. The noted abrupt increase in temperature is caused by the initiation of the phase transition from water to ice. This process releases energy (latent heat of fusion), which increases the temperature. The latent heat of fusion is the heat energy needed to change the state of a substance from a solid to a liquid. The abrupt temperature increase indicates the point of dendritic ice formation, resembling the branches of a tree (**Figure 2**). Once the water has fully phase changed from water to ice, the temperature then progressively decreases as the ice gets colder.

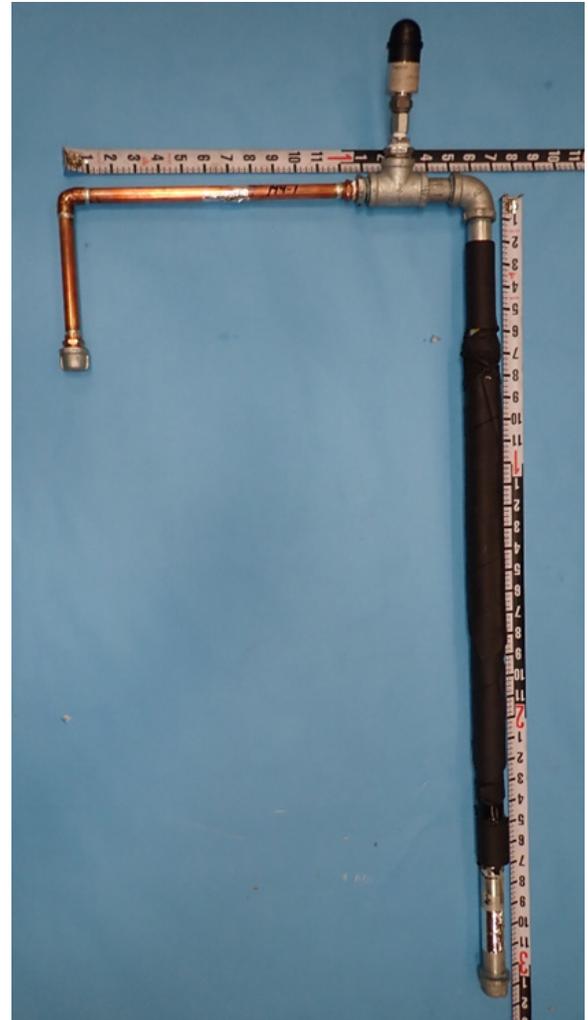
Figure 6
Photo of the galvanized pipe test apparatus, showing pressure transducer and copper tube test assembly attached. Different configurations of copper tube assemblies were tested. Accordingly, this copper tube assembly is different than the one illustrated in Figure 5.

Tests were performed on a closed piping system of galvanized pipe and copper tube (**Figures 5 and 6**). The test apparatus was in the shape of an inverted “L” of ¾-inch galvanized pipe. Galvanized pipe was used because it had a significantly higher burst pressure than

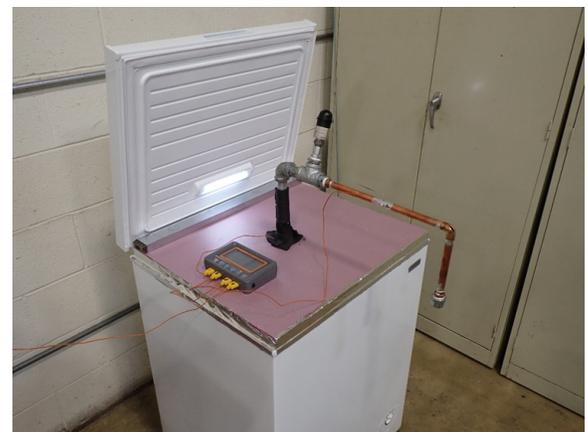
Figure 7
Photo of the test setup, showing test apparatus installed in freezer.

The vertical leg was placed inside an electric freezer and projected out the top of the freezer (Figure 7). The copper tube assembly was positioned horizontally above the freezer in the room environment, and remained well above freezing during the testing.

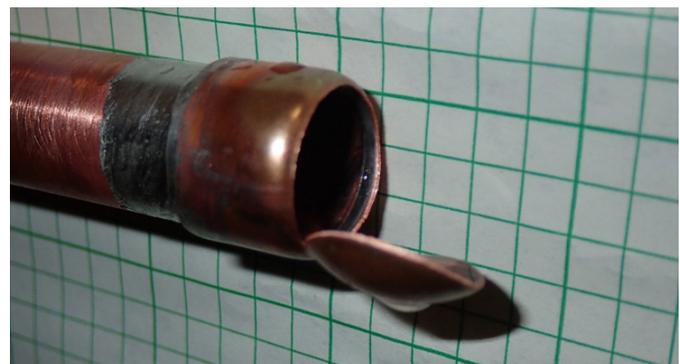
Figure 9
Photo of a “fish-mouth” rupture of copper cap.

distilled water to prevent air pockets. The freezer was then turned on, and the temperatures/pressures were recorded every minute. The copper caps ruptured in “fish-mouth”-type failures at an average pressure of 5,048 p.s.i. (**Figure 9**). Burst pressure readings from different trial runs were within 3 percent of each other. The burst

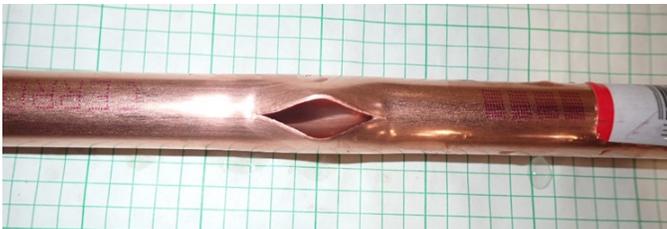
Figure 10

Photo of a longitudinal rupture in Type M copper tube.

Group 2 tests: The cap was replaced with a second male adapter and a galvanized cap, permitting higher pressures to be developed inside the tube. The tube was again attached to the test apparatus, filled with water, and the freezer was turned on. The Type M copper tube split longitudinally at an average pressure of 5,373 p.s.i. (**Figure 10**). Burst pressure readings from different trial runs were within 2 percent of each other. The splits generally occurred in the middle of the tube well away from any potentially heat-affected areas at the ends where the adapters had been soldered to the tube.

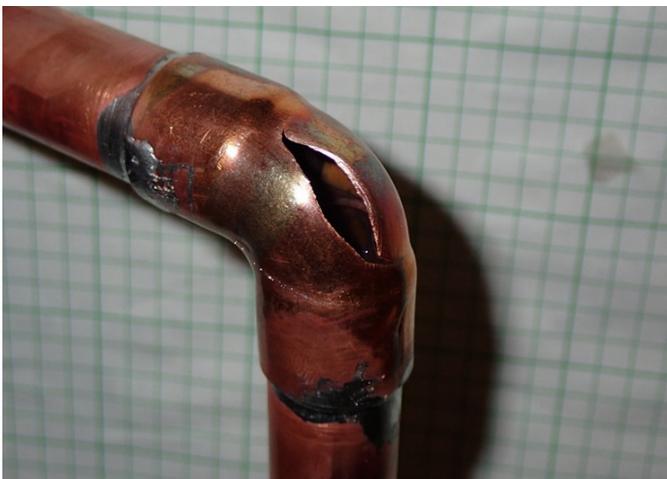
Figure 11

Photo of a longitudinal rupture in copper elbow fitting.

Group 4 tests: “L”-shaped copper tube assemblies with a copper 90° elbow fitting and a capped threaded adapter on the end were attached to the test apparatus. All ruptures occurred at the elbow fittings in longitudinal-type failures at an average pressure of 4,682 p.s.i. (**Figure 11**). Burst pressure readings from different trial runs were within 5 percent of each other.

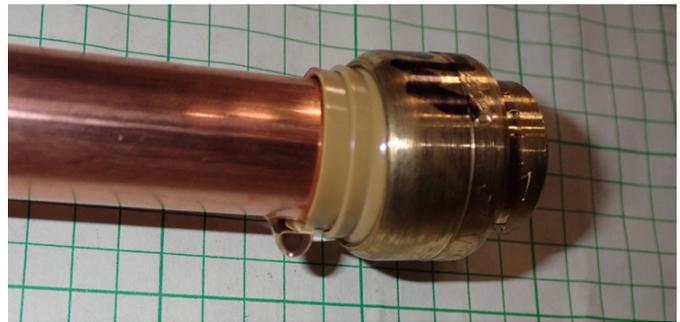
Figure 12

Photo of a push-to-connect cap dislocated on copper tube.

Group 5 tests: Push-to-connect caps were fully pressed onto the ends of copper tube so there was full engagement. The caps began to drip water at an average pressure of 1,029 p.s.i. (**Figure 12**). Failure pressure readings from different trial runs were within 30 percent of each other. Some movement of the caps on the tube was observed. In later tests, the caps were installed on copper tube and frozen solid (**Figure 13**). During those tests, the metal outer caps were pushed off the tube by the expanding ice. However, the inner plastic components remained on the tube.

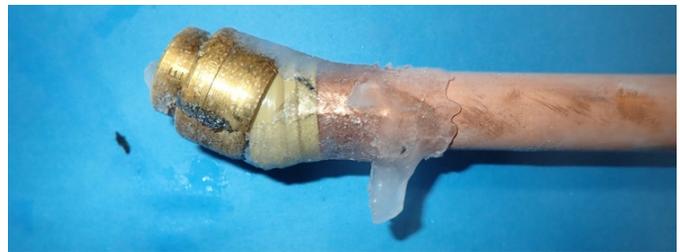
Figure 13

Photo of a push-to-connect cap separated from frozen solid copper tube.

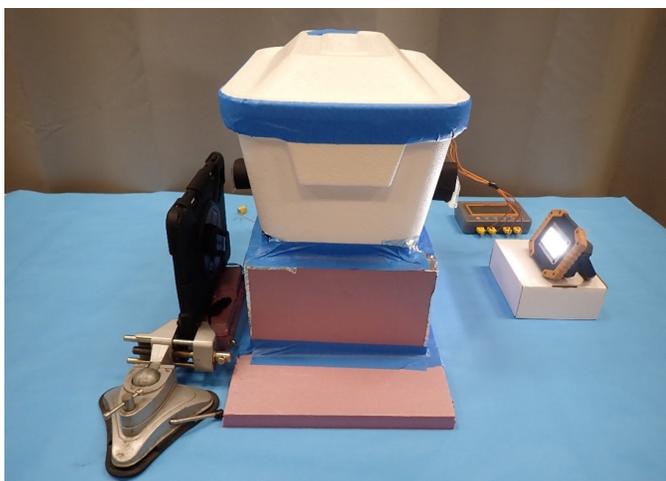
Figure 22

Photograph of ice plug formation test apparatus.

A test was performed to observe the formation of an ice plug in a section of copper tube (**Figures 21, 22 and 23**). A horizontal straight length of 1-inch copper tube with plexiglass windows on the ends was positioned horizontally through a cold chamber so that both ends extended through the walls and were located outside the chamber. Thermocouples were installed on the portion of the tube located inside the chamber (T1, T2, and T3). The freezer air temperature was also measured (T4). The tube was filled with distilled water, and the dry ice was placed inside the chamber with an air space of several inches between the tube and ice, assuring no contact between the two. A video camera was positioned at the front window to view the interior of the pipe, and lighting was positioned at the rear window to illuminate the interior of the tube. **Figure 24** illustrates the temperature data for a test run.

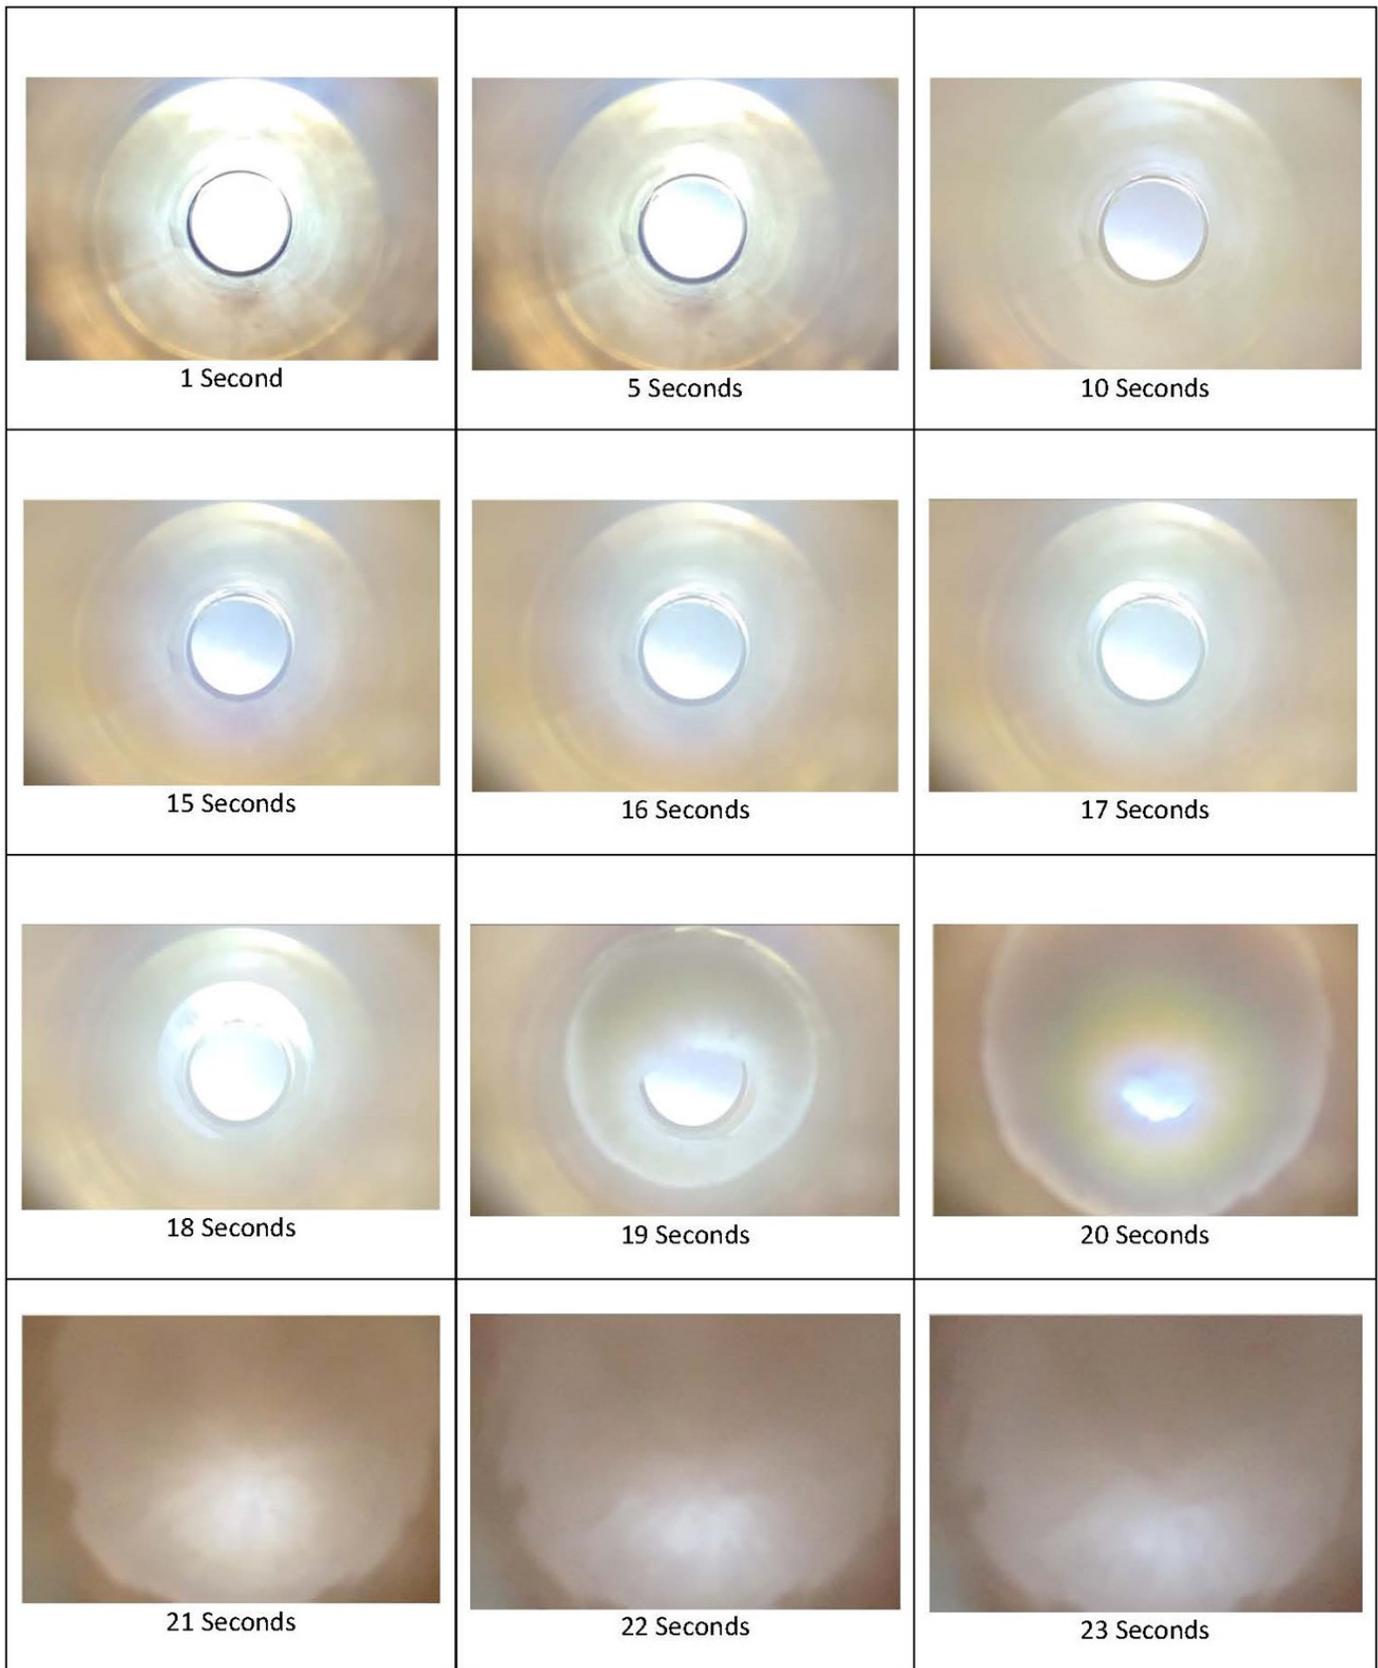
Figure 25

Screen shots of video depicting ice plug formation inside copper tube.

At the 3 hour and 6 minutes point, dendritic ice began to form on the interior of the tube wall. Ice was observed initially forming on the upper-left quadrant wall and growing circumferentially along the wall in both directions (clockwise and counterclockwise). At the same time, the ice layer began to grow longitudinally along the tube toward

the camera. This initial part of the process occurred over a 17-second period after the first ice was observed. The ice growth then accelerated significantly in both the circumferential and longitudinal directions. The layer grew into a solid plug, completely obstructing the tube. This second part of the process, which occurred over a 5-second period, was recorded on video. The total elapsed time was 23 seconds. Screen shots of the video are presented in **Figure 25**.
