# Forensic Engineering Investigation of a Machine Guarding-Related Injury

By Jason McPherson, PE, DFE (NAFE 852M)

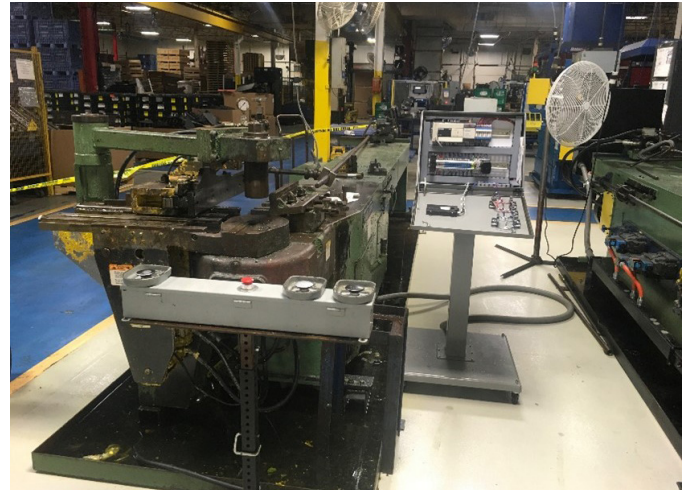
Automated hydraulic rotary tubing bender.

related to a partial amputation workplace injury involving an automated hydraulic rotary bending machine that was utilized to bend metal tubing. **Figure 2** shows the automated hydraulic rotary bending machine that was involved in the accident.
