Application of Matchmoving for Forensic Video Analysis with Recorded Event Data

By Richard M. Ziernicki, PhD, PE, DFE (NAFE 308F) and Ricky Nguyen, PE, DFE (NAFE 1223M)

Abstract

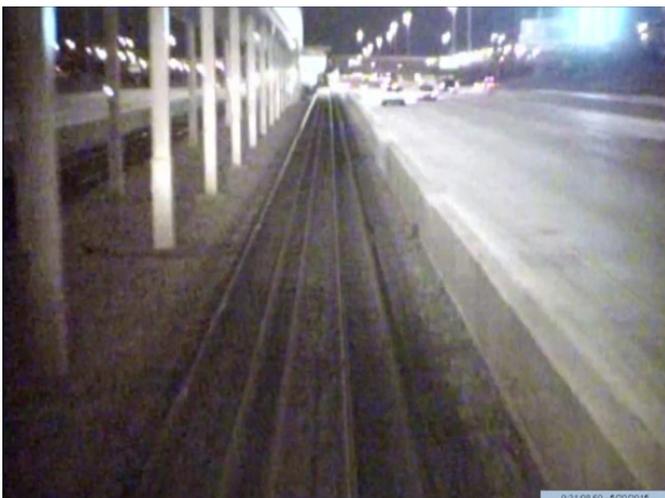
Figure 2

A screenshot from the footage recorded from the front camera of the train at the time of the incident, showing the train approaching the station.

The train was also equipped with several video cameras that recorded footage at the time of the incident, one of which was located at the train’s front car recording a forward view from the train (approximately from the viewpoint of the train operator). The camera recorded video footage at a rate of 5 frames per second (fps) and showed the train approaching the train station. As the train entered the station, a foreign object (determined to be the pedestrian who had fallen on the train tracks) could be observed. The footage then showed the train colliding with the pedestrian before coming to a complete stop (**Figures 2, 3, 4, and 5**).

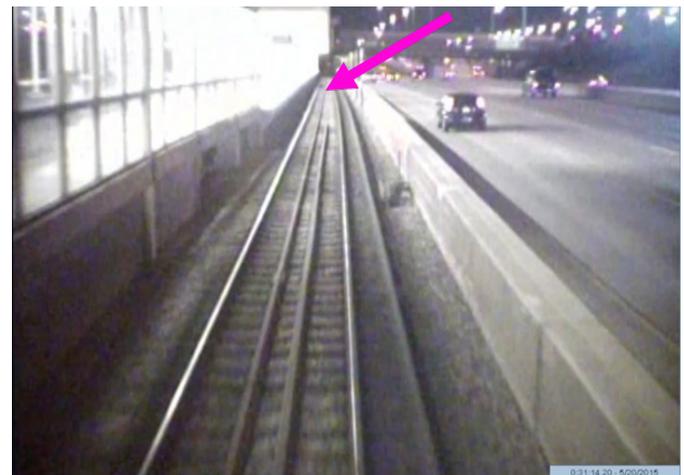
Figure 3

Another screenshot from the footage recorded from the front camera of the train at the time of the incident, showing the train approaching the station's passenger loading platform. The magenta arrow was added to show the position of the pedestrian lying on the train tracks.

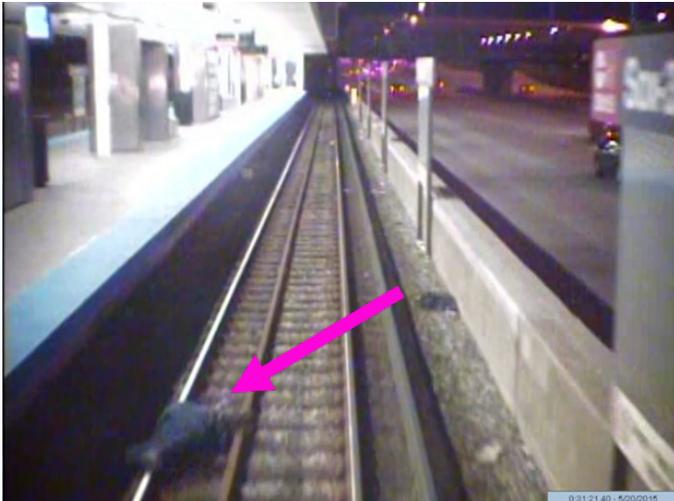
Figure 4

Another screenshot from the footage recorded from the front camera of the train at the time of the incident, showing the pedestrian lying on the train tracks. This was the last frame in which the pedestrian was visible before the train collided with him. The magenta arrow was added to show the position of the pedestrian lying on the train tracks.

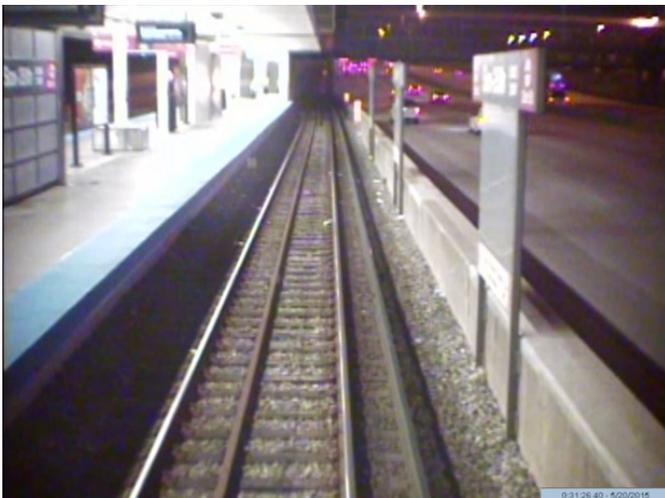
Figure 5

Another screenshot from the footage recorded from the front camera of the train at the time of the incident, showing when the train came to a stop after colliding with the pedestrian.

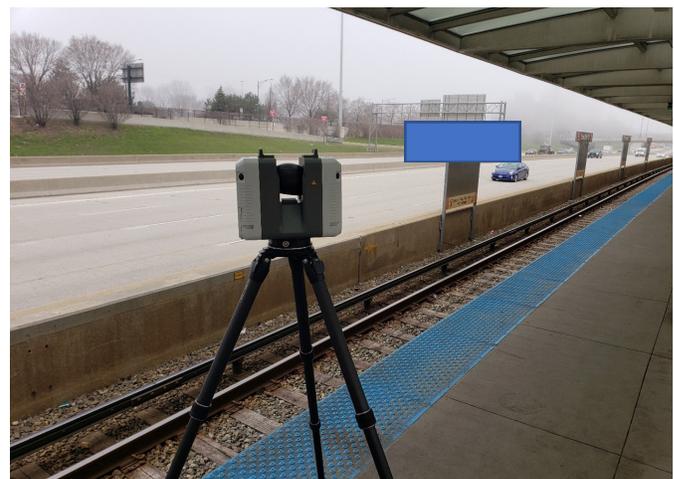
Figure 6

Photograph of the train station where the subject incident occurred. The station was inspected and 3D laser scanned. The laser scanner is shown in the foreground.

In conducting the forensic investigation and analysis, the authors inspected an exemplar train car and the subject train station where the collision occurred (**Figure 6** and **Figure 7**). The inspection consisted of taking photographs and performing a high-definition three-dimensional laser scan of the train and the crash site with a high-definition 3D light detection and ranging (LiDAR) scanner. More than 300 million data points were scanned/collected for the exemplar train, and more than 2 billion data points were scanned/collected for the crash site.

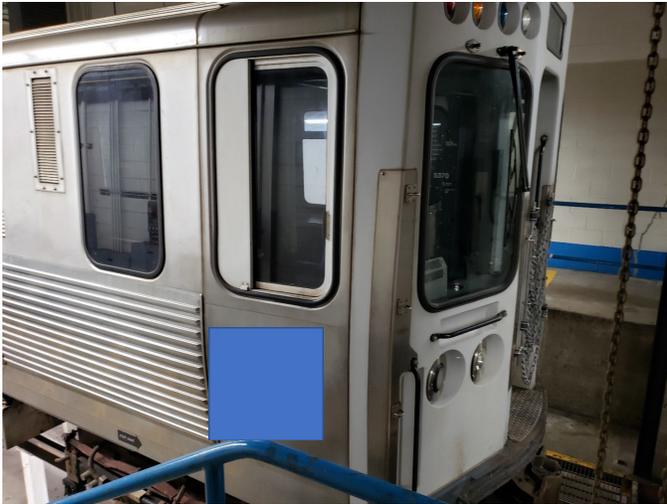
Figure 7

A photograph of the exemplar train car that was inspected and 3D laser scanned.

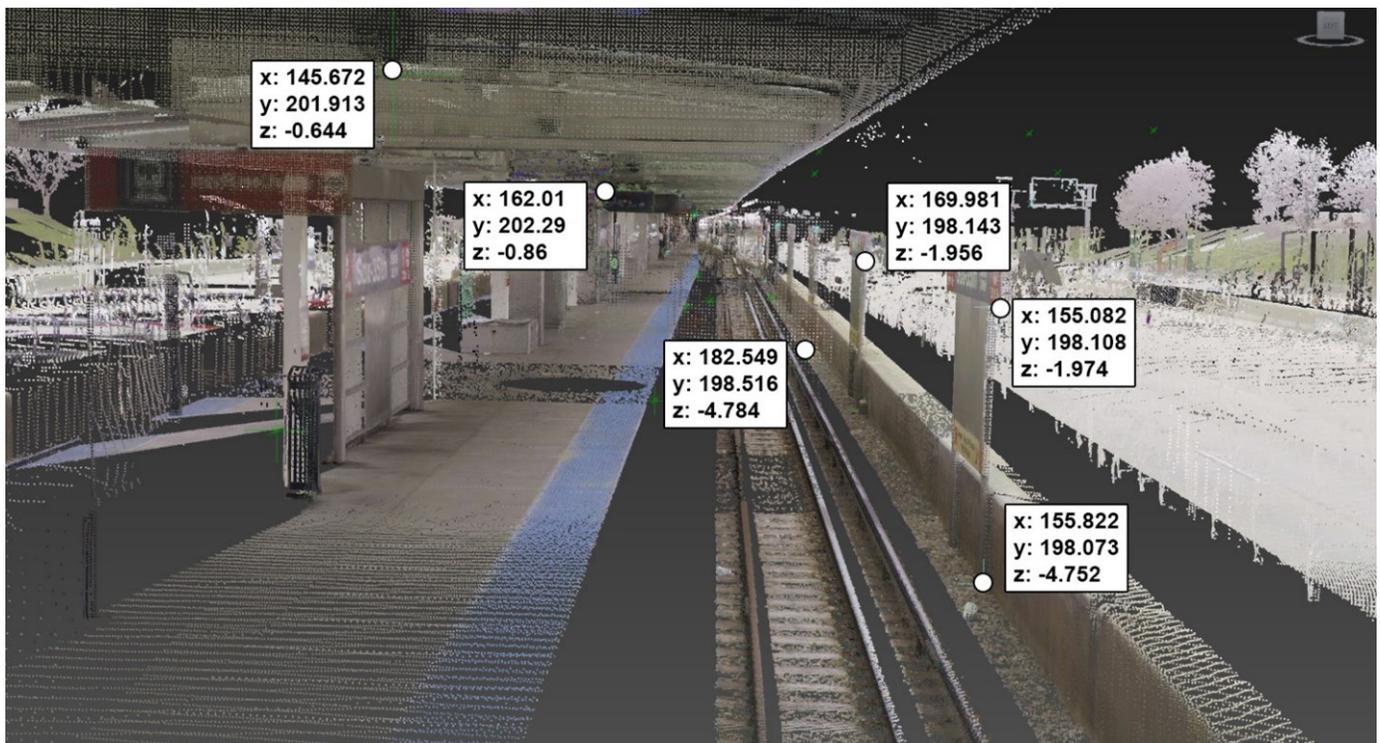
Figure 8

Screenshot showing a sample of the three-dimensional (x, y, z) coordinate data from the train station point cloud model used to constrain the corresponding two-dimensional trackers.

The author’s firm used widely and publicly available software (Syntheyes) to perform the matchmoving process. First, two-dimensional points (or features) were identified and tracked through multiple frames of the video. Each feature represents a specific point on the surface of some fixed objects of the train station (i.e., structural columns, signs, passenger platform corners, etc.). Each tracked feature was then assigned and constrained to the feature’s corresponding three-dimensional coordinates (x, y, z) as defined by the train platform point cloud (**Figure 8**).
