Vol. 41 No. 1 June 2024

Forensic Investigations of Low-Clamp-Force Type Wheel Separations

By Mark Bailey, PE, DFE (NAFE 1222S) and Dwayne Toscano, PEng

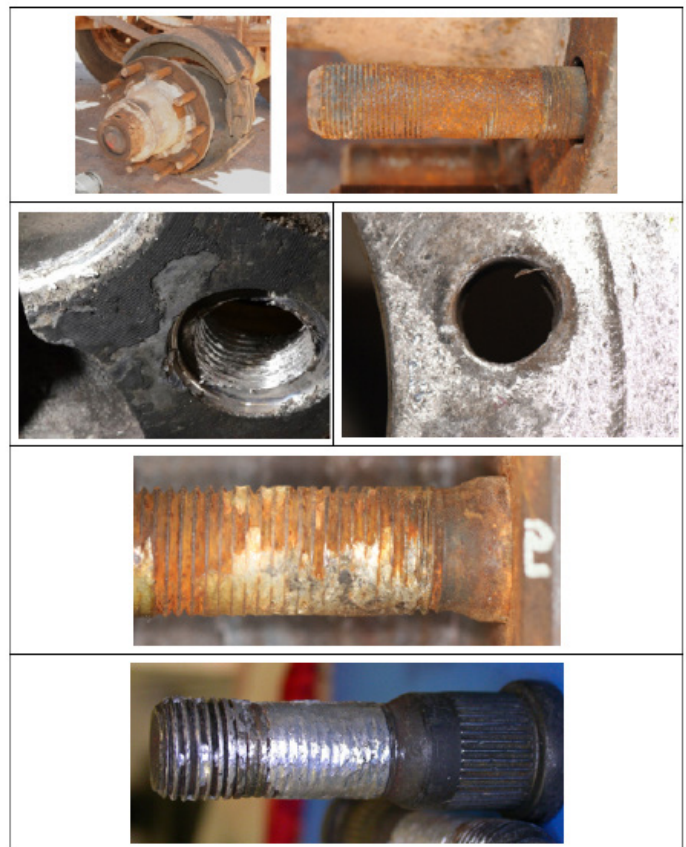
Figure 3

Examples of nut spin-off fastener failures. Top row: A left rear heavy truck axle end with missing dual wheels and brake drum. The threads of all 10 stud shanks were worn down like the one shown. Second row: wheel stud hole thread imprints from bearing on a stud and wheel stud hole elongation. Third and fourth rows: wheel metal embedment in stud threads on two left side wheel separations.

Many left side wheel separations present like the example in the upper left of **Figure 3** (wheel and all nuts missing — and all studs straight and unbroken). In addition to missing nuts, close inspection often reveals stud thread wear, wheel metal embedded in stud threads, stud thread imprinting in stud holes, and stud hole elongation. The nuts are most often not recovered.

implies LCF. In practice, the evidence of nut spin-off like those shown in **Figure 3** only needs to be observed to deduce an LCF type wheel separation occurred.

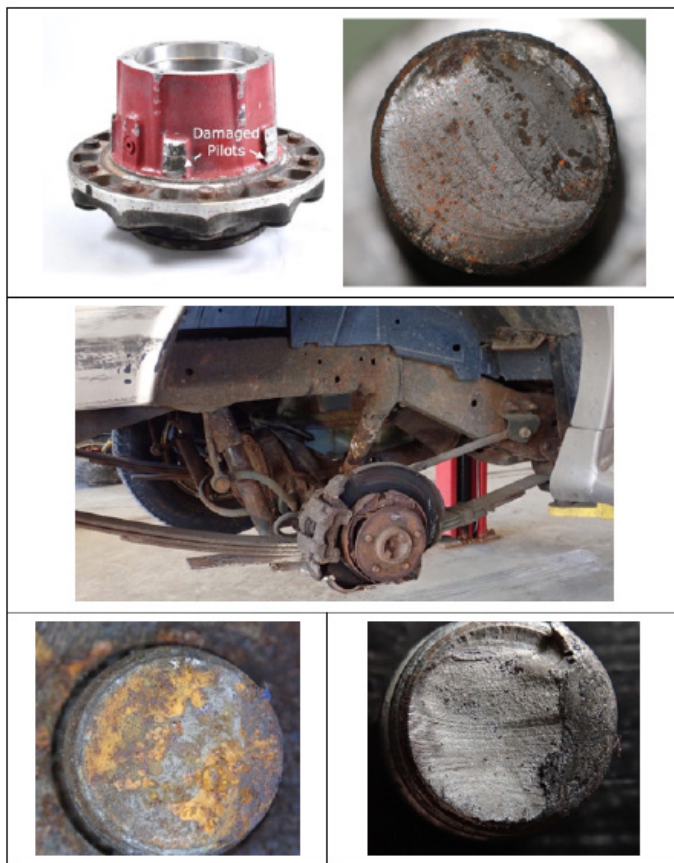
Figure 4

Examples of stud breakage fastener failures. Top row: a heavy truck hub with 10 broken studs — all with fatigue fractures like the one shown. Middle and bottom rows: an SUV right rear wheel separation. Bottom row shows a right rear wheel stud before and after cleaning. The stud fatigue fracture is readily apparent after cleaning.

Most right side and some left side wheel separations feature transverse stud fatigue fractures. The nuts and distal stud remnants are most often not recovered. In **Figure 4**, the five studs on the passenger vehicle and 10 studs on the heavy truck all broke transversely from fatigue.

For right side wheel separations, all the studs were broken in most cases. The broken studs typically displayed evidence of fatigue like the studs shown in **Figure 4**. Sometimes, the stud fractures were fresh enough to readily observe fatigue features, sometimes, the fracture had to be cleaned to observe fatigue features, and other times, the fracture surfaces had deteriorated so only transverse fractures were observed. No evidence of nut spin-off was observed in any of the right side fastener failure cases.

Where \equiv is the biconditional *iff* (if and only if). The form of the argument is valid (called a “biconditional hypothetical syllogism”), and the first two premises are true by the fatigue mechanism ($F \equiv B$ and $B \equiv L$). So, if the third premise is true (that there was a stud fatigue fracture), then LCF is implied. In practice, the fatigue fractures on the studs like those shown in **Figure 4** only need to be observed to deduce an LCF type wheel separation occurred.

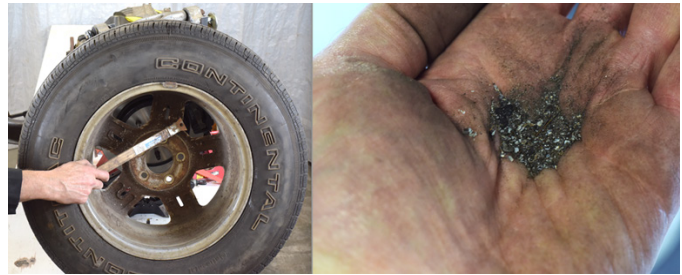
Figure 13
Debris from a wheel after it was removed from an SUV with a wire brush.

Cleaning wheel and brake rotor or drum interfaces is always part of wheel installation best practice. A considerable amount of debris can be quickly removed with a wire brush as shown in **Figure 10**. If the amount of debris shown in **Figure 13** became trapped in the interface, then it could lead to LCF.
