Journal of the
National
Academy OF
Forensic
Engineers[®]

Vol. 37 No. 1 December 2020

Use of the Repairability Assessment Method for Evaluating Asphalt-Composition Shingle Roof Repairs

By Chad T. Williams, PE (NAFE 937A)

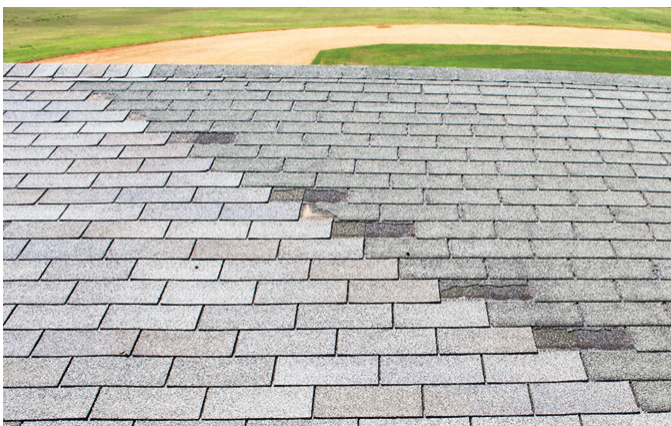
Figure 1

Failure of shingles along the perimeter of a previous repair. This represents a typical result of a nondurable and unreliable repair to a three-tab-style asphalt-composition shingle roof surface.

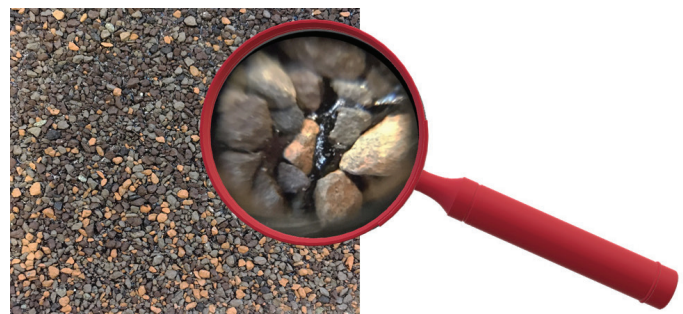
Figure 3

Magnified view of shingle granules.

The topmost layer typically consists of ceramic covered granules that are overlaid on an adhesive mix and then pressed into the asphalt mix (**Figure 2**). The ceramic coating is designed to protect the granule’s mineral core and prevent it from degrading. These granules not only provide vital protection to the asphalt mix against the sun’s ultraviolet radiation, but they also reflect the sun’s light away from the roof, thereby decreasing the temperature of the roof and the spaces below it (**Figure 3**).

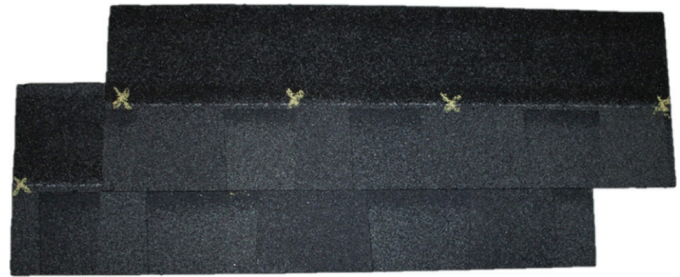
Figure 10

Typical shingle overlap, indicating the nail placement.

- Because of the nailing pattern previously discussed (**Figure 10**), the underlying shingles, 1 and 2, would be subjected to additional damage during the nail removal process. In these cases, the nail often strips through the shingle material, leaving tears and unsealed holes.

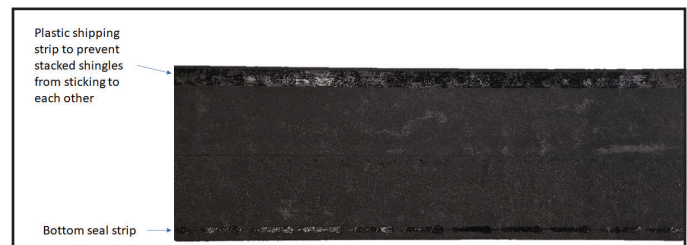
Figure 11

Typical seal strip location on the back side of a laminate asphalt-composite shingle.

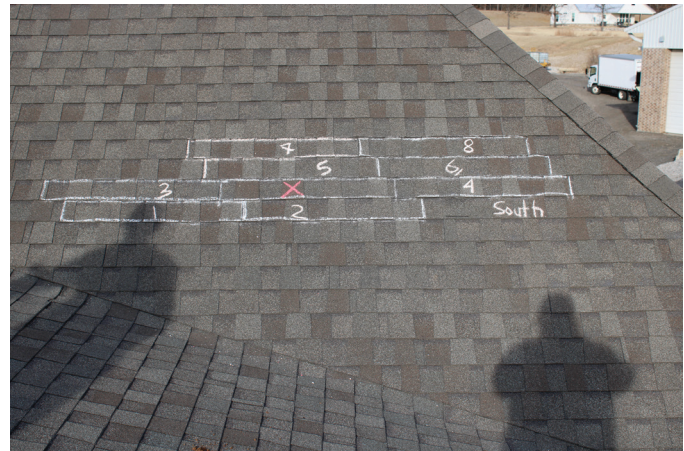
Figure 12

Outline of the primary damage assessment area.

in **Figure 12**, the shingle marked with an “X” represents a single damaged shingle. In order to remove and replace this shingle, approximately eight other shingles surrounding this one would be impacted.

- The sealant on the bottom of the damaged shingle, “X,” is adhering to the top surfaces of shingles 1 and 2. Therefore, there is potential to damage shingles 1 and 2 as the sealant is pried open in order to loosen the bottom edge of the damaged shingle.

- Conversely, the same thing exists for shingles 5 and 6, except in this case the sealant strip on the bottom edges of these shingles is bound to the top surface of shingle “X.” Again, there is potential to damage these shingles when prying the sealant loose.

- In order to access the nailing strips of shingles 5 and 6, the bottom sealed edges of shingles 7 and 8 must also be pried loose.

- Finally, shingles 3 and 4 are also susceptible to damage, resulting from the unsealing of the seal strips for shingles 5 and 6 above.

There are eight shingles that constitute the primary damage assessment area and form the basis of the repairability assessment (**Figure 12**). These shingles are specifically selected to capture the potential impact of repair actions. As outlined in the previous section, each of these eight shingles must be disturbed in order to remove a damaged shingle.

1. The first step is to mark the subject assessment shingle. This is the individual shingle to be removed and replaced as part of the repairability assessment. **Figure 12** has denoted this shingle with an “X” and pink outline. In some cases, more than one shingle can be used, depending on the area required to perform the assessment. However, for clarity, the steps and process provided below will use the layout described above.

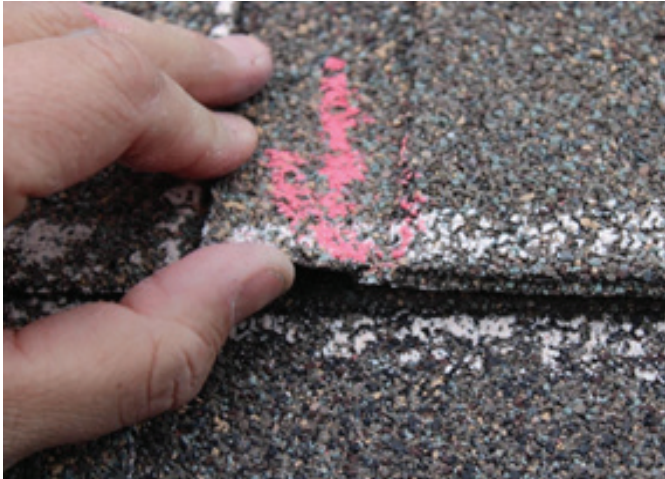
Figure 14
View of a narrow tear along the bottom edge of an asphalt-composition shingle.

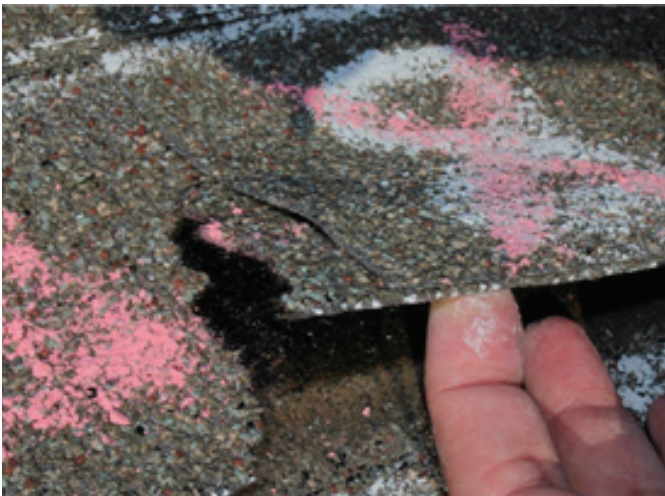
Figure 15
View of a tear along the bottom edge of an asphalt-composition shingle.

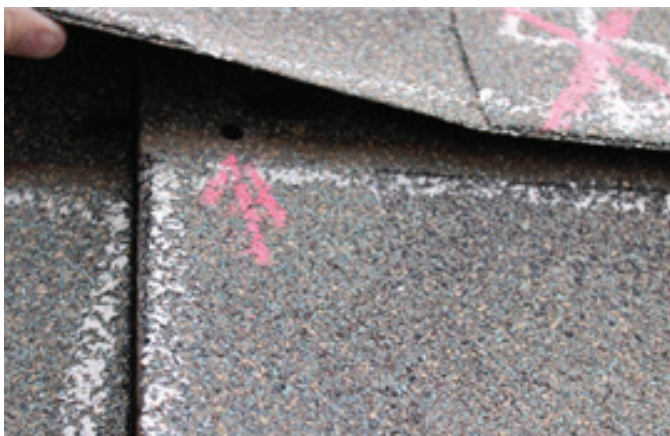
Figure 16
Shingle pulled past the nail head during the repairability assessment.

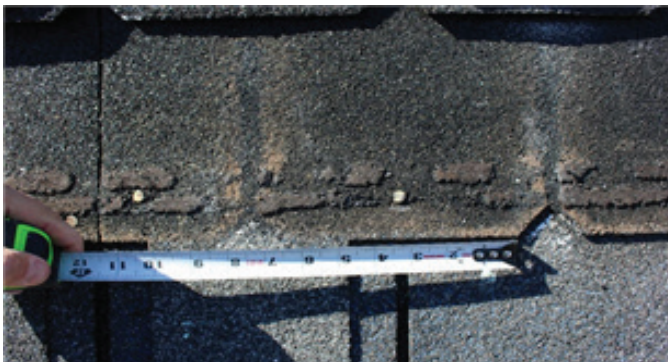
Figure 17

Transfer and accumulation of asphalt from the overlying shingle.

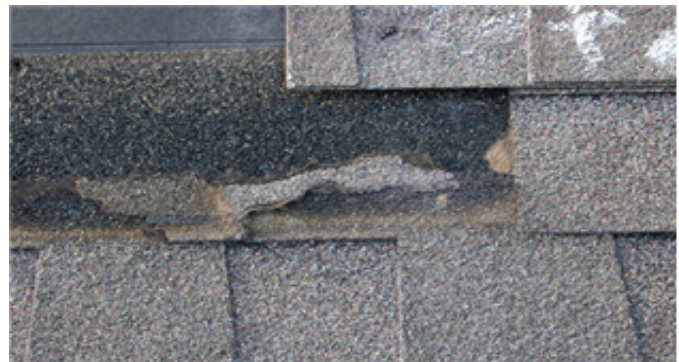
Figure 19

Shingles torn, and sections remained bonded to the underlying shingle.

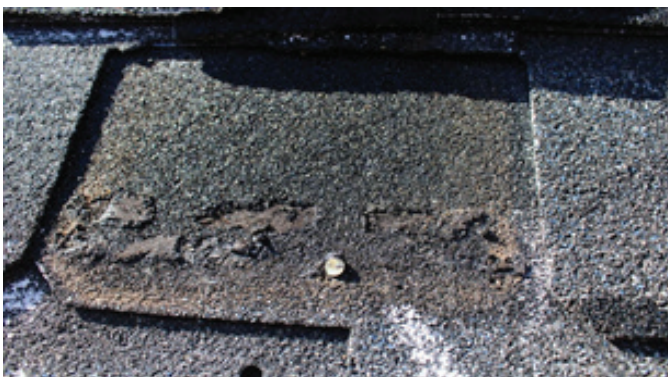
Figure 18

Displaced sections of granules at the lower seal strip. In this case, the granules and binder asphalt were transferred to the overlying shingle.
