Vol. 43 No. 1 June 2026

Investigating Effects of Imperfections on Aluminum Stepladder Using Finite Element Analysis

By John Thomazin, PE, DFE (NAFE #1188M), Bill Webster, and Sai Kosaraju, PhD

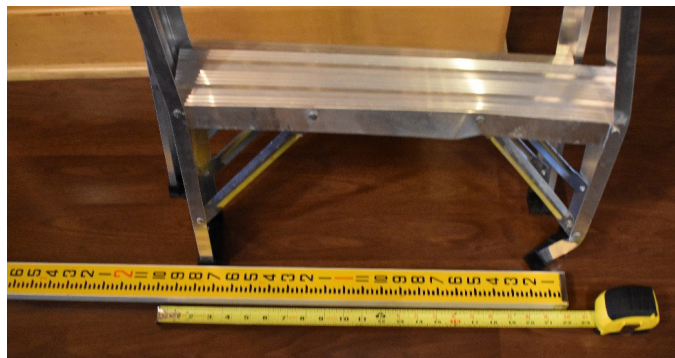
Figure 2

Buckled condition of the front side rails for the subject stepladder.

In the late summer of 2019, a homeowner was using a stepladder purchased from a home-improvement retail chain. As the stepladder was being used for household chores, the side rail components of the stepladder’s A-frame buckled, resulting in instability, downfall, and collapse. The stepladder was allegedly not overloaded or subject to abuse at the time of the collapse. The homeowner landed on his backside and was injured by the collapse. Settlement terms of the case prevent disclosure of the parties’ names and product brands. The subject stepladder was sold throughout the United States and distributed through major home-improvement retail chains. The subject stepladder is made of aluminum and has a rated load capacity of 250 pounds.

According to A14.2 requirements, the physical loads on the stepladder, and the homeowners' description of use before the collapse, the ladder should not have collapsed. The stepladder was set up on carpet, and the floor was even and firm. The homeowner weighed approximately 160 pounds — well below the ladder's working load limit. According to the claimant, at the time of the incident, the stepladder was not overloaded, and the weight was centered on its base. As shown in **Figure 2**, the right front side rail of the stepladder buckled near the first rung and braces by the connections. Overall, buckling initiated below the lower rung near the connections along the shorter, horizontal axis of the two front-side rails.

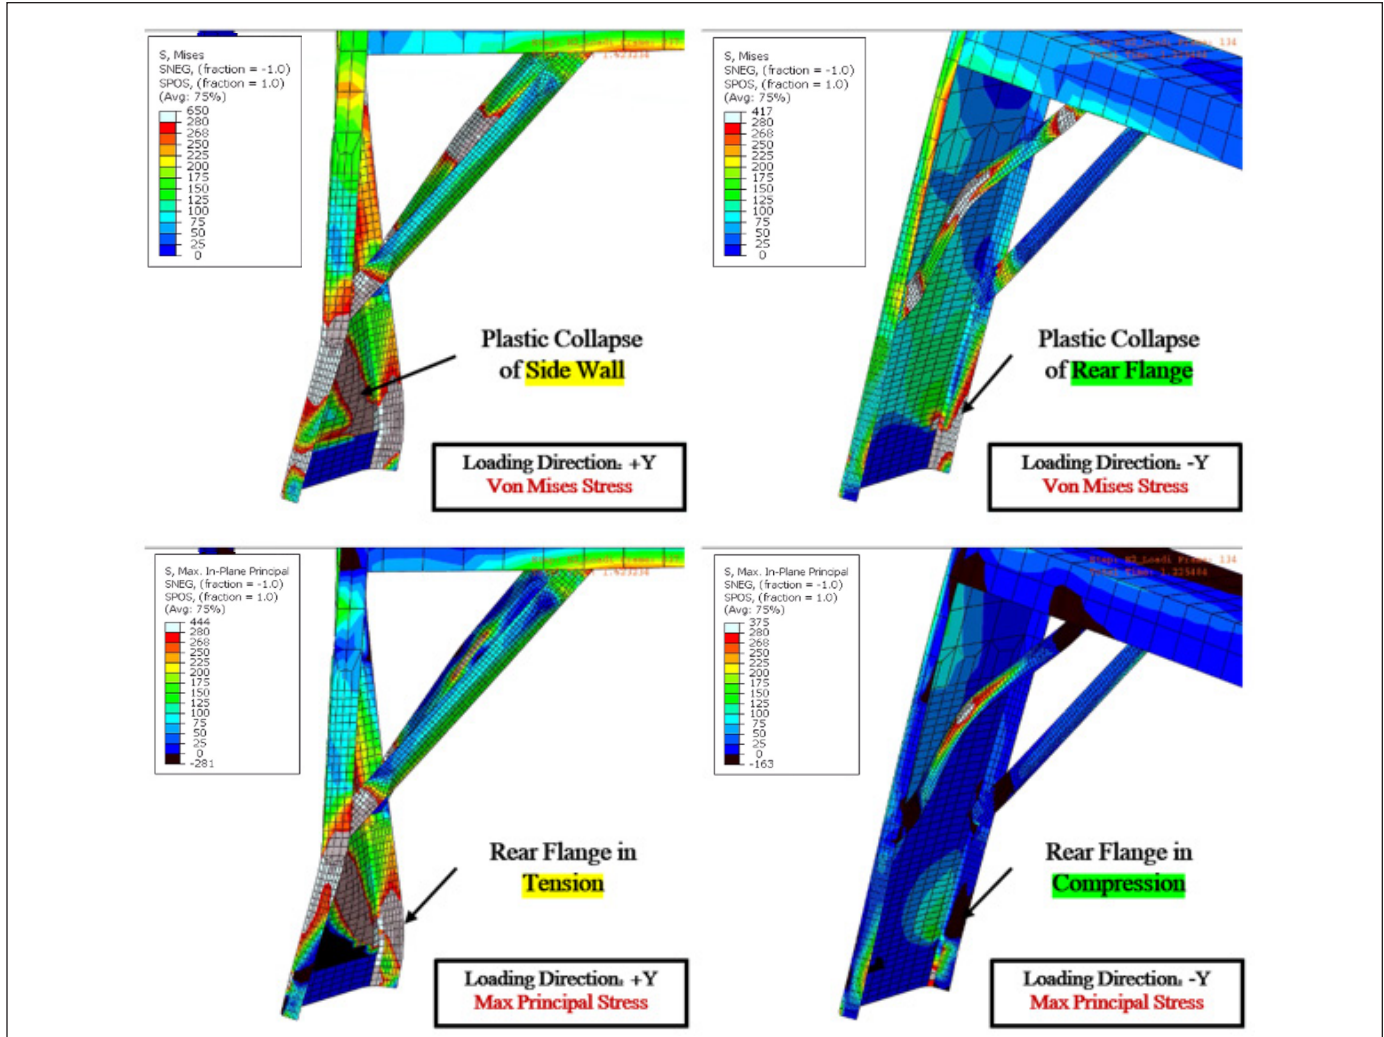
Figure 14

Nonlinear static analysis results for load directions +Y (left) and -Y (right).

The nonlinear results for the baseline ladder design indicated that the ladder buckles at 62 pounds under ANSI A14.2 loading conditions. However, when loaded in the opposite direction, the failure load is reduced to approximately 23 pounds — about one-third of the forward-loading capacity. As shown in **Figure 14**, while the ladder technically meets the 30-pound ANSI requirement when loaded according to the specification, it falls short when loaded in the opposite direction, highlighting a potential code enhancement concerning buckling collapse.

significant difference in results. When loaded according to the ANSI standard, Von Mises stresses showed material yielding initiates on the rear flange and ultimately extends across the side wall of the front leg prior to collapse. In contrast, when loaded in the opposite direction, yielding not only initiates on the rear flange but also collapses in this region (without propagating across the side wall of the front leg).

The Maximum Principal Stress plots provide additional insight into the observed failure mechanisms. Under ANSI A14.2 torsional loading (+Y direction), tensile stresses develop in the rear flange of the front leg, suppressing local flange buckling and allowing continued load transfer. As plastic deformation progresses, stresses redistribute through the side wall of the front leg, ultimately leading to global collapse driven by gross material plasticity. Conversely, when the load is applied in the opposite direction (-Y), the rear flange is placed in compression, promoting flange buckling and precipitating failure prior to significant load redistribution.

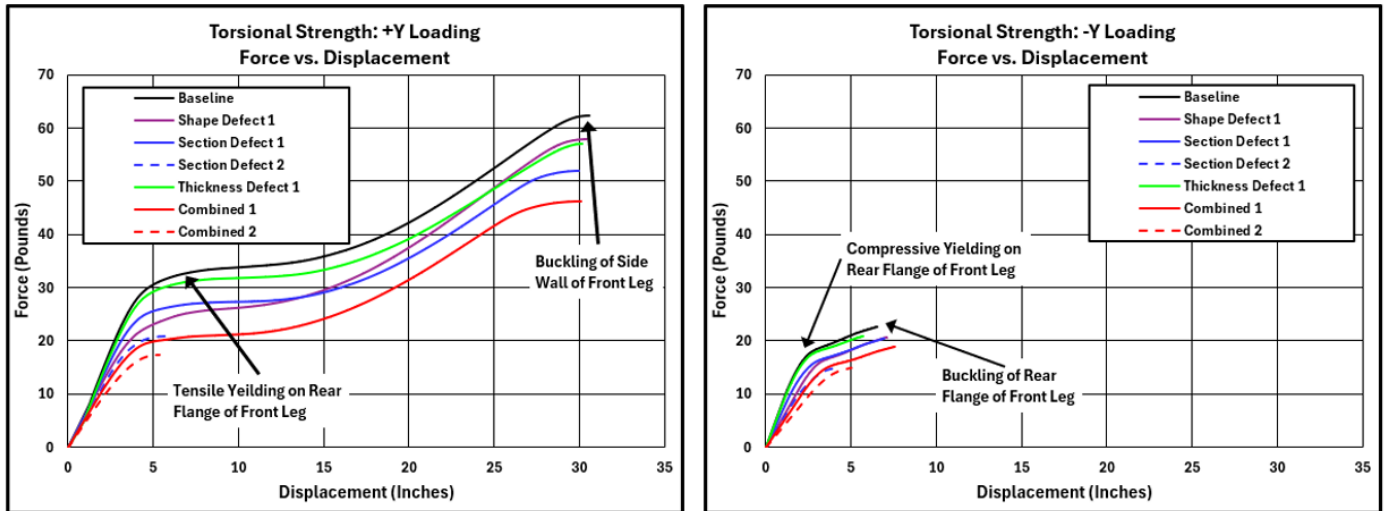
Figure 15

Force-deflection response from nonlinear static analyses for torsional loading applied in accordance with ANSI A14.2, where displacement denotes the resultant in-plane (x–y) translation of the load application node at the top of the stepladder (located 18 inches from the centerline on the rigid torsional loading bar), and force denotes the corresponding applied load transmitted through the rigid loading bar.

When the ladder is loaded in the direction opposite the ANSI A14.2 specification (–Y direction), the force–deflection curves for the baseline and imperfect models exhibit a similar response: Initial yielding in the rear flange of the front leg is followed by a rapid loss of load-carrying capacity (**Figure 15**, left). This behavior is characteristic of flange buckling and snap-through instability, in which compressive stresses dominate and prevent significant post-yield load redistribution.

In contrast, when loaded in accordance with ANSI A14.2 (+Y direction), the force–deflection response shows a distinctly different progression (**Figure 15**, right). Tensile yielding initiates in the rear flange of the front leg, suppressing flange buckling and allowing the structure to continue carrying load. As plastic deformation develops, load redistributes into the side wall of the front leg, producing a transient stiffening response before the onset of

global collapse due to gross material plasticity. The larger displacement values observed in these curves reflect continued global deformation of the ladder assembly under sustained load redistribution, rather than excessive deformation of an individual member. For clarity and comparison, all force–deflection plots were generated using consistent axis scales. While this approach introduces unused plot space in some cases, it enables direct visual comparison between loading directions and imperfection cases without rescaling effects.
