Journal of the
National
Academy of
Forensic
Engineers[®]

Vol. 42 No. 2 December 2025

Forensic Analysis of Construction Variances Associated with Cement Plaster (Stucco) Veneer Installed Over Wood Framing

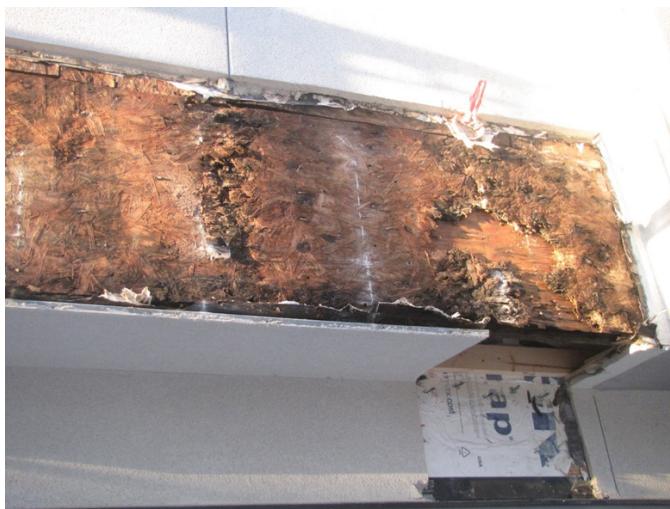
Figure 2

Example of deteriorated wood framing at vertical-to-horizontal transition without a drainage mechanism.

Although the omission of a drainage mechanism at a vertical-to-horizontal transition in cement plaster veneer may be a consistent industry practice in some locales, it may result in staining, potential biological growth, and/or other signs of distress due to water accumulation/entrapment, as shown in **Figure 2**.

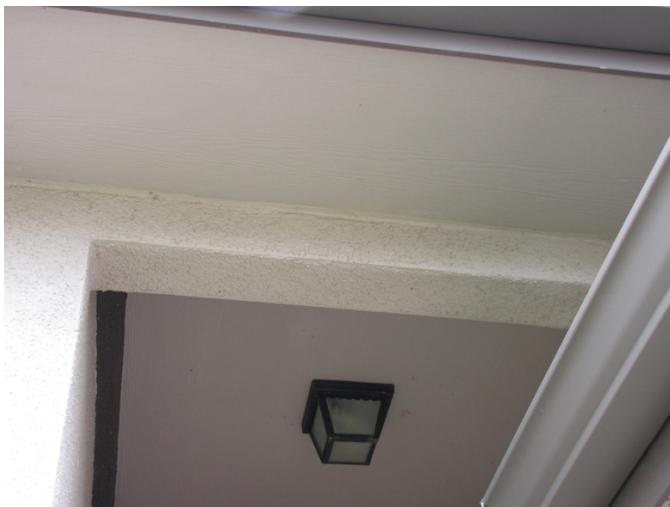
Figure 3

Example of a vertical-to-horizontal transition at a covered location.

A forensic investigation should consider other factors such as roof cover and/or weather exposure. For example, if the roof projects beyond the exterior wall/header plane for a horizontal distance greater than the vertical height of the wall/header area above the vertical-to-horizontal transition in the veneer (as shown in **Figure 3**), the investigator

may be justified in concluding that the as-built omission of a drainage mechanism at the vertical-to-horizontal transition is not susceptible to damage because the roof overhang would serve to mitigate any potential water contact with the upper portion of the wall above the transition and significantly decrease the volume of water to be evacuated from the drainage plane underlying the veneer above the transition, if any.

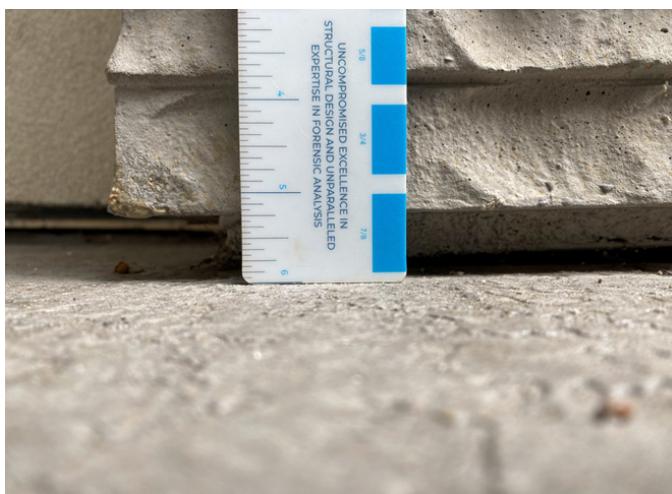
Figure 5

Adhered masonry veneer installed with not less than $\frac{1}{2}$ of an inch of clearance to the foundation.

Section R703.12.1 of the 2024 IRC specifies that adhered masonry veneer shall be installed a minimum of 4 inches above the earth and a minimum of 2 inches above paved areas — similar to the aforementioned prescriptive specifications for cement plaster veneer. However, unlike the prescriptive specifications for cement plaster veneer, Section R703.12.1 of the 2024 IRC also explicitly specifies that adhered masonry veneer shall be installed a minimum of ½ of an inch above exterior walking surfaces that are supported by the same foundation as the exterior wall (e.g., porch, patio), as illustrated in **Figure 5**.

The 2024 IRC permits the installation of adhered masonry veneer within a distance of ½ of an inch above a monolithic porch/patio surface, apparently acknowledging that ½ of an inch of clearance at such locations is sufficient to provide adequate drainage for a cladding system comprised of cement plaster (adhered masonry veneer and/or stucco). The intent of specifications associated with
