Journal of the
National
Academy of
Forensic
Engineers[®]

Discerning Wind-Related Damage to Residential Roofs

By Ziad Azzi, PhD, PE, DFE (NAFE #1343M), Krishna Sai Vutukuru, PhD, PE, and Manuel Matus, PhD

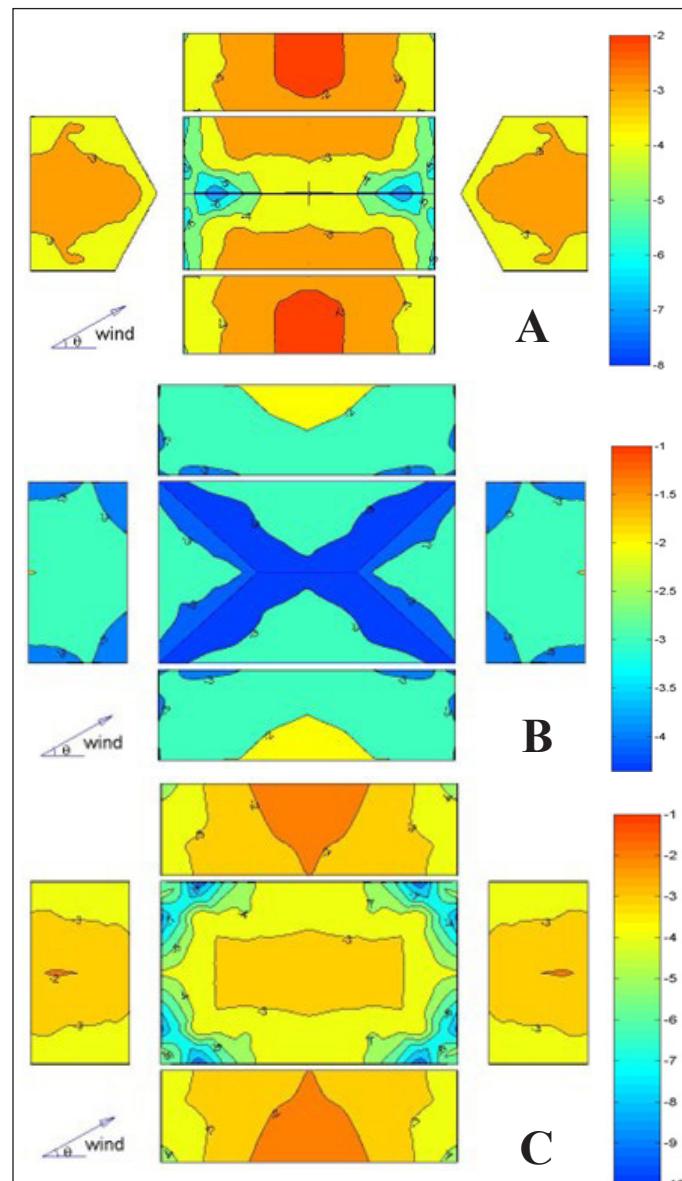
Figure 1
Contour plots of critical peak pressure coefficients for:
a) gable roof, b) hip roof, and c) flat roof.
Courtesy of Tokyo Polytechnic University (TPU)^{32,33}

This graphic demonstrates that a typical wind damage pattern is generally located near the roof edges, corners, and ridges (or hip lines in case of hip roof configuration) before the wind can cause uplift to other areas, such as the field of the roof. While this is true for shingle and tile roofs, flat or low-slope roofs are typically covered with membranes, which may call for stricter guidelines or

The shape and configuration of a roof determine how wind interacts with its surface, as depicted in **Figure 1**. Gable roofs, for instance, create strong uplift forces at the ridges due to flow separation, making them more vulnerable to wind-induced damage. In contrast, hip roofs tend to distribute wind loads more evenly, reducing the likelihood of localized failure. Flat roofs, on the other hand, are particularly susceptible to vortex-induced suction, which can lead to the detachment of the roof covering at the corners. Roof slope is another critical factor influencing wind pressure distribution. Studies using computational fluid dynamics (CFD) simulations indicate that steeper slopes can reduce uplift forces, while flatter roofs experience higher suction forces³⁴. Optimizing roof slope can significantly enhance wind resistance, particularly in hurricane-prone regions.

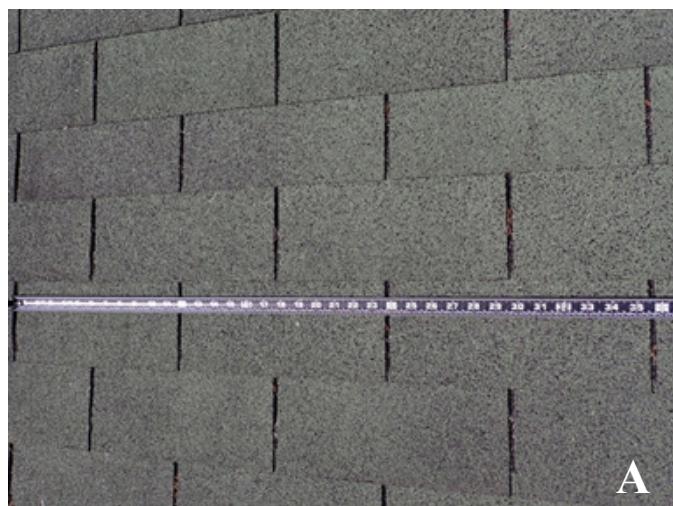
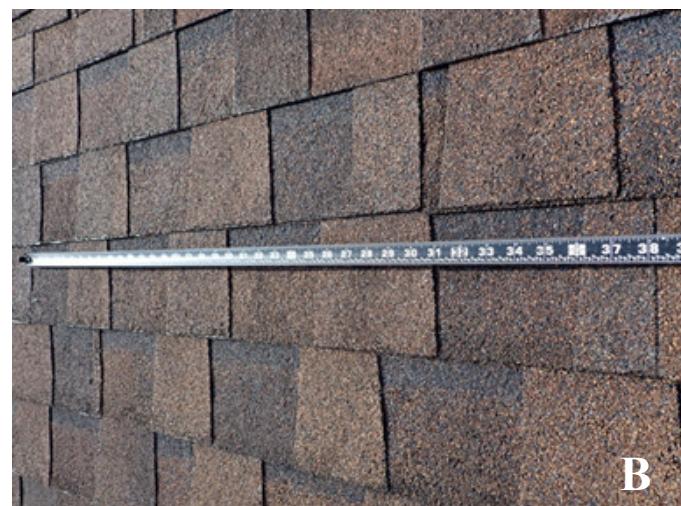
Figure 2
Types of shingles: a) 3-tab, b) architectural.

Architectural, or dimensional, shingles consist of multiple laminated layers of asphalt-saturated fiberglass mats, providing increased mass and enhanced mechanical interlock. This multi-layered configuration improves their modulus of elasticity and resistance to wind uplift forces. The irregular geometry and increased thickness contribute to better impact resistance. From a structural engineering standpoint, the higher unit weight imposes a slightly greater dead load but offers improved inertia against fluttering and delamination. These shingles generally exhibit a service life of 25 to 30 years (when adequately maintained). They are better suited for regions with moderate to high wind loads, offering enhanced aesthetic and functional performance (according to the International Association of Certified Home Inspectors or InterNACHI), as shown in **Figure 2**.

You can identify dimensional shingles by their unique look. Unlike 3-tab shingles, these shingles are not cut into identical shapes. Instead, each shingle is manufactured with alternating areas or tabs of single and double layers. This pattern is often referred to as “dragon’s teeth.” Some manufacturers also add a shadow line to some products,

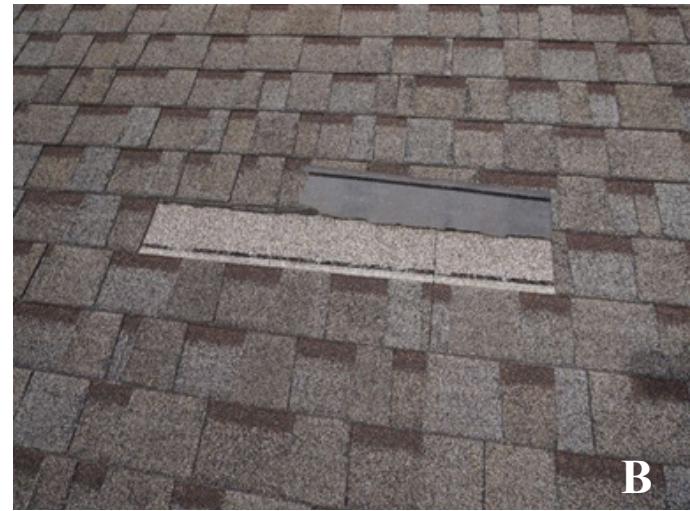
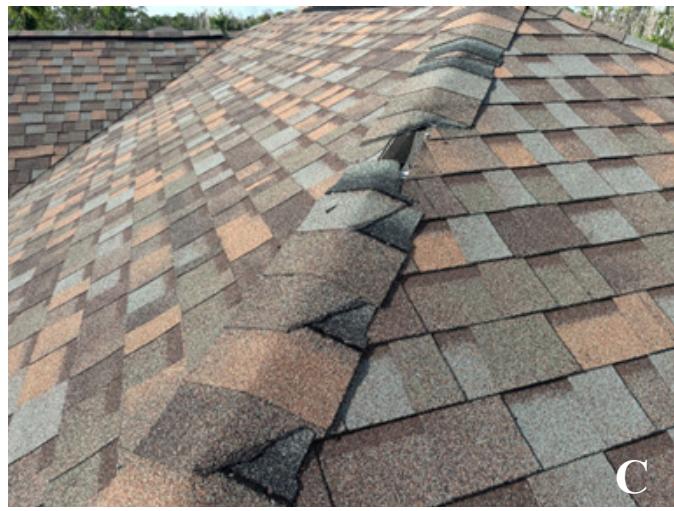
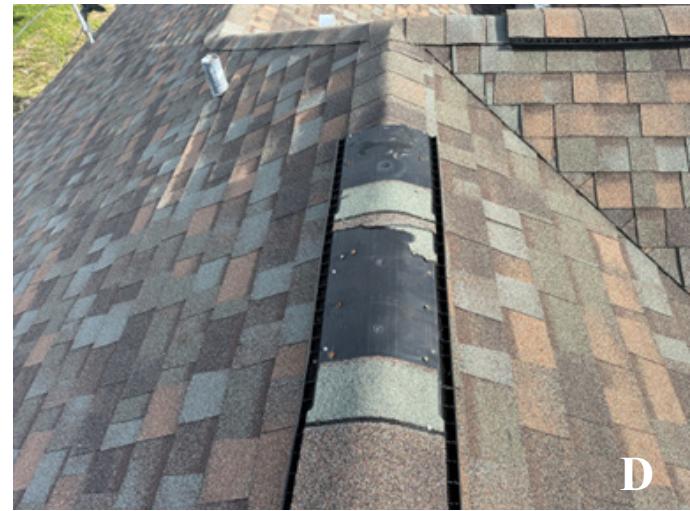
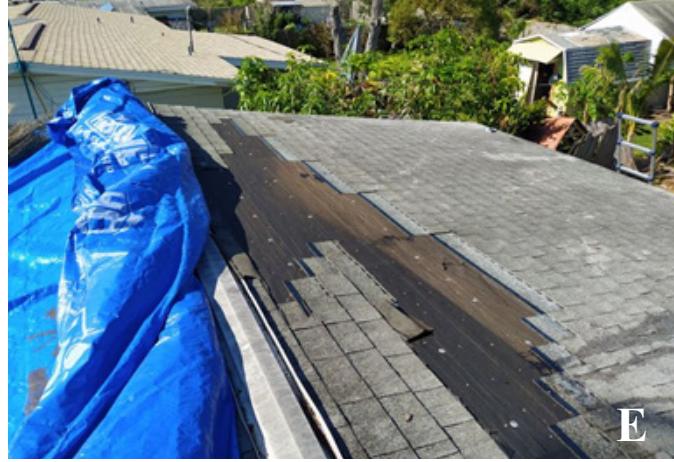
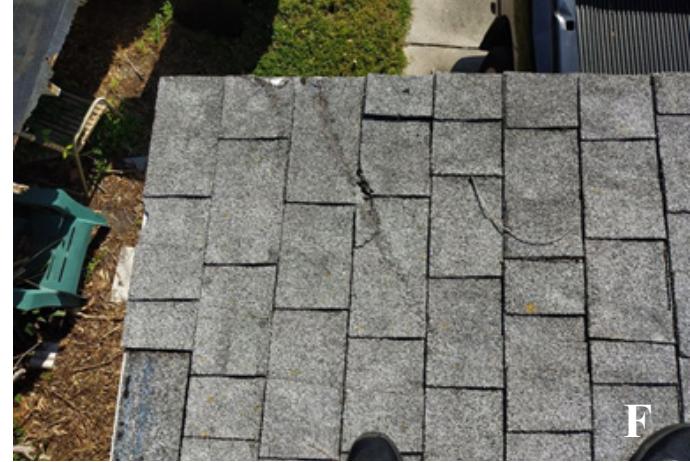
Figure 3

Wind-related damage: a) creasing, b) flipping/flapping, c) tearing of hip shingles, d) tearing of ridge shingles, e) removal, and f) windborne debris impact (linear pattern).

A previous study was able to identify four primary modes of asphalt shingle failures, which were obtained from field observations performed after Hurricane Frances in 2004⁴⁵. According to the study, the four identified wind-induced damage modes are: 1) creasing (Figure 3a); 2) flipping/flapping (Figure 3b); 3) tearing/removal (Figure 3c, Figure 3d and Figure 3e); and 4) abrading from flying

or falling debris (Figure 3f)⁴⁵. In addition, the study identified factors that can lead to asphalt shingle failure during windstorms, such as degree of weathering, design, quality of manufacture, and quality of installation.

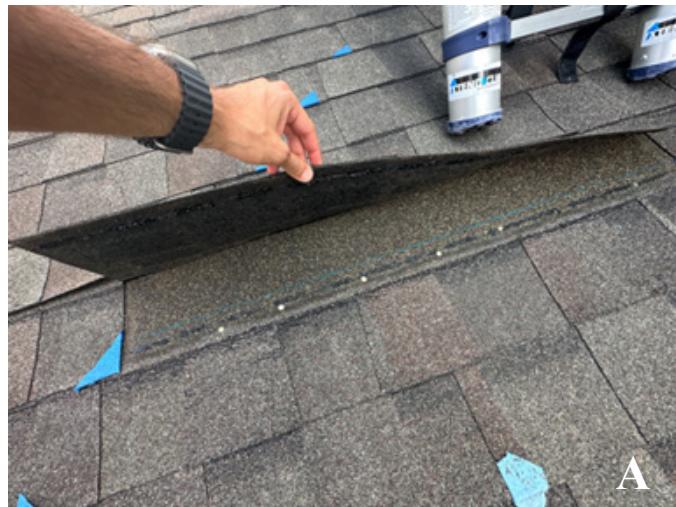
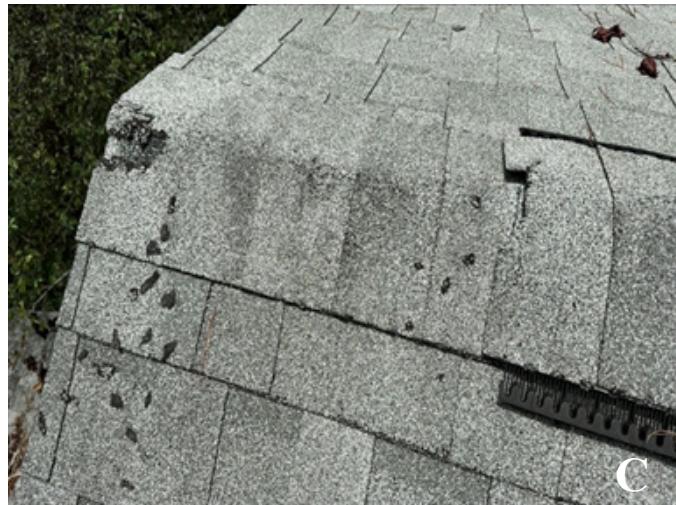
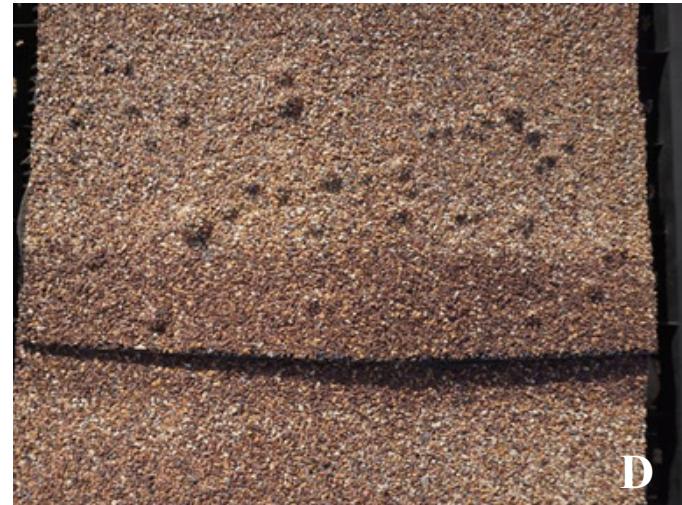
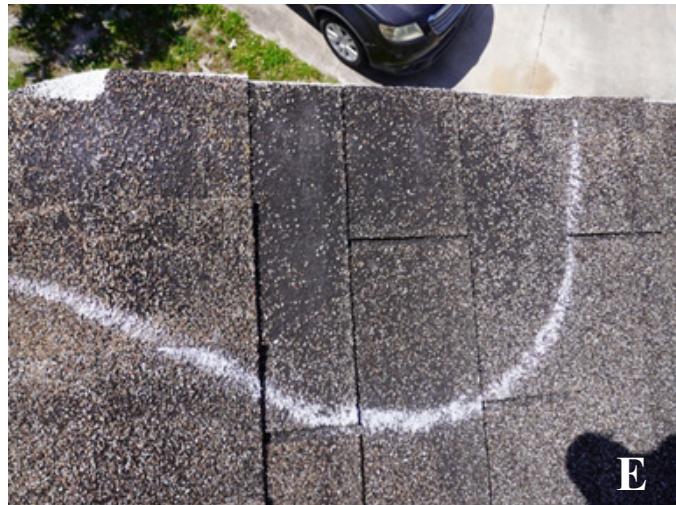
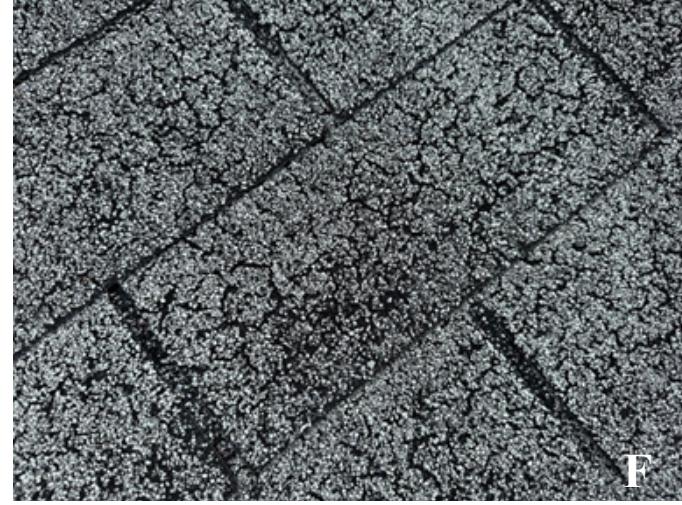
Figure 5

Nonwind-related damage: a) debonding, b) tree abrasion, c) animal activity, d) blistering, e) granular loss, and f) alligatoring.

Severe splitting of aged shingles is typically referred to as “alligatoring,” since the cracked and wrinkled appearance of the shingles surface resembles the hide of an

alligator (**Figure 5**). Random cracking does not follow any distinct pattern, often starting as surface crazing and eventually leading to complete splits as the shingle ages, while in-line cracking occurs directly above joints in the sheathing panels, depending on the movement of the roof decking⁴⁶. These cracks can significantly compromise the roof's structural integrity, increasing the risk of water infiltration and wind damage, making shingle splitting a critical concern for designers and contractors.

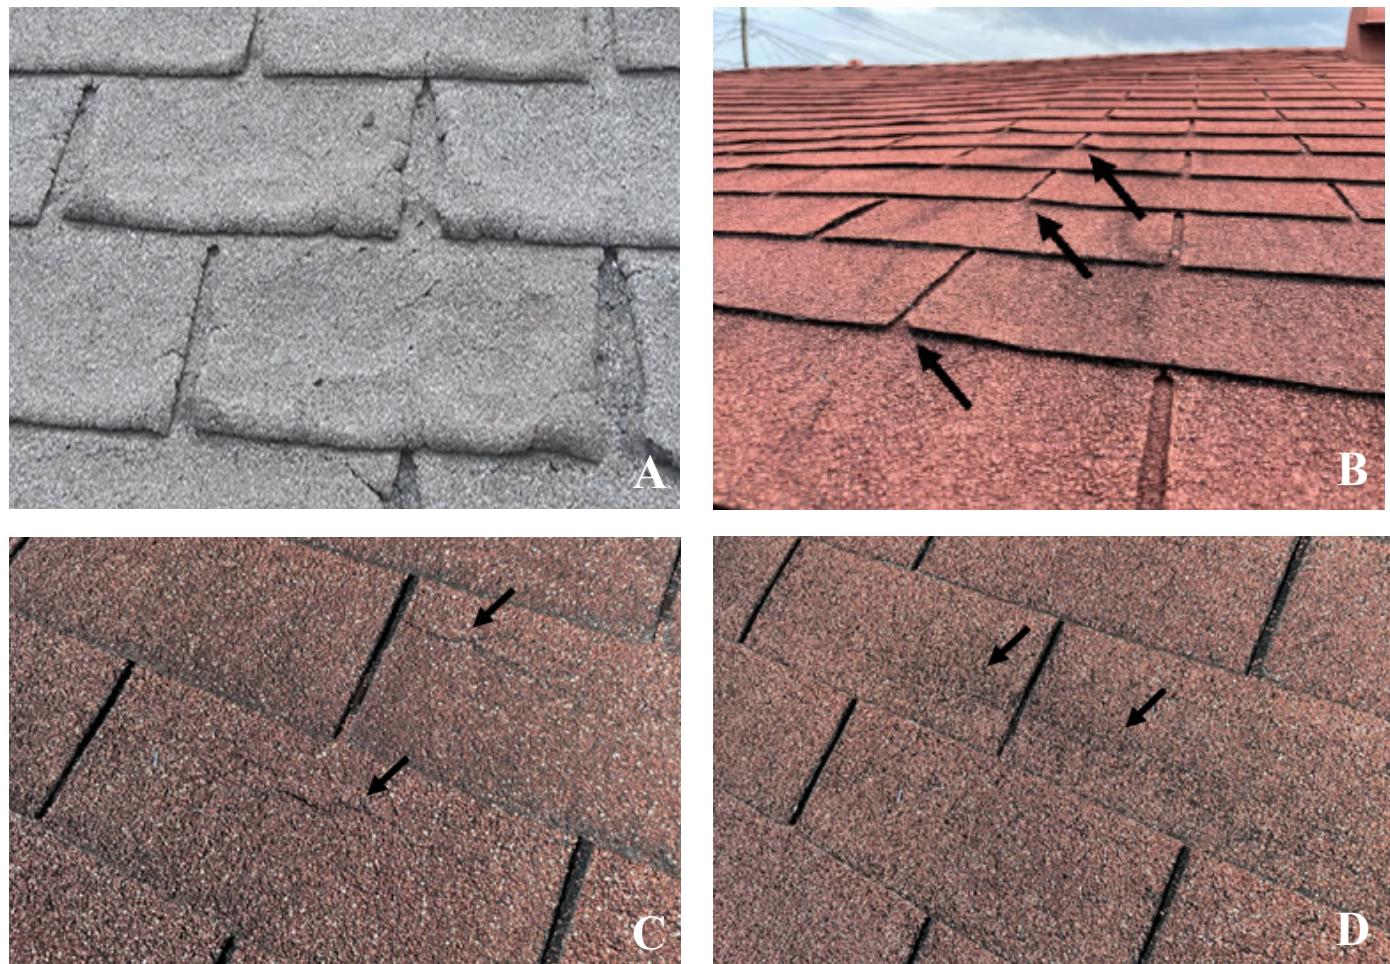
Figure 6

Nonwind-related damage: a) clawing, b) cupping (or curling), c) random thermal splitting, and d) horizontal thermal splitting.

deformation on the shingle tabs edges (**Figure 6**). Although commonly dismissed as aesthetic issues, these forms of deformation may signal underlying structural degradation and increase susceptibility to cracking or wind uplift over time. Differentiating them from true wind-induced failures, such as creasing or tearing, is essential for accurate roofing evaluations and insurance assessments^{45,46}.

Shingle splitting can take several forms, including horizontal, vertical, random, and in-line cracking. Horizontal splitting occurs between the two lines of restraint, with one part of the shingle fastened to the roof deck and the other edge secured by the sealant strip. Vertical splitting typically occurs when the top shingles shrink over the butted joints of the underlying shingles, with splits extending vertically upslope in raked installations and in curved patterns in diagonally installed shingles⁴⁵. A couple of examples of shingle thermal splitting are provided in **Figure 6**.

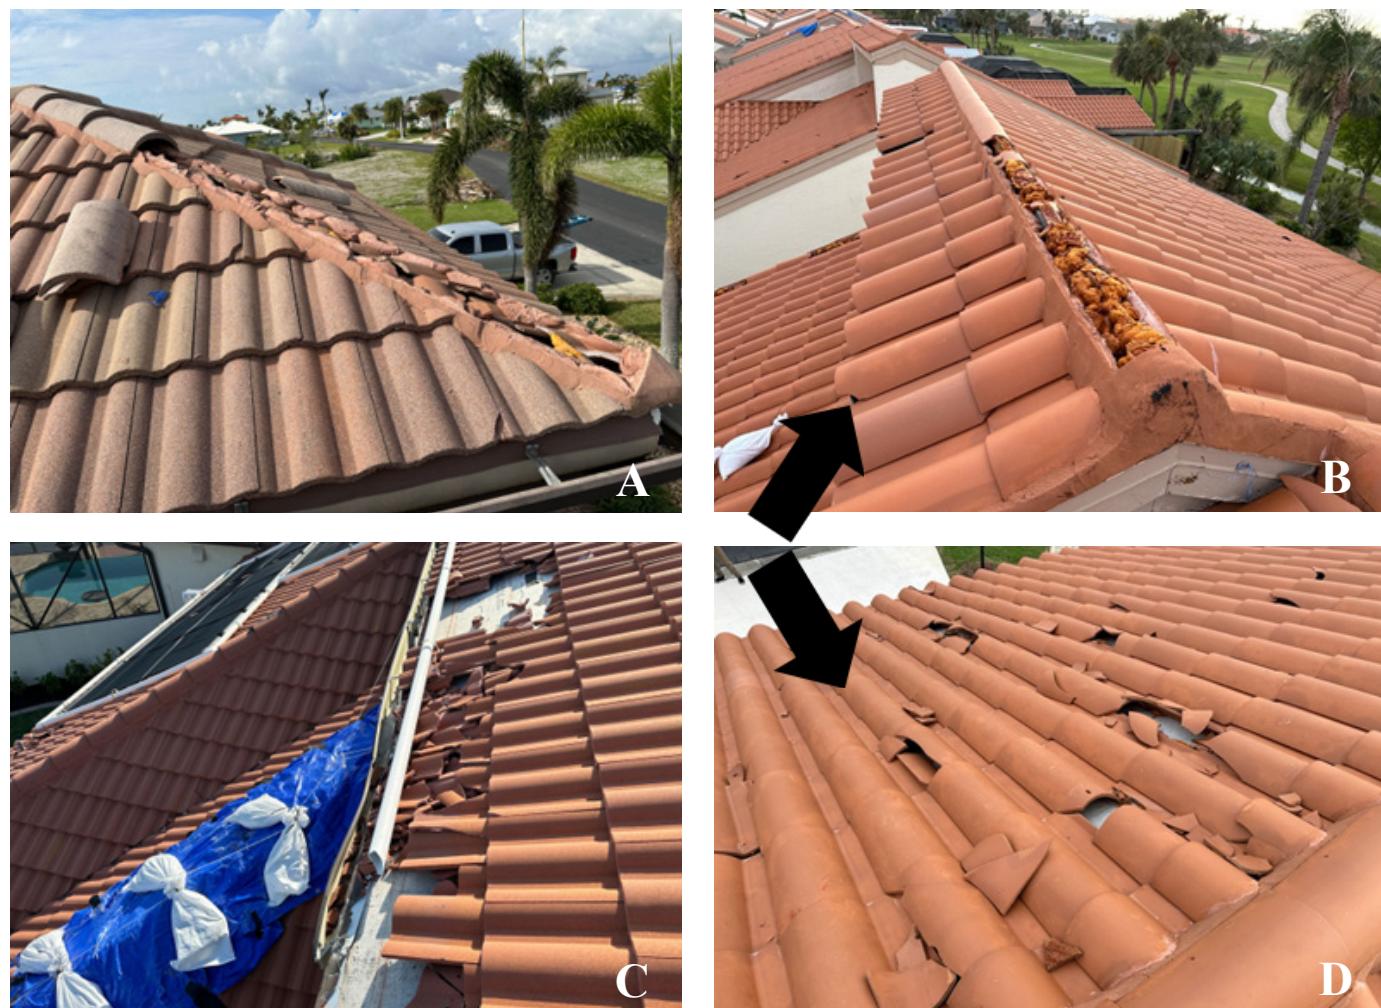
Figure 8

Wind-related damage: a) uplifting of hip cap tiles, b) uplifting of ridge cap tiles, c) impact with windborne debris, d) fractures from impact with windborne debris (black arrows indicate oncoming wind direction on the date of loss).

Some roof manufacturers, especially in recent times, have included additional fasteners in these zones to increase wind resistance in these zones. Further studies have shown that most roof damage tends to occur on the windward side, where tiles are subjected to higher net uplift forces. This is because both external and internal pressures (with internal pressure forming in the gap between the tiles and the roof deck) align in the same direction, increasing the overall forces on these tiles. In contrast, tiles on the leeward side benefit from a reduction in stress, as the internal and external forces act in opposite directions, providing a degree of relief^{63,64,65,66} (**Figure 8**).

Field investigations and past reconnaissance have shown that mortar attachments are often inadequate to withstand the high uplift pressures experienced during hurricanes, particularly in storm-prone areas. This is mainly because mortar tends not to bond effectively with the tiles unless the tiles are pre-wetted — a practice indicative of less effective construction⁵³. Consequently, when subjected to extreme wind forces, tiles either detach from the mortar or tear the underlayment, leading to significant roof damage⁵⁴ (**Figure 8**).

Damage to concrete roof tiles induced by windborne debris displays distinct failure mechanisms and fracture characteristics when compared to mechanical damage from nonwind-related sources. Windborne debris impacts are typically high-velocity and irregular, arising during extreme wind events such as hurricanes. These impacts frequently result in localized, brittle failures manifesting as transverse cracking, edge fragmentation, or surface spalling with the most damage observed on roof slopes oriented toward the prevailing wind direction (**Figure 8**).

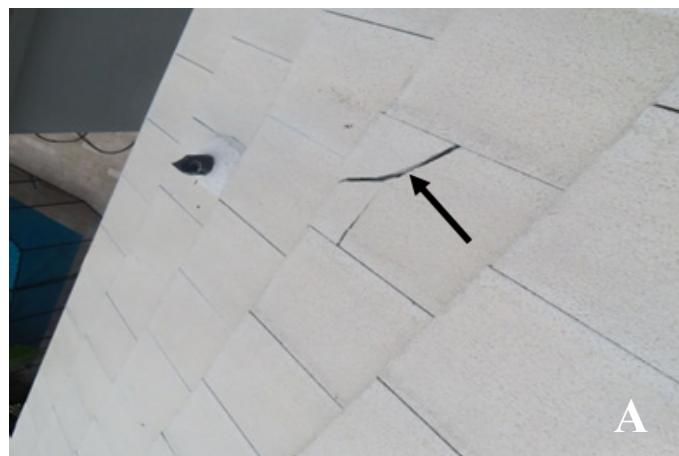
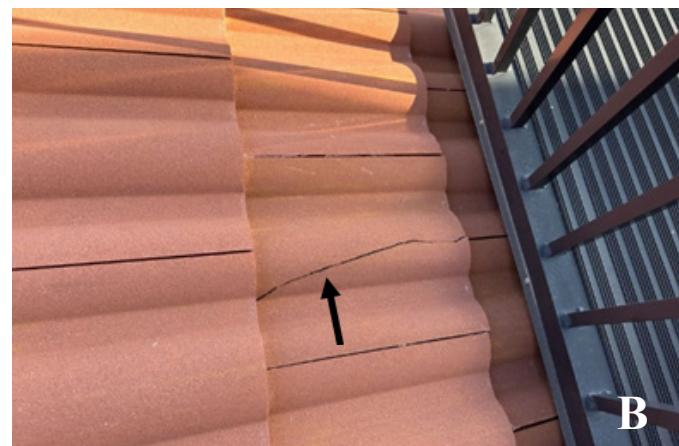
Figure 10

Nonwind-related damage: a) footfall damage, b) fractured tile due to foot traffic, c) algae accumulation, d) mildew growth.

Impact damage is a leading cause of nonwind-related failure in tiled roofing systems. This includes localized cracking from foot traffic, impacts from overhanging branches, and tool or ladder contact during maintenance activities. Such cracks are typically irregular and located in walkways, valley intersections, or under satellite dish mounts^{69,76}. Concrete tiles, though more resilient than clay, are still susceptible to cracking or chipping at unsupported corners when subjected to concentrated loads emanating from foot traffic and mechanical impact⁷⁰ (**Figure 10**).

Footfall damage to roof tiles is typically evidenced by a linear nature of the cracks and lack of radial cracks emanating from point of impact to broken tile surfaces. Broken tile pieces typically remain in place or are slightly displaced downward, depending on the age of the fracture itself. As such, broken tile fragments that remained in place are evidence that the cracking was not caused by wind, as strong wind would have removed the cracked portion from its original position.
