Journal of the  
**National**  
**Academy** OF  
**Forensic**  
**Engineers**<sup>®</sup>

Vol. 41 No. 1 June 2024

# National Academy of Forensic Engineers®

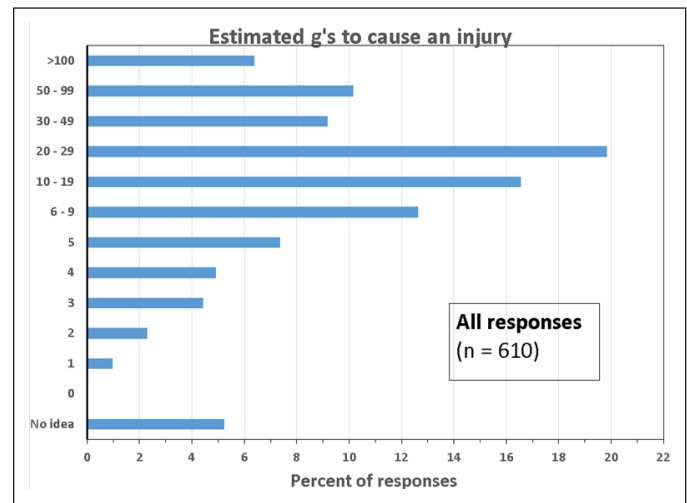
Respondent estimates of how many g's would be required to cause a bodily injury.

Figure 4 presents respondent estimates of how many g's it takes to cause a bodily injury.

For all 610 responses, a total of 32 participants (just over 5%) "had no idea" (only three of these were "completed physics" respondents). Fortunately, no one responded that 0 g's was a good estimate, indicating that all respondents felt that at least some force was required to cause a bodily injury. To cause a bodily injury, 14 respondents felt only 2 g's was required, 27 estimated 3 g's, 30

estimated 4 g's, and 45 indicated 5 g's. A total of almost 46% of all respondents thought the value was between 10 and 50 g's; 62 respondents felt the value was between 50 and 99 g's, and 39 felt it was greater than 100 g's. Of those who "completed physics," less than 8% felt the value was 5 g's or less whereas almost 22% of "no physics class" estimated the value to be < 5 g's. This question was intended to get a general feel for what respondents felt about how many g's were needed to cause a bodily injury; no specific injury or injury type was indicated in the question. Obviously, the estimate range is injury-specific and a function of age, gender, and other biomechanical and physiological parameters.

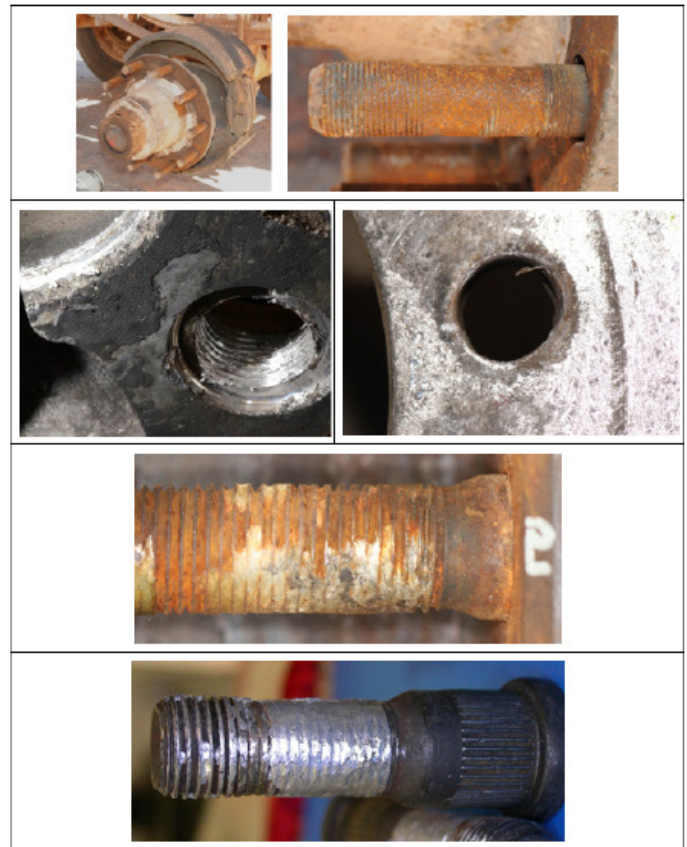
**Figure 3**  
Examples of nut spin-off fastener failures. Top row: A left rear heavy truck axle end with missing dual wheels and brake drum. The threads of all 10 stud shanks were worn down like the one shown. Second row: wheel stud hole thread imprints from bearing on a stud and wheel stud hole elongation. Third and fourth rows: wheel metal embedment in stud threads on two left side wheel separations.

Many left side wheel separations present like the example in the upper left of **Figure 3** (wheel and all nuts missing — and all studs straight and unbroken). In addition to missing nuts, close inspection often reveals stud thread wear, wheel metal embedded in stud threads, stud thread imprinting in stud holes, and stud hole elongation. The nuts are most often not recovered.

implies LCF. In practice, the evidence of nut spin-off like those shown in **Figure 3** only needs to be observed to deduce an LCF type wheel separation occurred.

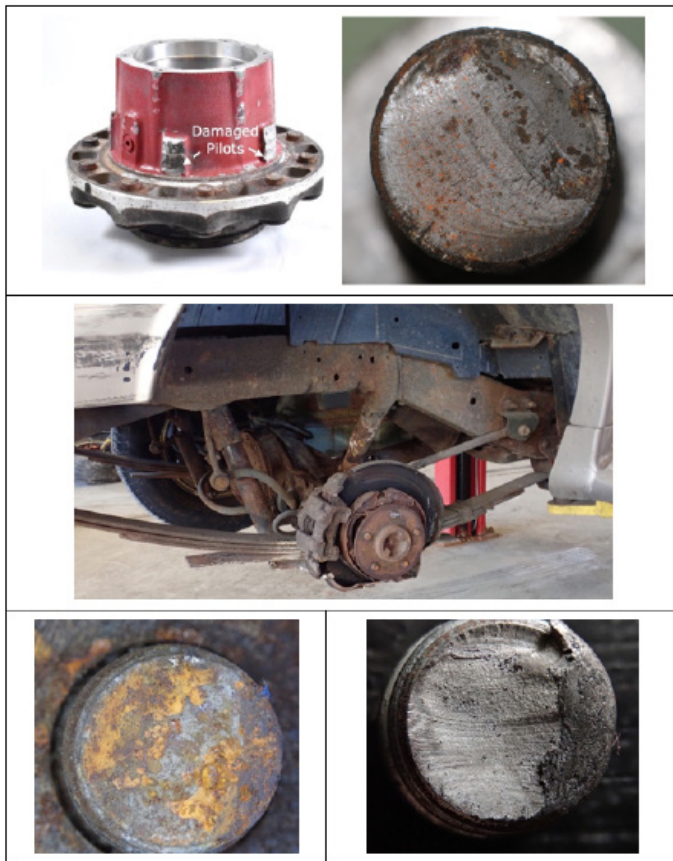
Examples of stud breakage fastener failures. Top row: a heavy truck hub with 10 broken studs — all with fatigue fractures like the one shown. Middle and bottom rows: an SUV right rear wheel separation. Bottom row shows a right rear wheel stud before and after cleaning. The stud fatigue fracture is readily apparent after cleaning.

Most right side and some left side wheel separations feature transverse stud fatigue fractures. The nuts and distal stud remnants are most often not recovered. In **Figure 4**, the five studs on the passenger vehicle and 10 studs on the heavy truck all broke transversely from fatigue.

For right side wheel separations, all the studs were broken in most cases. The broken studs typically displayed evidence of fatigue like the studs shown in **Figure 4**. Sometimes, the stud fractures were fresh enough to readily observe fatigue features, sometimes, the fracture had to be cleaned to observe fatigue features, and other times, the fracture surfaces had deteriorated so only transverse fractures were observed. No evidence of nut spin-off was observed in any of the right side fastener failure cases.

Where  $\equiv$  is the biconditional *iff* (if and only if). The form of the argument is valid (called a “biconditional hypothetical syllogism”), and the first two premises are true by the fatigue mechanism ( $F \equiv B$  and  $B \equiv L$ ). So, if the third premise is true (that there was a stud fatigue fracture), then LCF is implied. In practice, the fatigue fractures on the studs like those shown in **Figure 4** only need to be observed to deduce an LCF type wheel separation occurred.

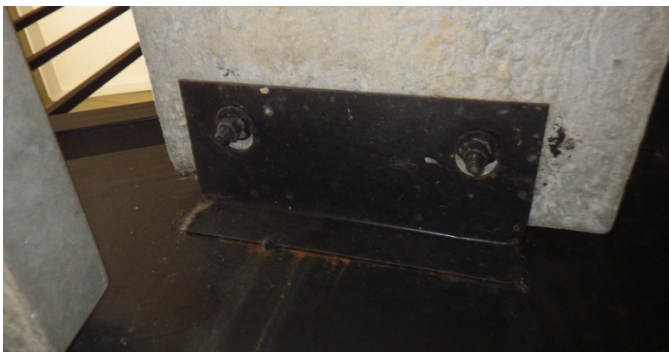
**Figure 3**

Concrete stair tread attachment to steel frame.

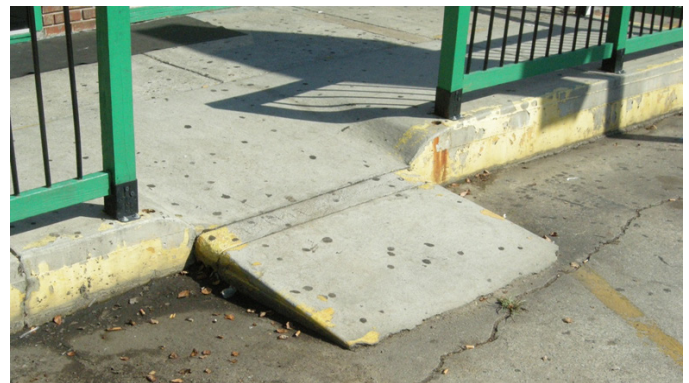
**Figure 4**

Combination standard and extended curb ramp. Lack of side flares on the extended portion presents a trip hazard to pedestrians approaching laterally.

An increasingly widespread type of exterior ramp is a curb ramp, which provides for elevation change access across a curb. They are of two types: ramps formed or cut into the curb and sidewalk (standard type) or extended (built-up) curb ramps that are built out from a curb onto the lower elevation paving (**Figure 4**). Curb ramps

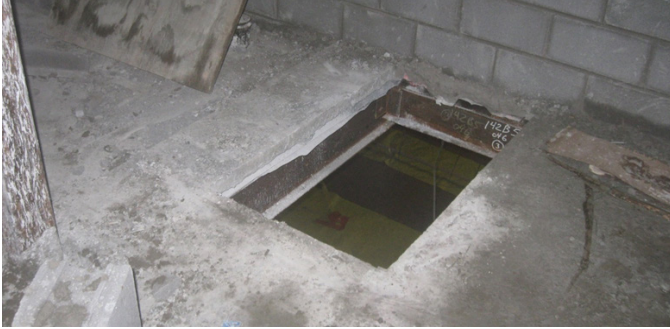
**Figure 5**

Temporary floor opening at construction site requiring fall prevention features, such as covers or barricades per OSHA and ANSI requirements.

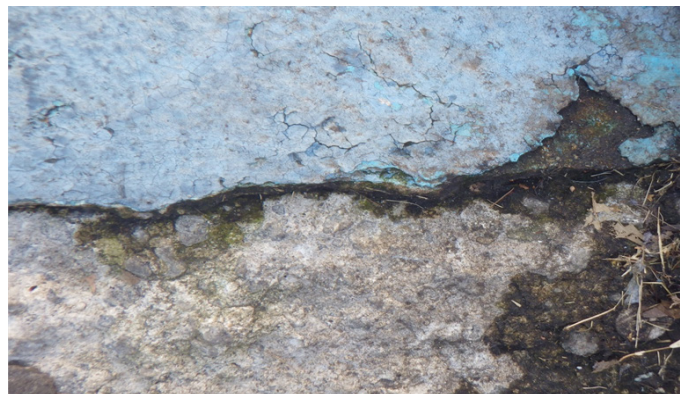
**Figure 7**

Extended curb ramp edge material loss potential trip hazard.

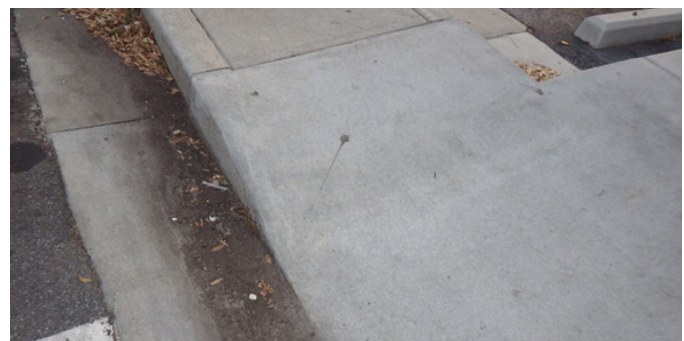
**Figure 15**

Curb ramp flare with excessive slope.

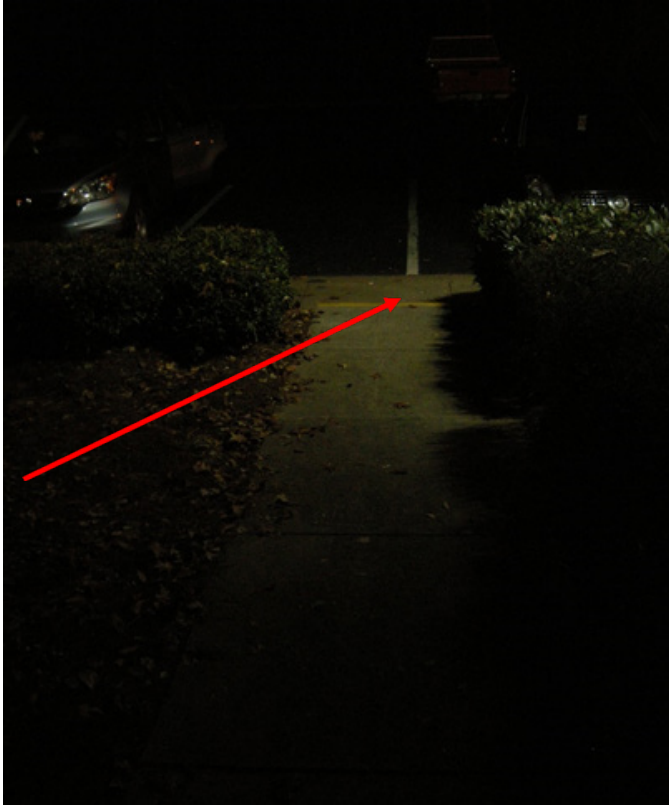
**Figure 16**  
Walkway at night looking toward  
single step down (indicated by arrow).

crossing sidewalk where it approached the parking area. A visitor did not visualize this feature at night and lost balance, crossing it from above (**Figure 16**). Illumination during nighttime inspection was documented to differ from the time of the incident — namely that new fixtures had been added, and non-functional fixtures had been restored to service (**Figure 17**). An illumination study at the walkway level indicated that in areas shadowed by adjacent shrubs and/or the walkway elevation change that lighting levels were less than 0.13 fcd with all lighting functioning. Temporary removal of that reportedly added illumination resulted in measured lighting levels below 0.06 fcd. At the inspection, the elevation change was striped yellow, although it was documented that this striping was not present on the incident date.

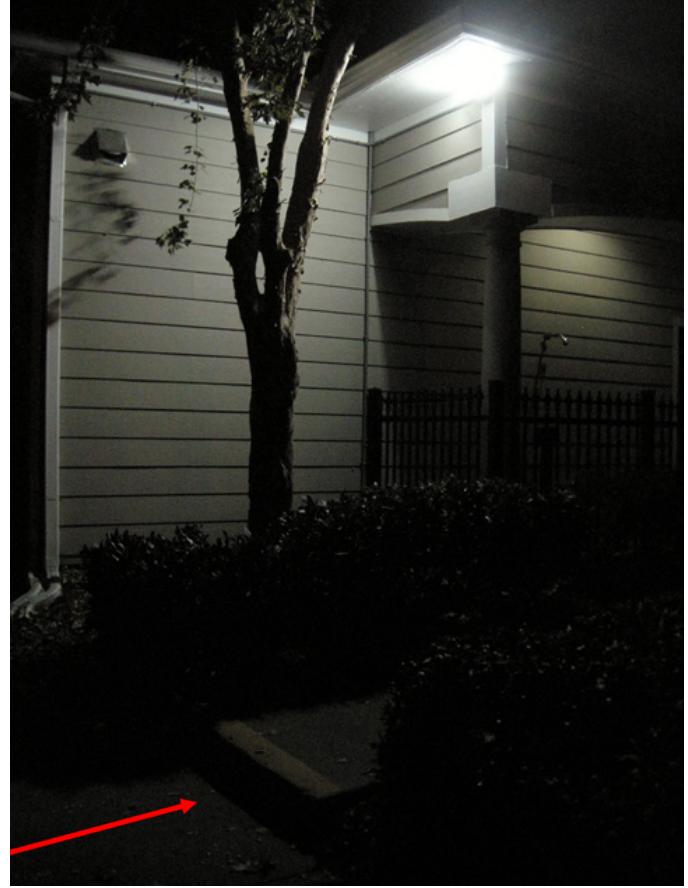
**Figure 17**  
Primary illumination for walkway step  
down (arrow) at time of inspection
