Forensic Engineering Investigation and Analysis of a Tower Crane Collapse

By Bransford Pickett, MScBa, P.E. (NAFE 795M)

Abstract

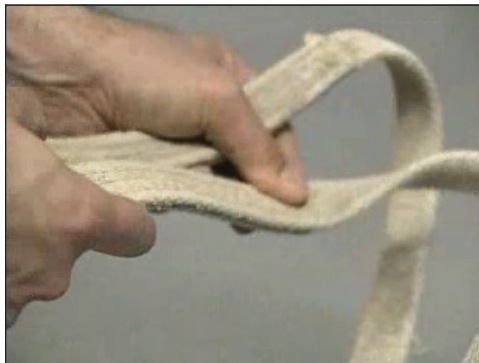
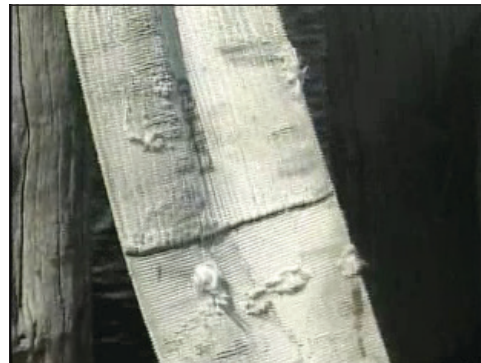
Figure 9

A leading authority on synthetic slings, the WSTDA has produced several publications and videos on slings, including an educational video that shows an inspection protocol for polyester slings with tips for recognition of UV-degraded slings. The excerpts in **Figure 9** and **Figure 10** are examples from the video identifying UV-degraded slings. **Figure 10** shows a comparison of the Ex_Lift sling and a WSTDA UV-degraded sling. Note the distinct bleached appearance of the WSTDA sling versus the intact color of the Ex_Lift sling. The most significant finding from the Ex_Lift sling inspection was that the stiffness and brittleness was comparable to the All_Lift slings that were regarded as newer.

The review and comparison of the Ex_Lift sling to both the WSTDA sling inspection protocol for UV-degraded slings and the newer All_Lift slings showed no UV degradation present, surface abrasion, stiffness, bleaching, or brittleness.

Signs of bleaching, abrasions, stiffness, and brittleness indicated by UV degradation.

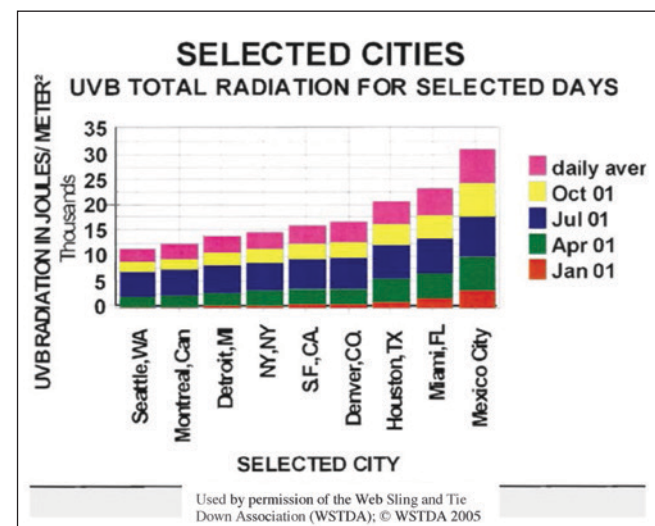
Figure 16

The WSTDA conducted an extensive ultraviolet degradation study of synthetic slings in 1981. Excerpts of the findings are presented below. **Figure 16** shows the UVB radiation by city. Of the U.S. cities shown, Miami has the highest radiation level, which is some 40% greater than New York City.

UV energy radiation by location in United States and Mexico. NYC UV radiation energy is approximately 60% of that in Miami.

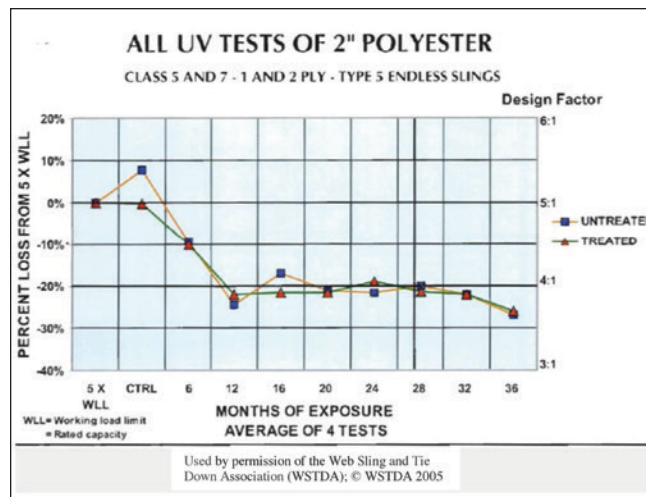
Figure 17 shows the reduction in breaking strength measured in WLL versus months of UV exposure. The maximum loss in WLL occurs around 12 months of exposure for polyester slings. Further exposure to UV radiation did not show any appreciable degradation below 3.7 times the WLL in 36 months. After 12 months of UV exposure, the breaking strength of the sling has

been reduced by approximately 26%. The WSTDA test establishes a relationship between UV exposure and reduction in sling strength for polyester synthetic slings through destructive testing. Because the subject sling was manufactured on 07/03/2006 — and the incident occurred on 03/15/2008 — the worst-case UV exposure can be estimated at approximately 20 months in New York. Given this worst-case assumption, the reduction in tensile strength can be estimated. The decline in design factor can be estimated from 5 to 1 — to a safety factor of approximately 3.7 to 1. The breaking strength of the Ex_Lift polyester slings exposed to UV radiation can be estimated from **Figure 17** as 3.7 times WLL, which is equal to $3.7 \times 6,400$ pounds or 23,680 pounds. The strength retained by the assumed UV-exposed sling exceeds the proof load test of 200% of the WLL or 12,800 pounds required by manufacturers and the WSTDA for slings consistently used in a UV environment. The proof load testing of slings used in a UV environment confirms that there is no clear non-destructive method of establishing any level of UV degradation for a synthetic sling.

WSTDA graph of breaking strength loss versus months of continuous UV exposure.

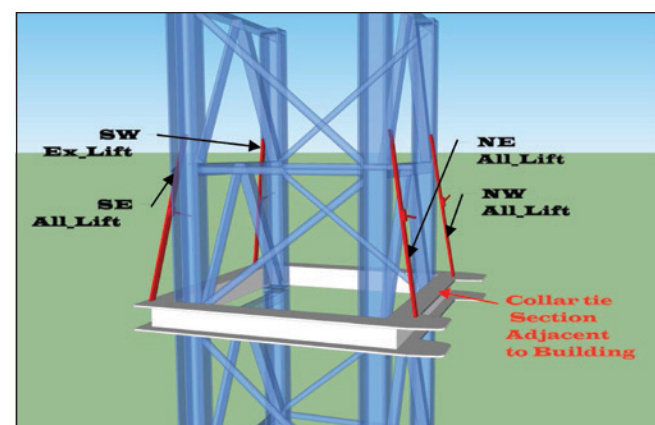
Figure 18

The arrangement of the 11,280-pound collar tie, crane tower, and rigging.

Based on **Figure 18**, the distribution of collar tie weight (11,280 pounds per the manufacturer) on the four slings was unknown at the time of failure. However, an upper and lower limit to the sling loads could

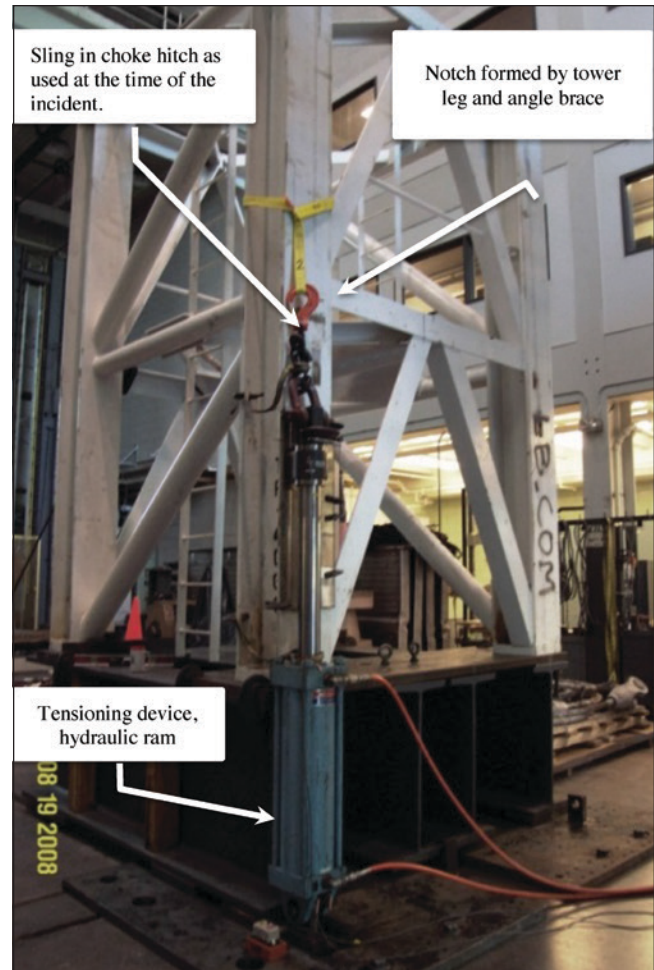
Figure 20
The setup used in the regulatory agency-sponsored test.

The regulatory agency sling test was designed to evaluate the actual configuration the slings were used in lifting the collar tie and the actual tower crane section involved in the incident. The test evaluated nine new All_Lift polyester slings and three new Ex_Lift polyester slings. The test configured the polyester sling in a choker hitch around the tower crane leg and between the support structures as the sling was used on the day of the incident. Absent from the test setup used to pull test the slings was the lever hoist that was an actual part of the collar tie lifting arrangement at the time of the incident. The regulatory agency-sponsored test setup is shown in **Figure 20**.

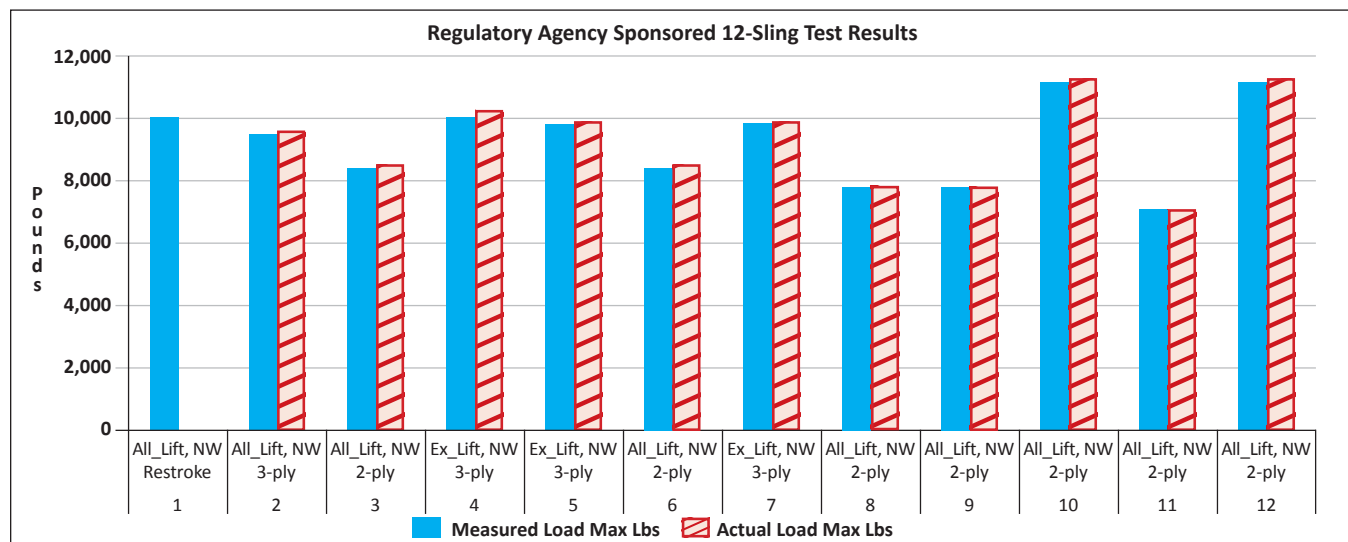
Figure 22
Results of the regulatory agency-sponsored test.

A summary of sling test results conducted under regulatory agency sponsorship is presented in **Figure 22**. Test number 4, 5, and 7 are the results from exemplar Ex_Lift slings. In each case, the test load exceeded the rated capacity of 5,100 pounds. More importantly, test 7 showed the Ex_Lift sling was able to sustain a minimum of 9,887 pounds. This failure load would

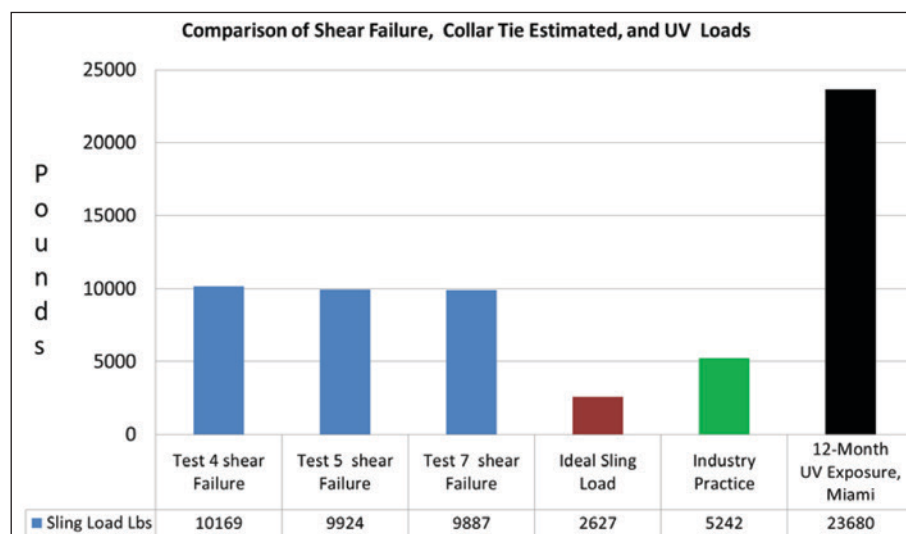
Figure 23
Test load comparison versus slings loads and UV-degraded sling safety factor.

Figure 23 presents the load comparison for the subject sling. The test loads obtained by the regulatory agency-sponsored test exceeds the loads the sling experienced lifting the collar tie. In addition, the capacity of the assumed UV-degraded Ex_Lift sling exceeded the regulatory agency test load by more than a factor of two.

However, the test failed to capture one key characteristic that was very evident at the time of the sling inspections and discussed in the textile expert's report — the substantial melting of the fibers found at the sheared or abraded surfaces of the slings.

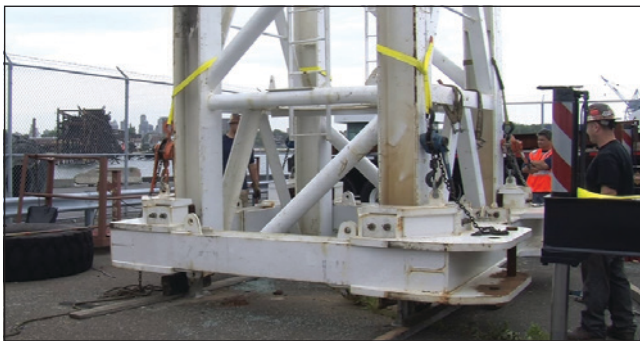
Collar tie test in progress.

Figure 46 shows the completed assembly of rigging and collar tie suspended for approximately 40 minutes to match the elapsed time to failure of the actual setup on the day of the incident. The elapsed time contradicts regulatory agency conclusions that once the collar tie is rigged, the continuous elongation of the polyester slings would require adjustment, hence making synthetic slings incorrect for this rigging operation — no violation of Hooke's law here.

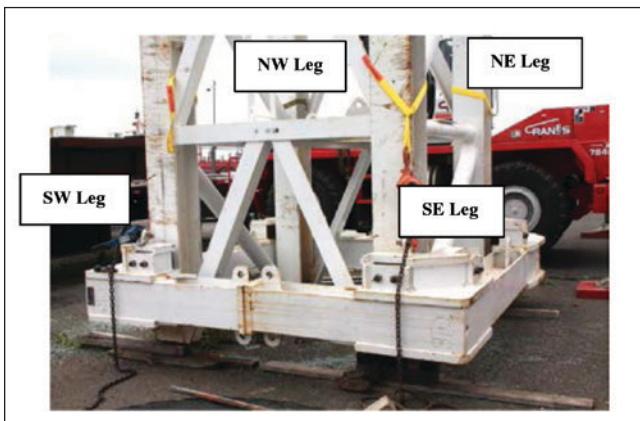
Figure 47

Collar tie suspended from three slings with the SW sling disconnected.

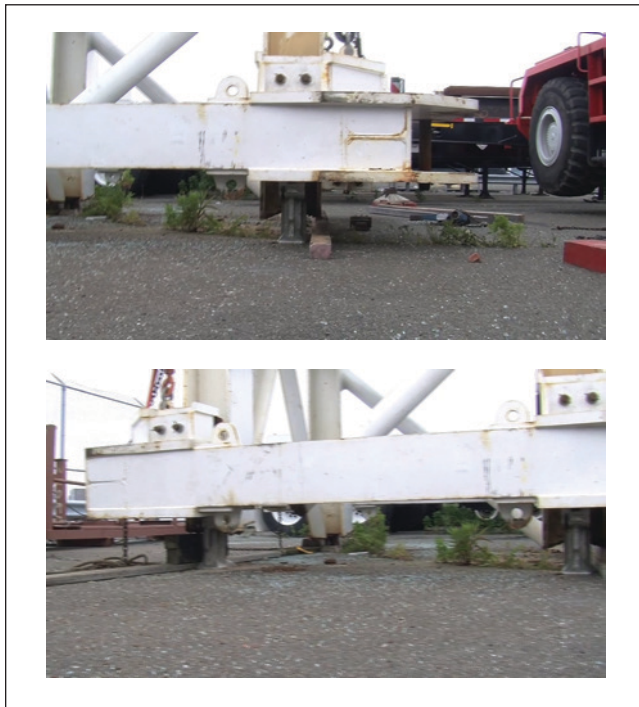
Figure 50

Ground clearance is maintained during the static tests using four sling and subsequent three slings.

During the tests performed on the sling, collar tie, and tower, the clearance between the rigged collar tie and the ground was maintained, as shown in **Figure 50**. The clearance between the ground and the collar tie was estimated to be between 14 to 18 inches. Maintaining clearance between the ground and collar tie was essential to ensure the four slings were carrying the total weight of the collar tie. The situation was continuously monitored during each phase of the test.
