# Forensic Engineering Evaluation and Testing of Horizontal Intrusion Protection Equipment for Stand-Up Forklifts

By Ben T. Railsback, M.S., P.E. (NAFE 713S) and Richard M. Ziernicki, Ph.D., P.E. (NAFE 308F)

## Abstract

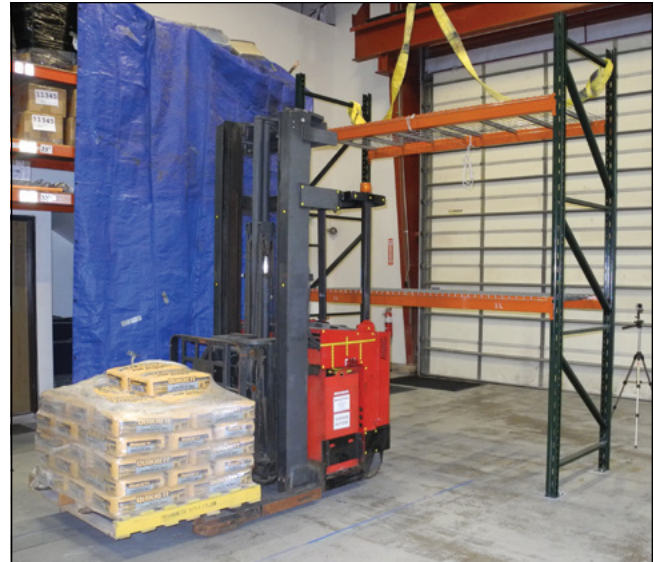
**Figure 4**

Stand-up forklift and rack configuration during first test.

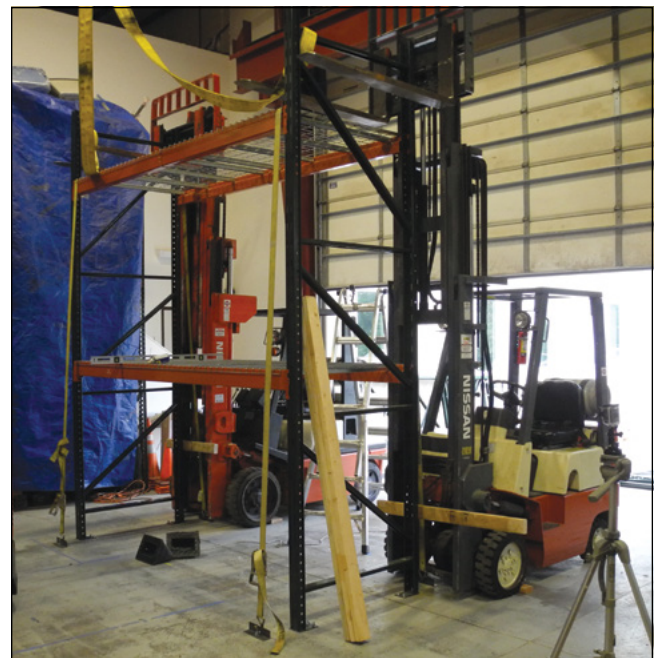
**TESTING:** During the first test, there was no load on the rack frame. In the second, third, and fourth tests, a nylon ratcheting strap was placed at each end of the rack and anchored to the floor using wedge anchors and angle iron brackets. The tension in each strap was approximately 1,000 lbf, simulating a 4,000-pound load on the rack system. Further, two sit-down forklifts were placed behind the rack system with masts raised and load carriages placed against the top of the rear of the rack system to increase the rigidity of the rack structure. **Figure 4** is a photograph of the forklift and rack configuration during the first test, and **Figure 5** shows the rack configuration for the subsequent tests. The simulated load and forklift placed behind the rack increased the rigidity or stiffness of the rack section.

Rack configuration during second, third, and fourth test: Nylon ratcheting straps at each end of rack frame and sit-down forklifts. (Note that the 2x4 wood pieces in the foreground provide no structural support and are not part of the test equipment.)
