Forensic Engineering Analysis of a Shopping Mall Explosion

By Jerry R. Tindal, PE (NAFE 642M)

On May 7, 2009 a catastrophic explosion occurred at a shopping mall located just outside of Washington, D.C. As a result of the explosion, several persons, including multiple firefighters, were injured, and a large portion of the mall was destroyed. This paper examines the cause of the explosion.

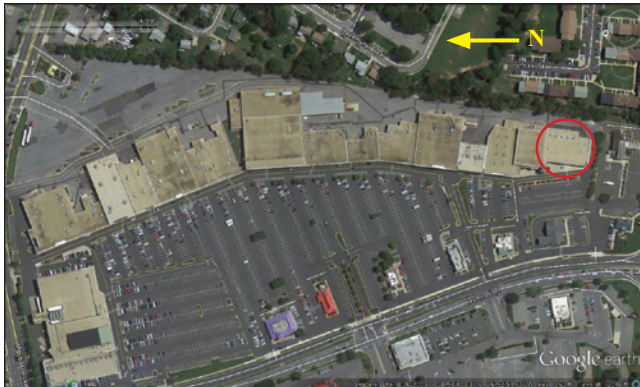
Figure 1

A Google earth image of the shopping mall. The section of the mall that sustained the most extensive explosion damage is circled.

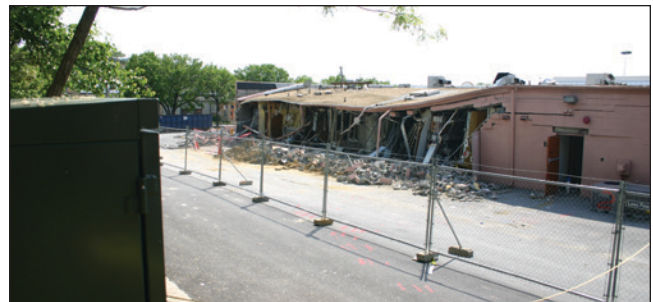
Figure 3

A view from the rear of the shopping mall of the tenant spaces that sustained the most extensive explosion damage.

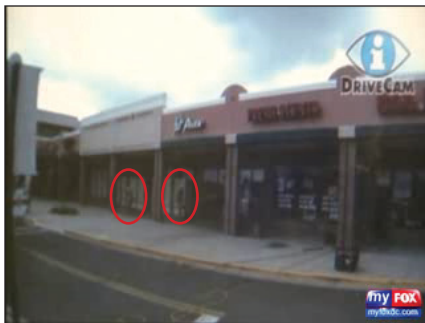
Figure 4

Firefighters making entry seconds before the explosion.

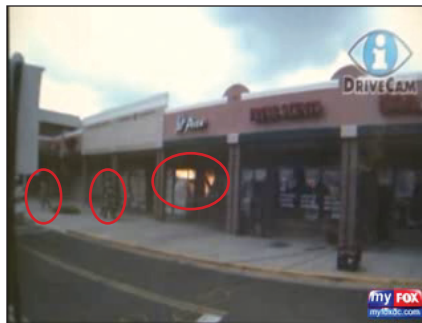
Figure 5

Additional firefighters approaching the front entry just as the explosion occurs. Note the expanding fireball through the glass window panes.

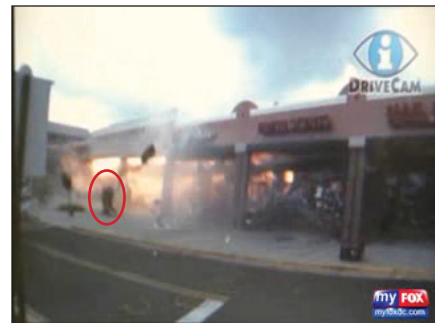
Figure 6

Explosion as viewed from the front of the building. Fireball venting through the front windows. Two of the firefighters are circled.

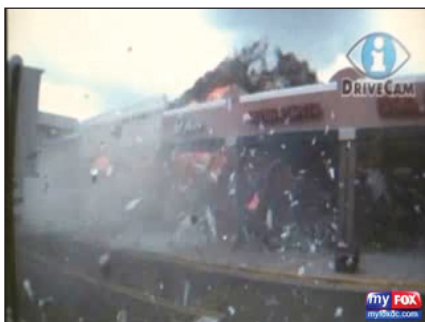
Figure 7

Explosion as viewed from the front of the building. Note displacement of the roof and subsequent venting of the fireball.

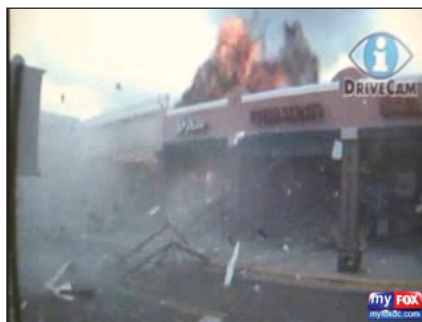
Figure 8

Fireball continuing to vent through the displaced roof.

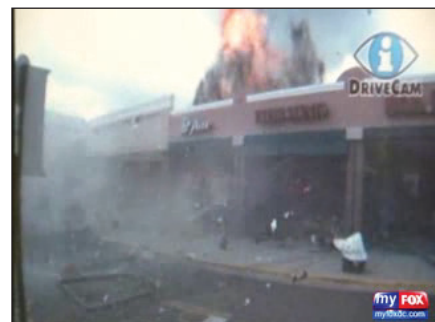
Figure 9

Fireball continuing to vent.

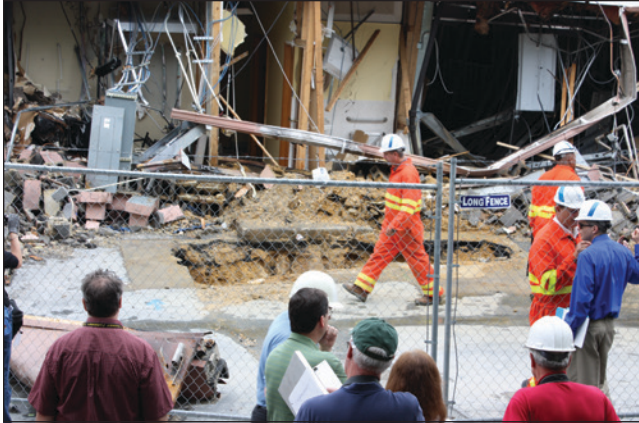
Figure 14

A joint inspection of the scene and the excavated pit area was performed at a later date with all parties of interest. Examination of the excavated area indicated that the 2-inch plastic gas main converged on and crossed in between multiple direct buried electrical power cables in the area behind the pizza shop. Measured clearances between the plastic gas main and the remains of the electrical power cables within the excavated pit in the general area of the crossover were as little as 3 inches. Several feet of the electrical cables in the area of the crossover had been destroyed by an electrical arcing event that preceded the explosion. The faulted power cables with subsequent gas line damage were consistent with the loss of electrical power followed by a gas smell shortly before the explosion. The power cables were installed in 1977, and the extensive heat produced from the catastrophic electrical faulting of several feet of the cables resulted in multiple burned, charred, and melted holes in the plastic gas main. Although the cause of the power cable failure was undetermined due to the extent of damage, such cable failures (as will be discussed later) are engineering-foreseeable events. **Figures 14 through 19** indicate the excavated area of where the gas pipe main leaked.

A view of the excavated area immediately behind the pizza shop.
