Journal of the
National
Academy OF
Forensic
Engineers[®]

Forensic Engineering Analysis of a Sequence of Power Infrastructure Failures Atop an Office Building

By Mauricio Cueva-Eguiguren, PE (NAFE 776S)

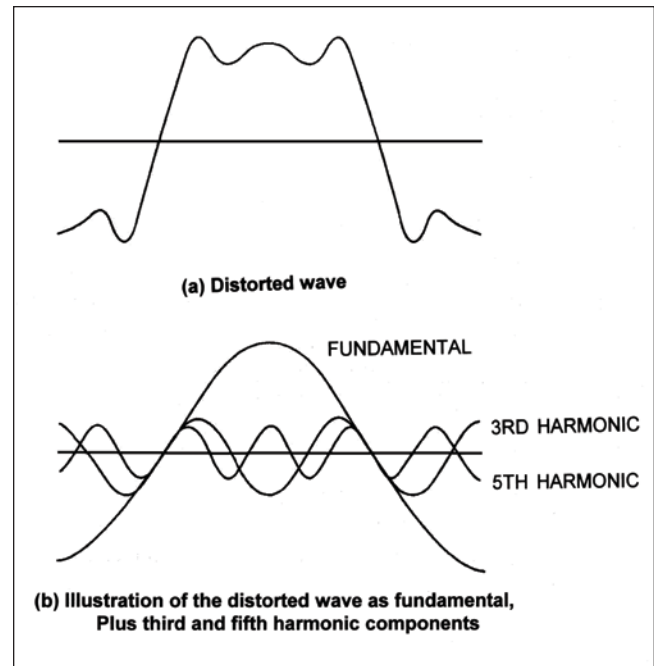
Figure 13

The effect of harmonics in the current and voltage waveforms shown in **Figure 13** were very similar to the results obtained from the power quality monitoring tests in the electrical distribution system in the building, which are shown in **Figures 14 and 15**.

Voltage or current waveforms with harmonic distortions. Upper waveform illustrates with total voltage or current waveform.
