Journal of the
National
Academy OF
Forensic
Engineers[®]

Forensic Engineering Analysis of Failed UTV Roll Cages

By Olof H. Jacobson, MS, PE (NAFE 496F), Stephen A. Batzer, PhD, PE (NAFE 677M),
Mark H. Kittel, PE (NAFE 757M), Jesse A. Grantham, PhD, PE (NAFE 597S),
Guy J. Barbera, PE (NAFE 732M), and Allen Molitoris, PE (NAFE 464C)

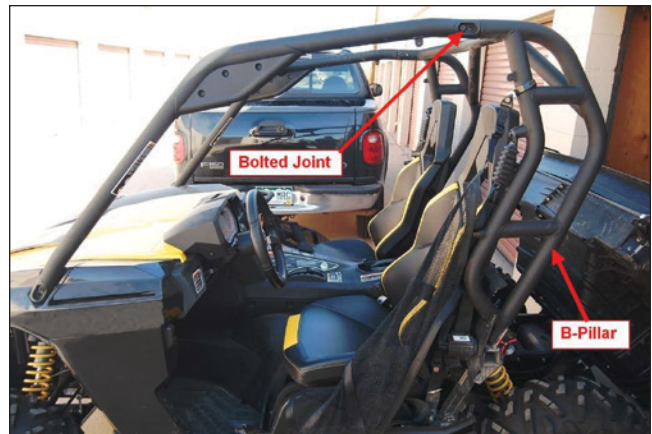
Figure 1

Undamaged exemplar UTV roll cage.

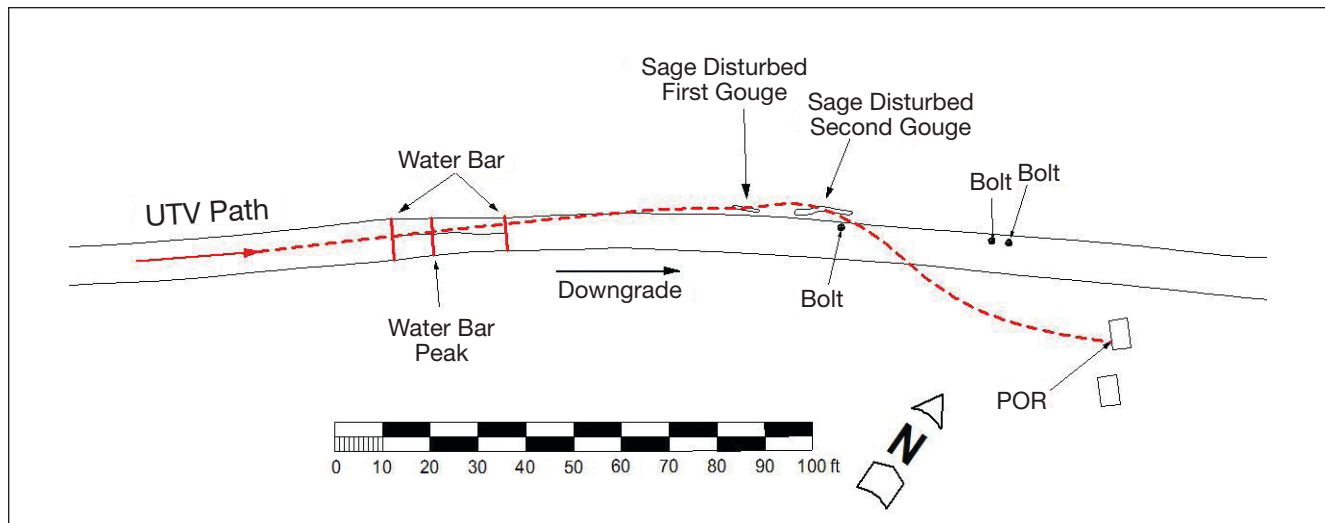
The road is relatively straight, approaching the water bar, and it curves slightly to the right downhill from the water bar. With respect to the plane of the road, the peak of the bump was approximately 1 foot high, and the entire bump was 8.4 feet long. A plan view of the accident scene is shown in **Figure 2**. Photographs of the accident site are shown in **Figures 3 and 4**.

Figure 2
Case A: Scale drawing of accident scene.

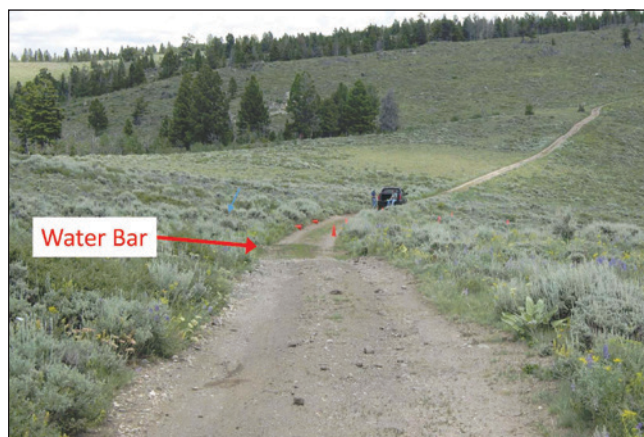
Scene Geometry: The accident occurred on a two-track dirt road that is 7 feet wide. Sagebrush borders the road on both sides. The road slopes downward at a grade of 7 percent.

Figure 3
View of accident location, looking downhill in direction of UTV travel.

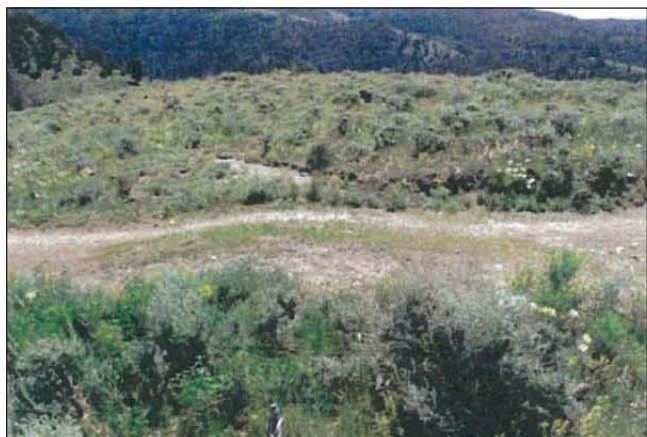
Figure 4
Side view of water bar. UTV traveled from right to left.

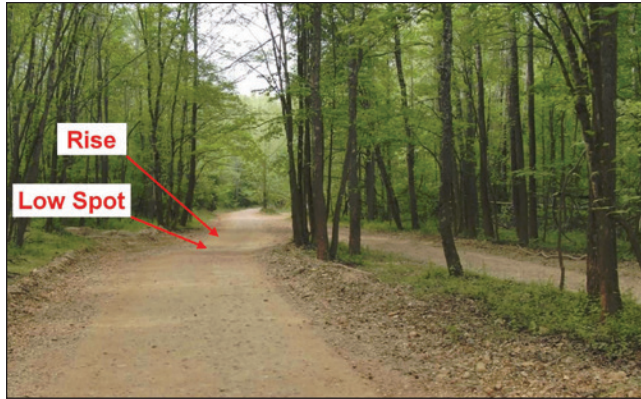
Scene Geometry: The trail is relatively flat throughout the rollover path. A shallow dip is present at a small drainage channel that enters the trail from the left. The entry to the dip descends very gradually over a distance of 25 to 30 feet. The profile transitions to a slight rise, leaving the low spot over a distance of 10 to 12 feet, with the final 7 feet at a 14 percent upgrade. Photos of the site are seen in **Figures 12 and 13**.

Figure 12
Case B: Accident site.

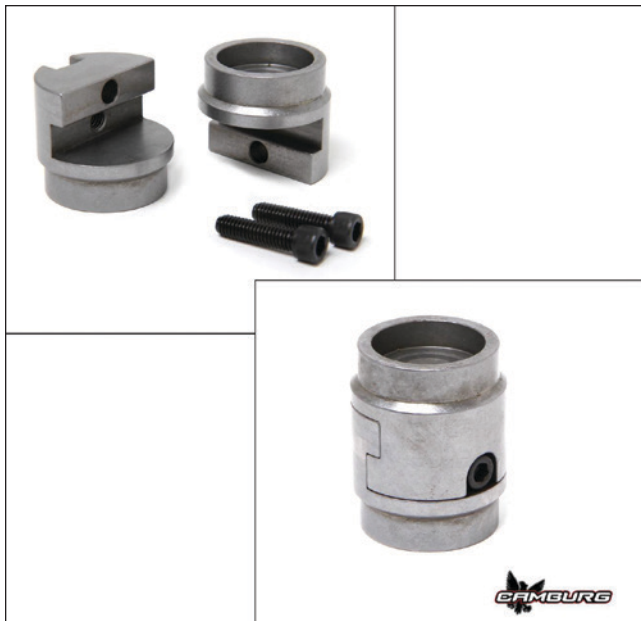
Figure 17

Camburg tube clamp

engineered products such as the Camburg Tube Clamp seen in **Figure 17**. In this design, if properly oriented, bending moments and resultant shear forces would be transferred through interlocking features and not through the bolts.

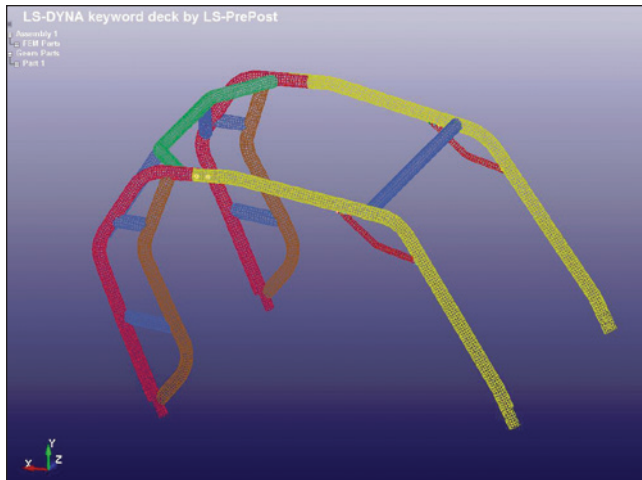
A graphical output from the FEA model is shown in **Figure 20**. The FEA model predicted a failure load of 17,200 pounds with a deflection of 0.5 inches compared to the laboratory test results of 16,500 pounds with a deflection of 0.675 inches. The FEA model had a somewhat stiffer initial response as shown by the steeper curve. Peak loading was about 4% greater than the measured physical peak cage load, and peak deformation of the model occurred with ~0.2 inch less deformation compared to the physically tested roll cage. The general shape and resulting peak load are very similar. **Figure 21** shows the data from the physical test and the output of the FEA model. Overall, the testing provided a reasonable validation of the FEA model.

Figure 20
LS-DYNA graphical output of roll cage model.

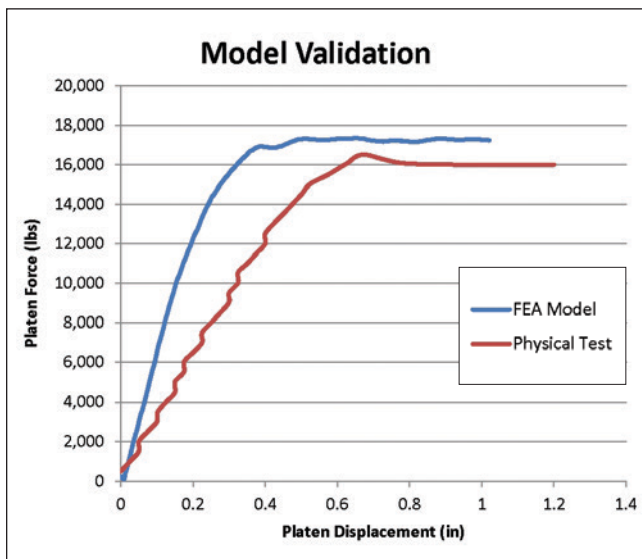
Figure 21
Validation of FEA model vs. laboratory test.

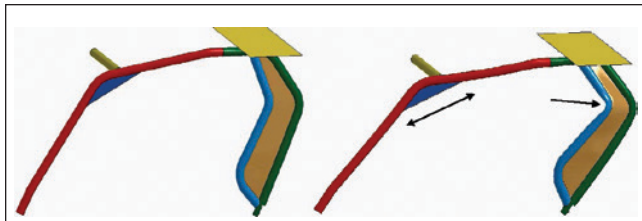
Figure 22
Graphic of conceptual alternative 1. Conceptual design shown in left panel. Resulting deformation shown in right panel.

Figure 22 shows the first alternative concept, which uses a 0.090-inch (2.3 mm)-thick steel web to fill in the area between the two B-pillar uprights in order to transfer shear loading between the uprights. As such, this concept deletes the two horizontal connecting tubes. The rear-most cage to chassis attachment

points are identical to the baseline model. The model is shown in the unloaded and heavily loaded states with 4 inches of deformation. Note the maximum distortion at the top bend of the rear cage forward upright. Also, note the straightening of the A-pillar / roof rail segment and minor rotation about the rear mount. The peak load of conceptual Alternative 1 measures 21,600 pounds at 0.5 inches of platen movement.

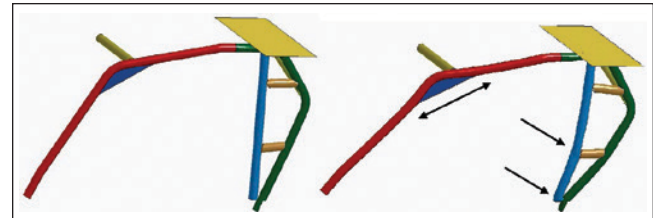
Figure 23
Graphic of conceptual alternative 2. Conceptual design shown in left panel. Resulting deformation shown in right panel. Z-shaped tube has been replaced by a straight vertical tube (see blue member).

Figure 23 shows the second alternative concept that uses a vertical tubular member in place of the original Z-shaped tube, eliminating the bends in the column. The bottom of the tube has been modeled as a fixed connection to the chassis. Thus, the fixation of the rear cage to the vehicle chassis has been strengthened by replacing the two fixed rear chassis connections with four fixed connections. This design concept is shown below in the unloaded and heavily loaded states with 4 inches of vertical deformation. The rear upright is not grossly distorted; the B-pillars rotated rearward about the mount with plastic deformation. The A-pillar / roof rail intersection straightened. The peak load of conceptual Alternative 2 measures 37,900 pounds at 2.0 inches of platen movement.

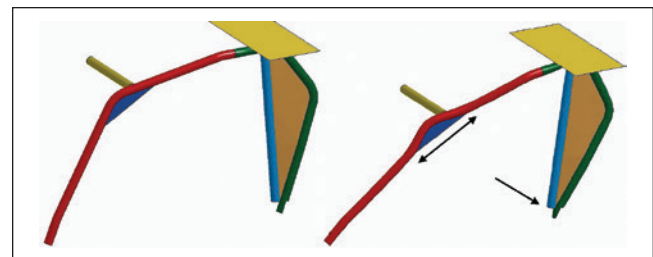
Figure 24
Graphic of conceptual alternative 3. Conceptual design shown in left panel. Resulting deformation shown in right panel.

Figure 24 shows the third alternative concept, which is a combination of concepts 1 and 2. The design
