# Effects of Evidence Spoliation on Forensic Engineering Analysis of Alleged Brake Servicing Defects

By John Leffler, PE (NAFE 709S)

*A forensic case involved an allegation of defective minivan brake repairs. On a wet two-lane road, the minivan left the road while stopping, and impacted a telephone pole. The plaintiff driver's complaints implied a dragging brake, and the plaintiff's expert reported a bent lower caliper bolt. This forensic investigation involved instrumented exemplar analysis of the effects on caliper drag that could be caused by a bent caliper bolt. The investigation methodology was chosen (in part) based on significant evidence spoliation on the part of the plaintiff's expert. This paper will also discuss the effects of the spoliation and resulting limitations on the scope of the analysis.*

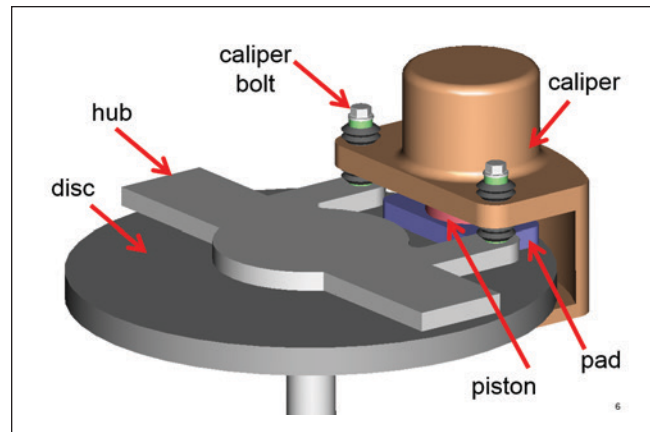
**Figure 2**

The plaintiff's expert alleged that the incident was due to this bent lower caliper bolt causing brake pulling upon application. The subject minivan utilized single-piston sliding front brake calipers that have two bolts (**Figure 2**). In such designs, the caliper piston is inboard and (when actuated) presses the inboard brake pad against the disc. This piston force simultaneously causes the caliper to slide axially along lubricated cylindrical "slider" bushings (**Figure 3**), in turn causing the outboard features of the caliper to pull the outboard brake pad against the disc. The upper and lower caliper bolts locate and retain these lubricated cylindrical bushings. Over time, improperly maintained sliding caliper assemblies may bind or drag if the caliper itself cannot slide freely on the lubricated cylindrical bushings. Additionally, since the piston's force application is offset from the cylindrical bushing axes, a bending load is imparted to the cylindrical bushing/caliper interface. The bushings often (including on this minivan) have a rubber "bellows" type boot around them to reduce the ingress of contaminants into the bushing grease. It can

be seen from **Figures 2** and **3** that if one of the caliper bolts were significantly bent, it could causing binding or dragging of the caliper in use.

Simplified representation of sliding brake caliper.

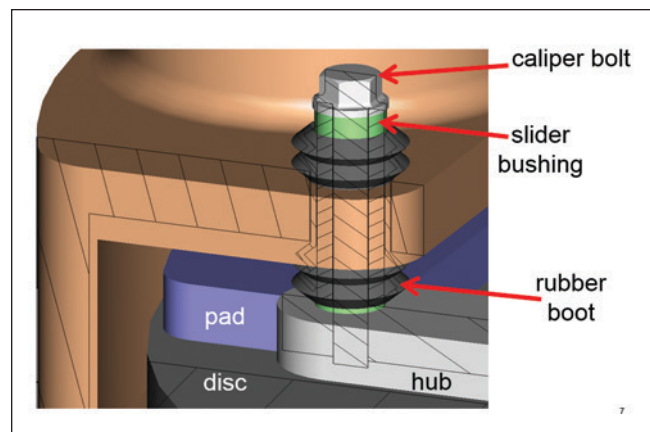
**Figure 3**

Close-up of caliper bolt area.

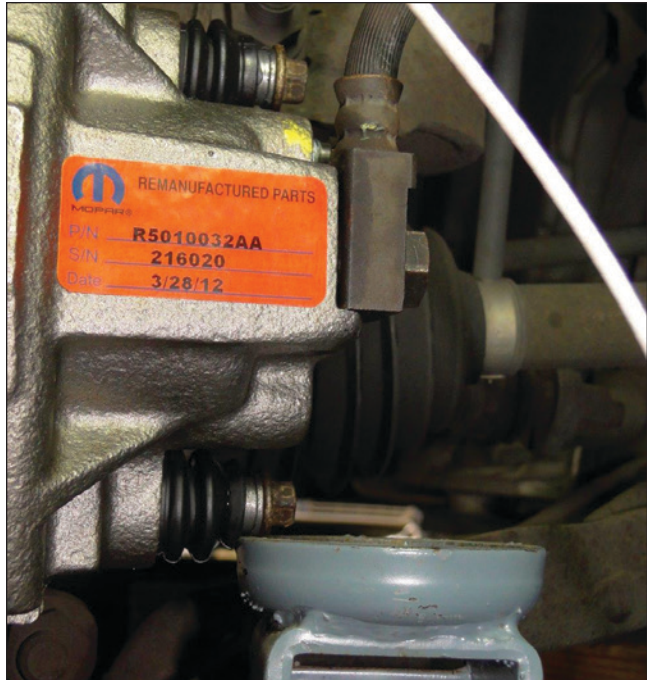
3. The baseline evaluation provided usable data, showing a consistent force response of the caliper piston to repetitive pedal input. The sampling frequency was 1,000Hz. Once the baseline was obtained, the head of each lower caliper bolt was bent vertically up to a total bend of approximately 6 degrees. The bolt was bent first through the use of a bar clamp and then (when the bar clamp proved inadequate) by lifting the vehicle (in effect) by raising a floor jack under the caliper bolt (**Figures 16 and 17**).

**Figure 16**  
Bending bolt with jack.

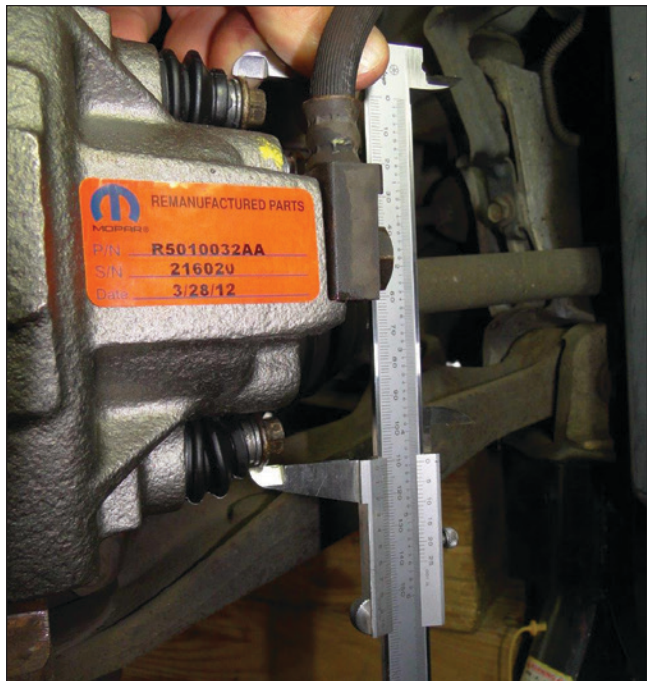
**Figure 17**  
Measuring amount of bend.
