Journal of the
National
Academy OF
Forensic
Engineers[®]

Vol. 33 No. 2 December 2016

Forensic Engineering Analyses of a Home Fire

By R. Vasu Vasudevan, PE (NAFE 619F) and Jeremy Britton, PE (NAFE 943M)

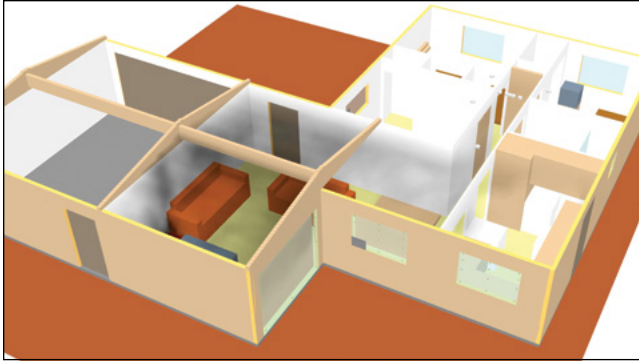
Figure 27
Smoke @ 45 sec.

activation time of 45 seconds are shown in **Figures 27, 28, and 29**, respectively. The temperature, carbon monoxide and visibility levels, smoke detector activation, and egress times are presented, and the computed values for selected times (slices/snap-shots) are illustrated in **Figures 30 to 32**.

Based upon the most probable simulation, a smoke detector in the hallway would have annunciated between 34 and 45 seconds after ignition-flame/fire originated, depending upon the detector location, and provided approximately 1 minute for egress through the kitchen and front entry doors. The annunciation would have provided approximately 2 minutes for safe egress through the bedroom windows.
