Journal of the
National
Academy OF
Forensic
Engineers[®]

Vol. 34 No. 2 December 2017

Forensic Engineering Analysis of a Motorsports Racing Incident

By Stephen D. Knapp, PE (NAFE 891S), Richard M. Ziernicki, PhD, PE (NAFE 308F), and Ben T. Railsback, PE (NAFE 713S)

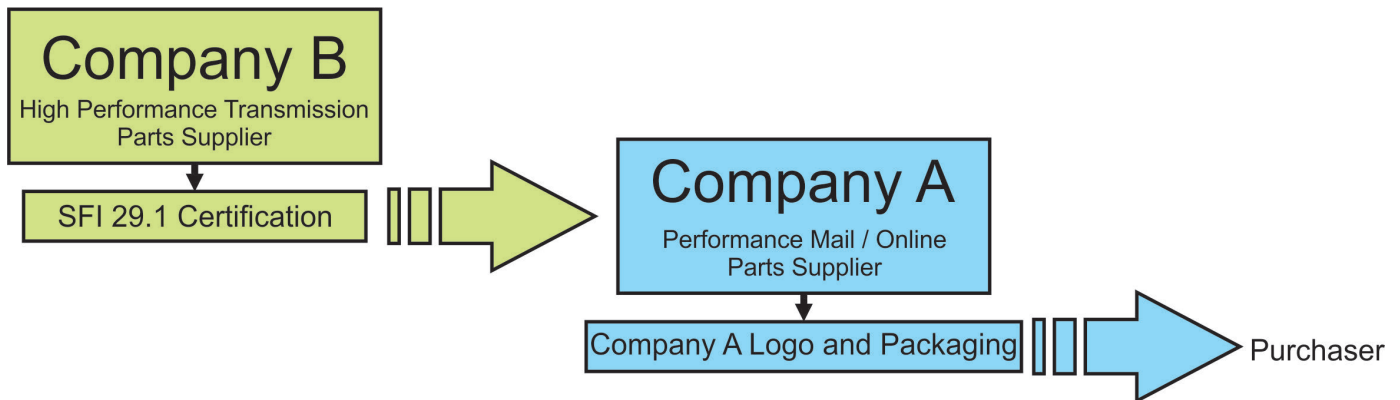
Figure 2
Company A original business model.

The subject flexplate was purchased by the racer from an online/mail-order high-performance parts distributor (Company A). The heavy-duty flexplates sold by Company A were originally supplied in bulk from a performance transmission parts distributor (Company B) and came complete with an SFI certification sticker. After being received by Company A, the part was packaged with the logo of Company A and put into inventory for sale. A flow chart showing the original business model established by Company A is shown in **Figure 2**.

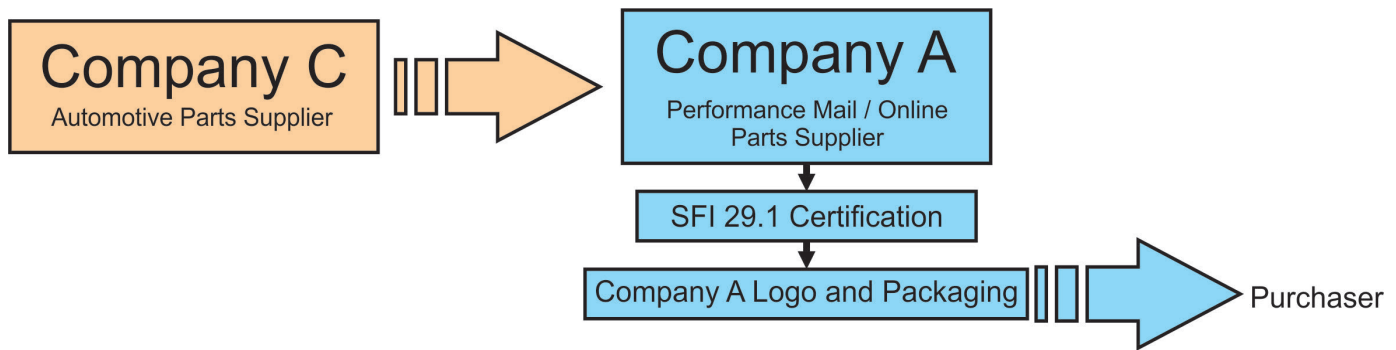
Figure 3

Company A modified business model.

to continue to sell flexplates to Company A, provided that Company A perform its own SFI testing and certification process on the flexplates. To accomplish this, Company A consulted directly with SFI and its test lab to comply with the necessary SFI testing protocols required to continue selling the flexplates as SFI certified. The business model known to Company A at the time of the subject flexplate sale is shown in **Figure 3**.

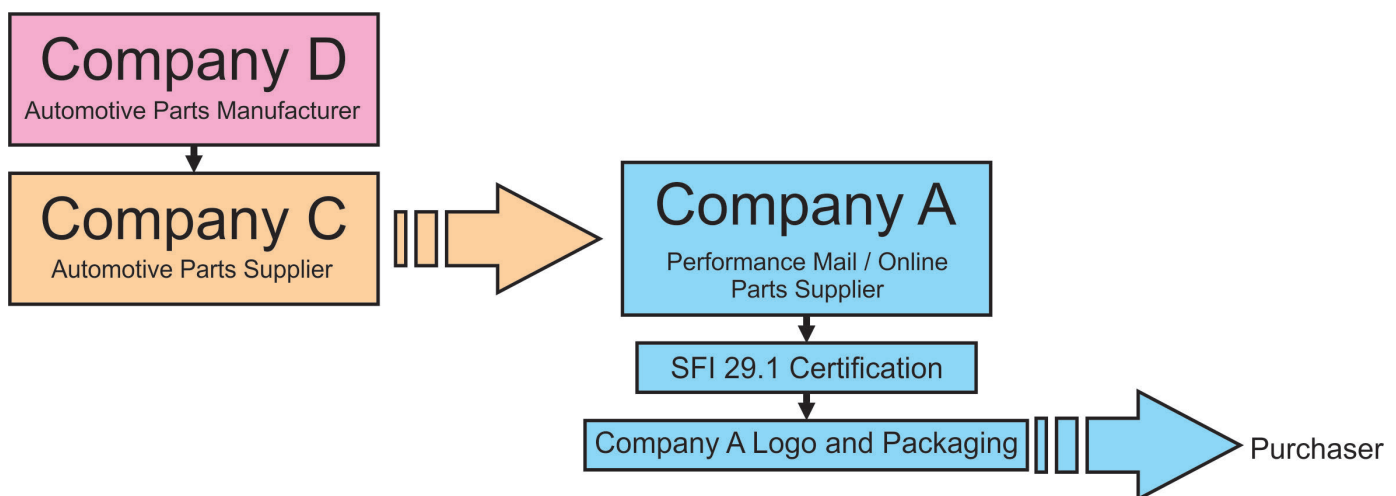
Figure 4

After the subject incident (and all parties were put on notice), it was discovered that the actual manufacturer of the part was a fourth entity (Company D), which sold its product as a heavy-duty flexplate to Company C. This company contended that the part it manufactured was never intended for the high-performance market. The flow chart of the actual business model that was in place at the time the subject flexplate was sold is shown in **Figure 4**.

Actual business model at the time of the product sale.
