Vol. 34 No. 2 December 2017

Forensic Engineering Analysis of a Fatal Trailer Wheel-Separation Failure

By Stephen A. Batzer, PhD, PE (NAFE 677M)

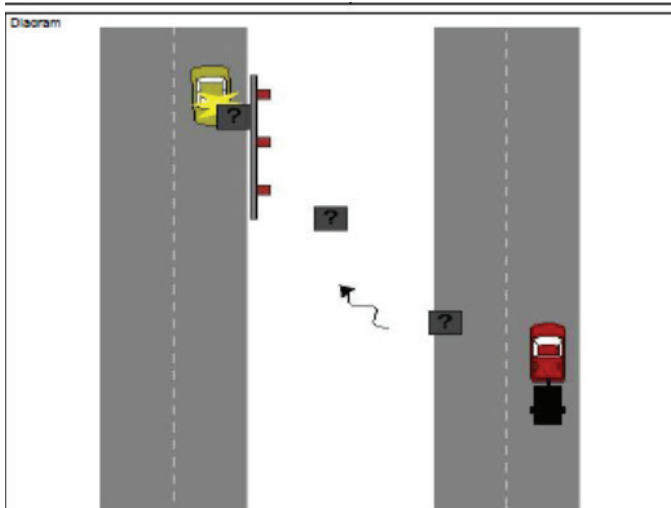
Figure 1

Accident diagram from police report.
