Journal of the  
**National**  
**Academy** OF  
**Forensic**  
**Engineers**<sup>®</sup>

Vol. 35 No. 1 June 2018

# Forensic Engineering Analysis of an Electrical Substation Fire in a Manufacturing Plant in Brazil

By Mauricio Cueva-Eguiguren, PE (NAFE 776S)

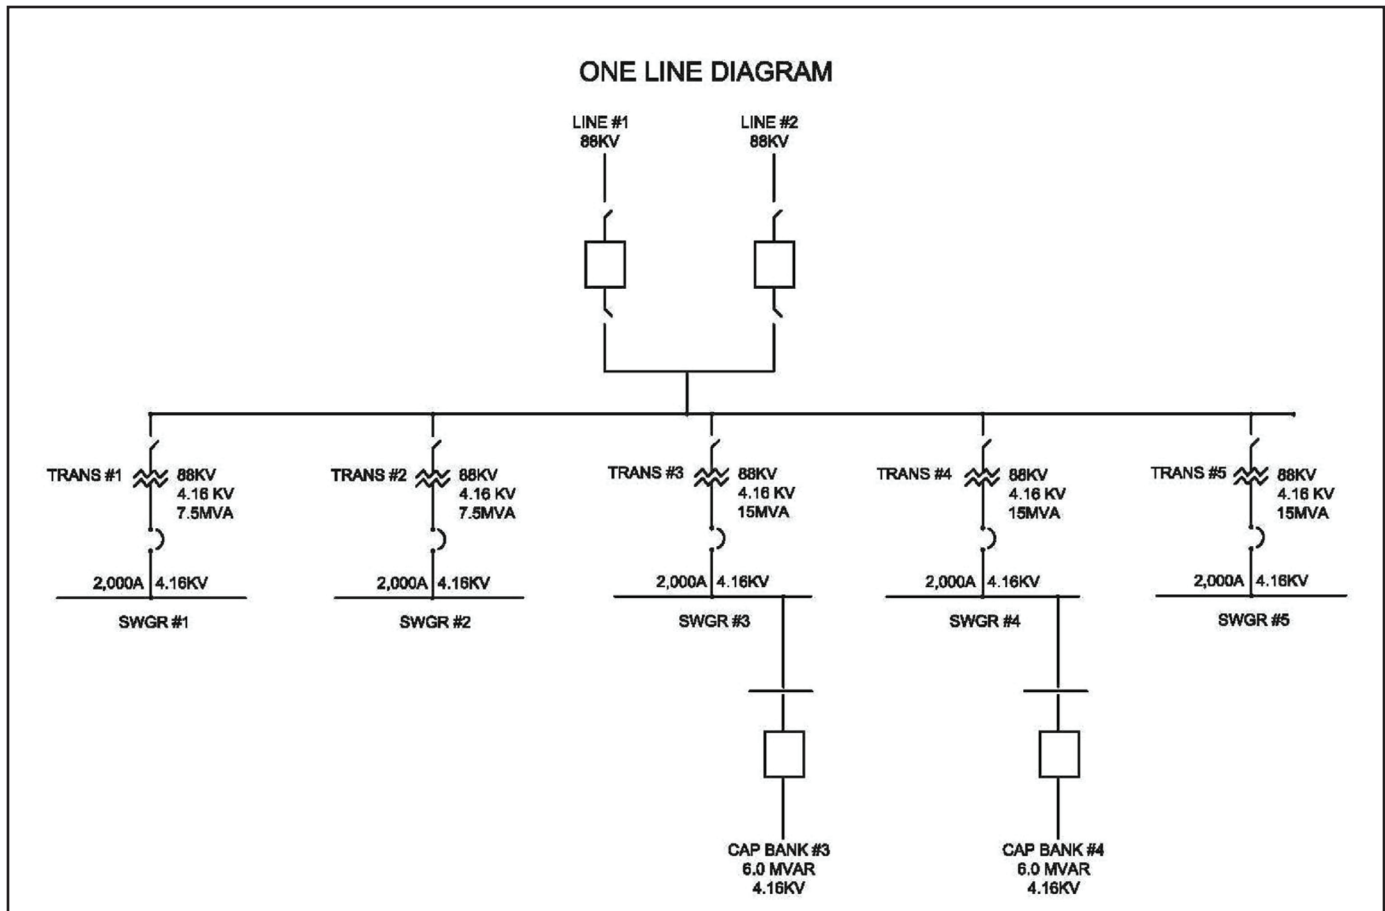
local utility via two 88kV overhead transmission lines. Only one of the 88kV lines is required to meet the power demand from the plant, and the second is used as a secondary power source in case of an outage (**Figure 1**).

**Figure 1**  
One-line diagram of substation.

The voltage signal for the voltage recorder is connected to the 88kV potential transformers in an open “Delta” configuration as shown on the one-line diagram (**Figure 1**). The voltage signal for the secondary windings of Transformer Nos. 2, 3, 4 and 5 is connected to the 4.16 kV potential transformers in an open “Delta” configuration.

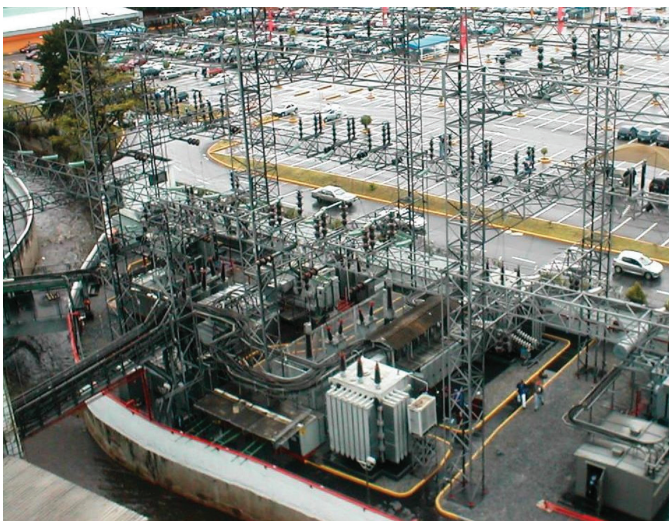
The electrical substation is located on the southeast corner of the property. Initially, the substation consisted of two 88kV – 4.16kV, 7,500kVA stepdown transformers labeled Transformer Nos. 1 and 2. As the plant expanded in subsequent decades, two additional 88kV – 4.16kV, 15,000kVA step-down transformers were added (Transformer Nos. 3 and 4). These transformers were located adjacent to the existing Transformer Nos. 1 and 2 (see **Figure 2** and **3**).

**Figure 2**  
Partial view of substation (north view).

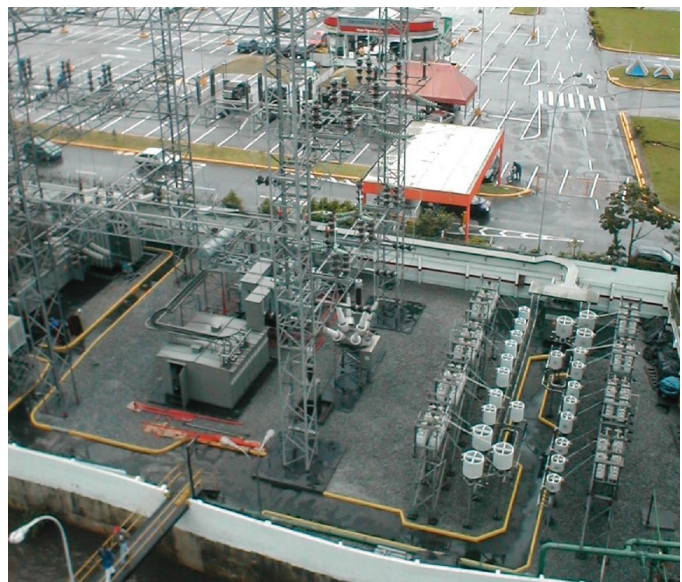
**Figure 3**  
Partial view of substation (south view).
