Vol. 35 No. 1 June 2018

# Forensic Engineering Metallurgical Analysis of PTO Air Compressor Rupture and Fire

By Raymond G. Thompson, PhD, PE (NAFE 763F) and Dustin Nolen, PE

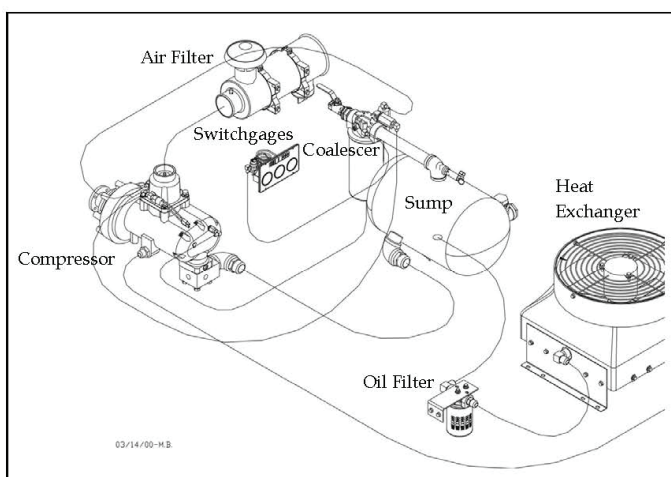
Figure 1

Diagram of air compressor system showing the major components.

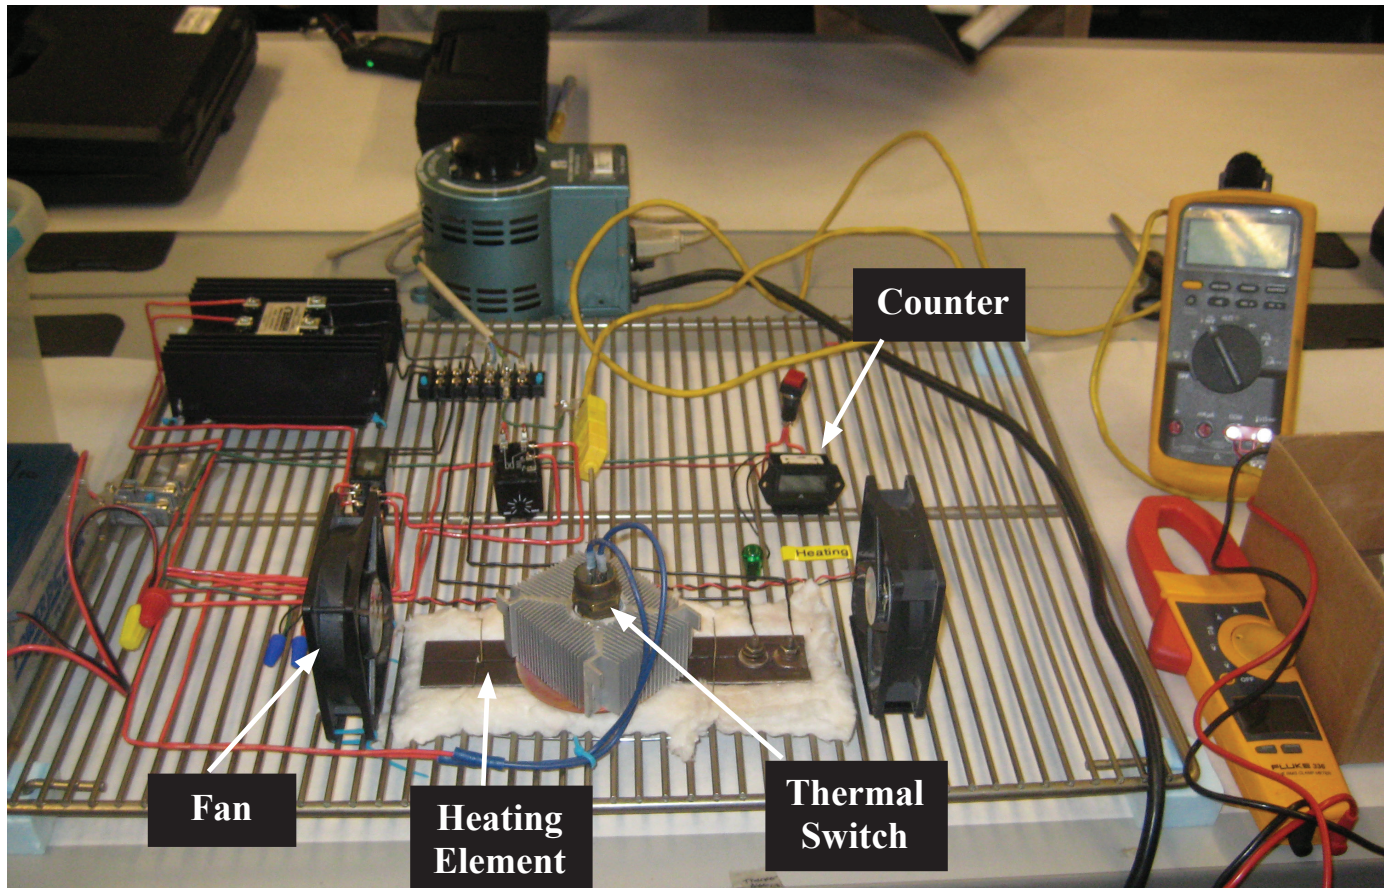
A second series of tests was performed on the thermal switch to test its long-term cyclic performance. **Figure 6** shows the thermal switch mounted in a heat sink connected to a 350W Omega resistive heating element. Heat was applied to the thermal switch until the contacts changed state, simultaneously energizing a 12V relay to turn off the heating element, turn on the 12V fans for cooling, and increment a step counter. The step counter would not increment until the next high temperature cycle. The test was a fully automated process and was not halted until the consensus of the experts agreed to conclude. The testing showed that the thermal switch operated as intended.

Test apparatus to measure cyclic temperature performance of thermal switch.
