Vol. 35 No. 2 December 2018

Forensic Engineering Investigation of a Fatal Farm Tractor Incident

By Daniel P. Couture, PEng (NAFE 951M)

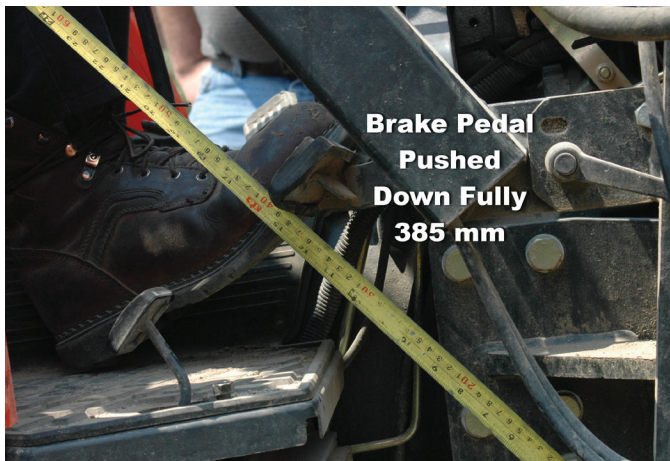
Figure 8
Brake pedal pushed down fully.

The tractor's brakes were properly adjusted and functioned correctly, according to the technical service representative who test drove the tractor around the site. The range of free movement of the brake pedals was about 50 mm (2 inches), and another expert report cited 36 mm as the norm, although the workshop manual contains a value of 40 to 45 mm. The range of movement is shown in **Figure 8** and **Figure 9**. The parking brake adjustment turn-buckle had not been altered by servicing since the incident.

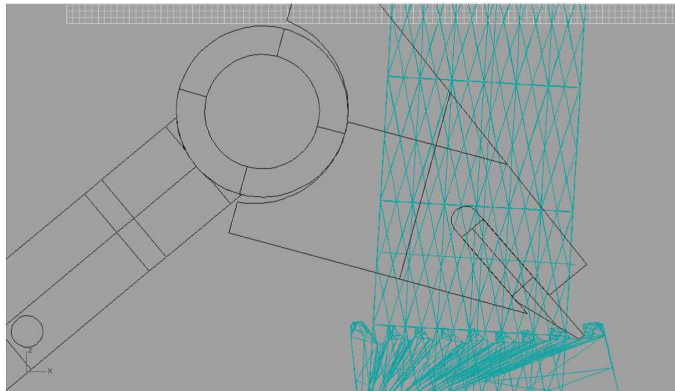
Figure 15

For each of the three brake assemblies, 2-D flat-bar tooth engagement was quantified for the eight different gear engagement positions. The amount of tooth engagement (i.e., locking) was related to both the relative positions and orientations of the flat bar and dog bar. Eight locking positions were made possible by the eight slots in the dog bar. For example, Position 1 for EX is shown in **Figure 15**.

Position 1 for EX in two dimensions.
