Forensic Engineering Experience with Electrically Ignited Fires

By Roger L. Boyell, P.E. (NAFE 696F)

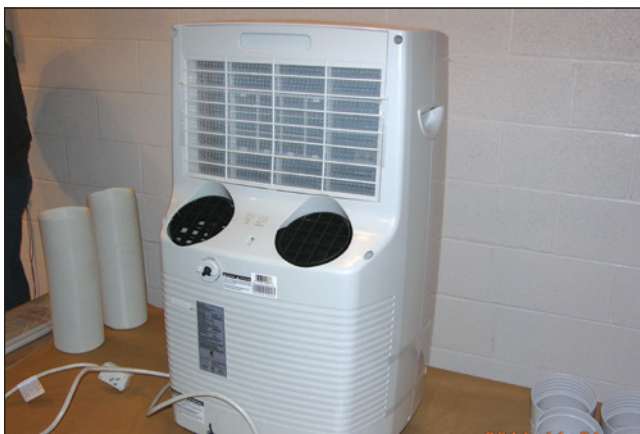
Figure 22

Exemplar of room air conditioner.

With this portable air conditioner (see exemplar in **Figure 22**), room air is blown through the evaporator coils at the top, and outside air is circulated through the interior by plastic ducts that run to an adjacent window. The molded plastic case can be removed to show the internal construction (**Figure 23**).

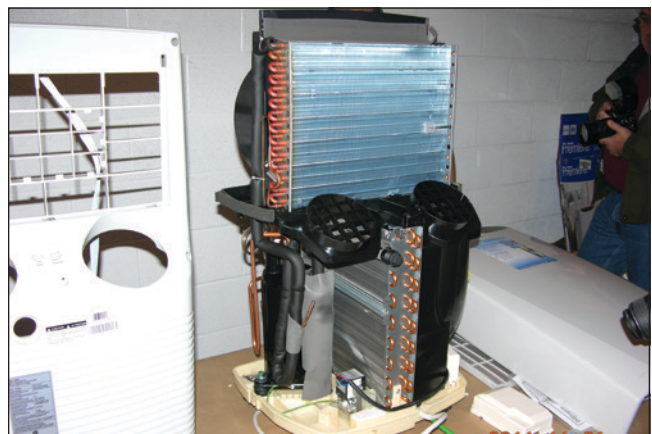
Figure 23

Interior of exemplar unit.

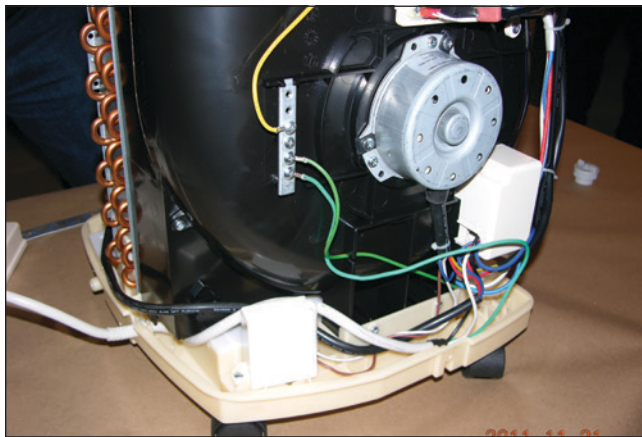
The exemplar exhibits electrical wiring, a compressor motor, and fan motors (**Figure 24**), all of which can be compared with the evidence unit to locate the presumed defect or malfunction. Upon investigation, such comparison revealed that the bottom of the evidence unit was surprisingly intact (**Figure 25**), considering that the fire was said to have begun there.

Figure 24
Fan motor and electrical wiring.
