Vol. 37 No. 1 December 2020

Forensic Engineering Analysis of Fatal Overhead Crane Accident

By Richard M. Ziernicki, PhD, PE, (NAFE 308F) and Ricky Nguyen, MS, PE

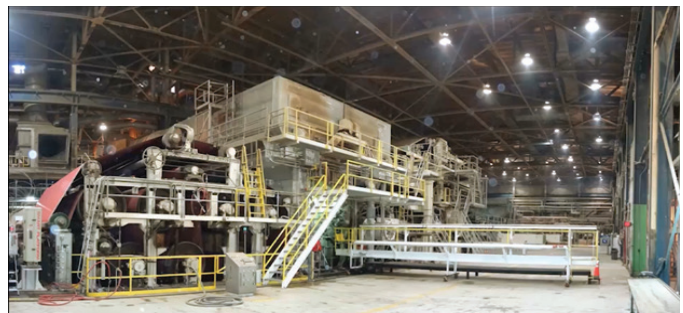
Figure 4

Photograph taken during the inspection of the plant.

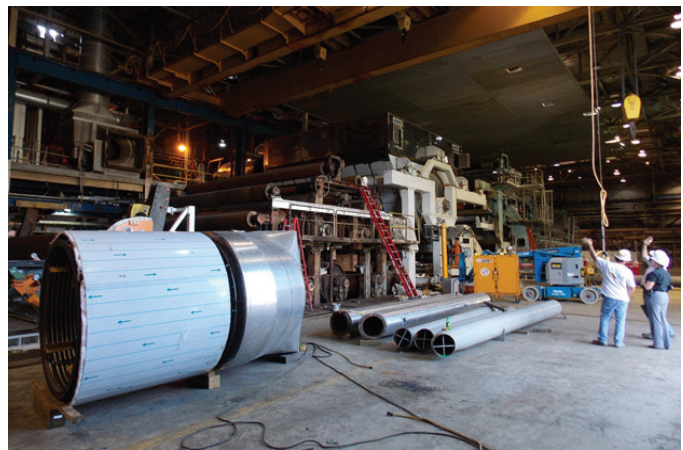
Figure 5

The 3D point cloud model of the plant was then put into a computer-generated virtual 3D space. Since the construction of the large equipment had already been completed at the time of the authors' inspection (years after the accident), photographs taken immediately after the accident by the VOSH official and the construction manager (**Figure 5**) were analyzed to determine which pieces of

Provided photograph of the plant taken immediately after the accident.

equipment and construction were present at the time of the accident (such as certain ladders, rails, incomplete ductwork, and pipework, etc.). The equipment and materials, which did not exist at the time of the accident, were then removed from the 3D model of the plant. **Figure 6** demonstrates a 3D model of the plant during the inspection — with the pieces of equipment that did not exist or was constructed at the time of the accident highlighted in green. The photographs were also analyzed to determine which equipment and construction existed at the time of the accident but did not exist at the time of the inspection. Computer-generated 3D models of the equipment and construction were then digitally generated. The placement

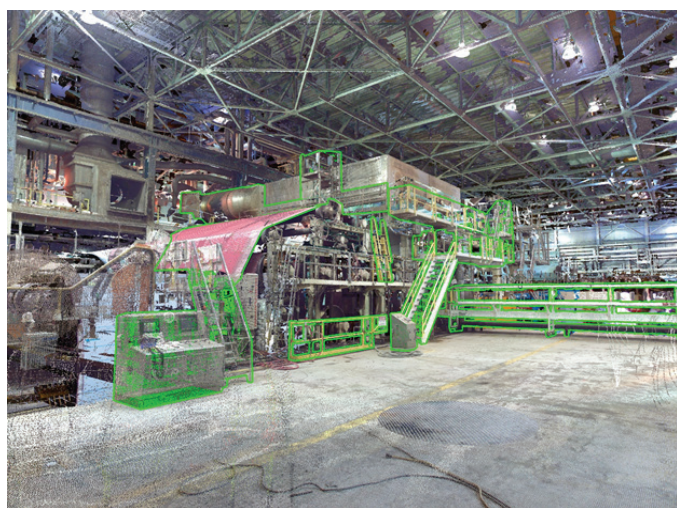
Figure 6

Computer-generated 3D virtual model of the plant at the time of inspection. Equipment and construction, which was not present at the time of the accident, is highlighted in green.

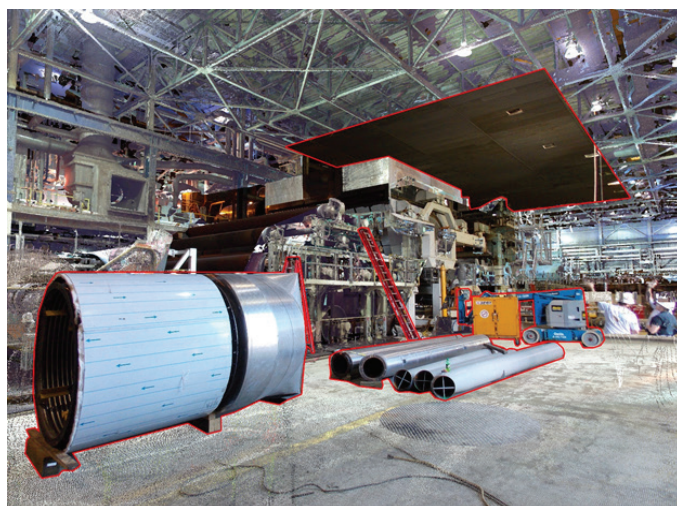
Figure 7

Computer-generated 3D models of the equipment and construction that was present at the time of the accident, highlighted in red, added into the accident scene virtual model.

of the modeled equipment in the 3D virtual space was established using principles of photogrammetry, in conjunction with the 3D point cloud model as a reference^{3,4,5,6,7,8}. **Figure 7** shows the added computer-generated 3D models of the equipment and construction, placed in the 3D virtual model of the plant, highlighted in red. **Figure 8** is a graphic of the 3D virtual model of the reconstructed accident scene, matching the conditions and phase of the construction at the time of the accident.

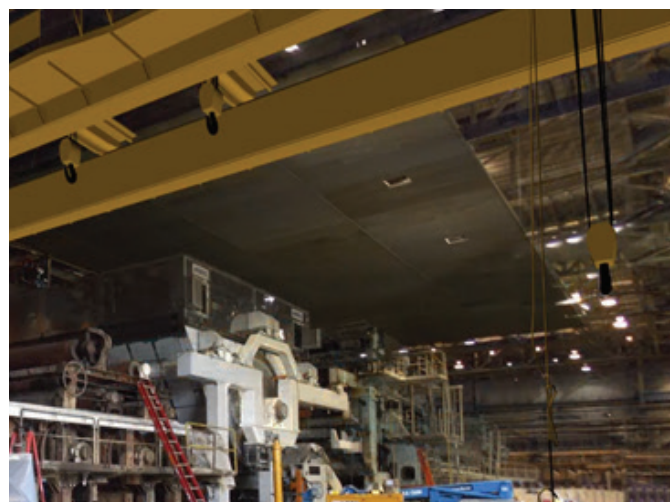
Figure 8

Graphic of the computer-generated, reconstructed accident scene, matching the condition and phase of construction at the time of the accident.
