Vol. 37 No. 1 December 2020

# Forensic Engineering Analysis of Projectile Thrown from Phantom Vehicle

By Richard M. Ziernicki, PhD, PE (NAFE 308F), William H. Pierce, PE (NAFE 846C),  
and Angelos G. Leiloglou, M Arch., (NAFE 956C)

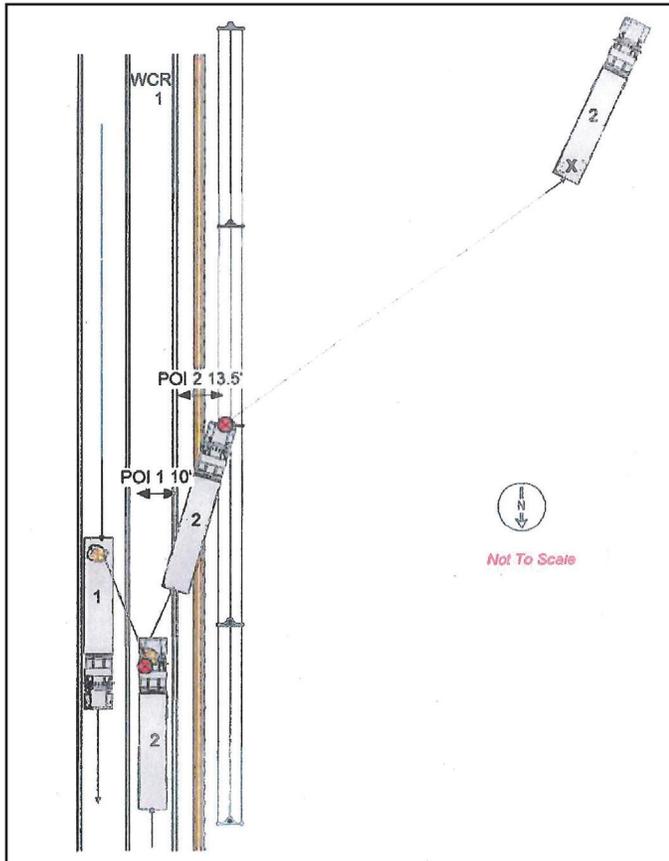
Figure 1

Police diagram of the accident (north facing down). Northbound vehicle one is the phantom semi, and southbound vehicle two is the plaintiff's semi.

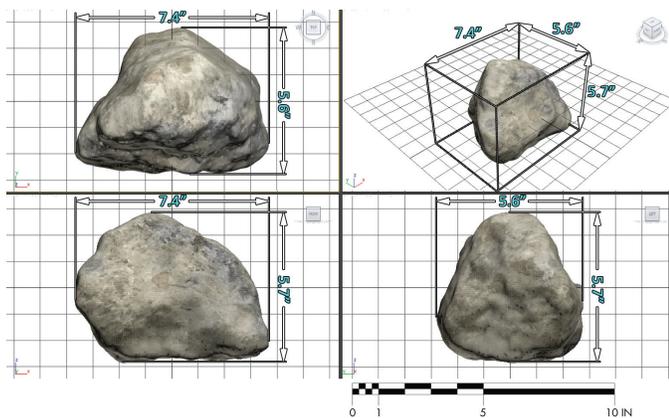
General envelope of the concrete projectile based on HD scans.

The concrete projectile was documented using photography and high-definition (HD) 3D scanning. Six HD scans were taken around the entire surface of the concrete projectile. A virtual model of the concrete with textures was created with a high degree of engineering precision from the HD scans and photographs<sup>1</sup>. Figure 2 shows the virtual model generated from the HD scans and the general envelope (or overall dimensions) of the concrete. The concrete was, at its widest extents, 7.4 in. by 5.6 in. by 5.7 in. and weighed approximately 8 lb.

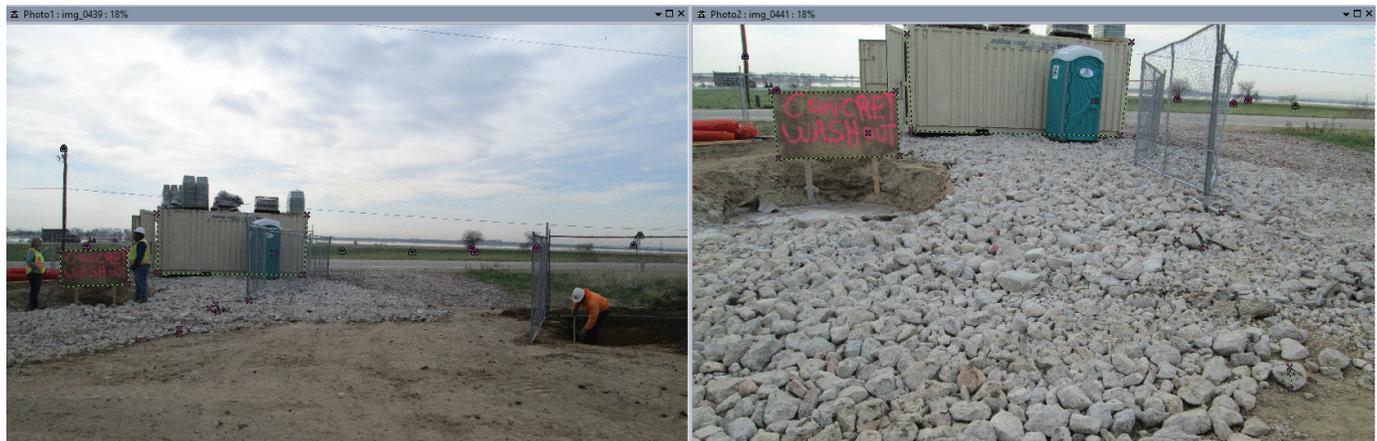
**Figure 8**

Control points between the two photographs and reference points used to solve for the cameras.

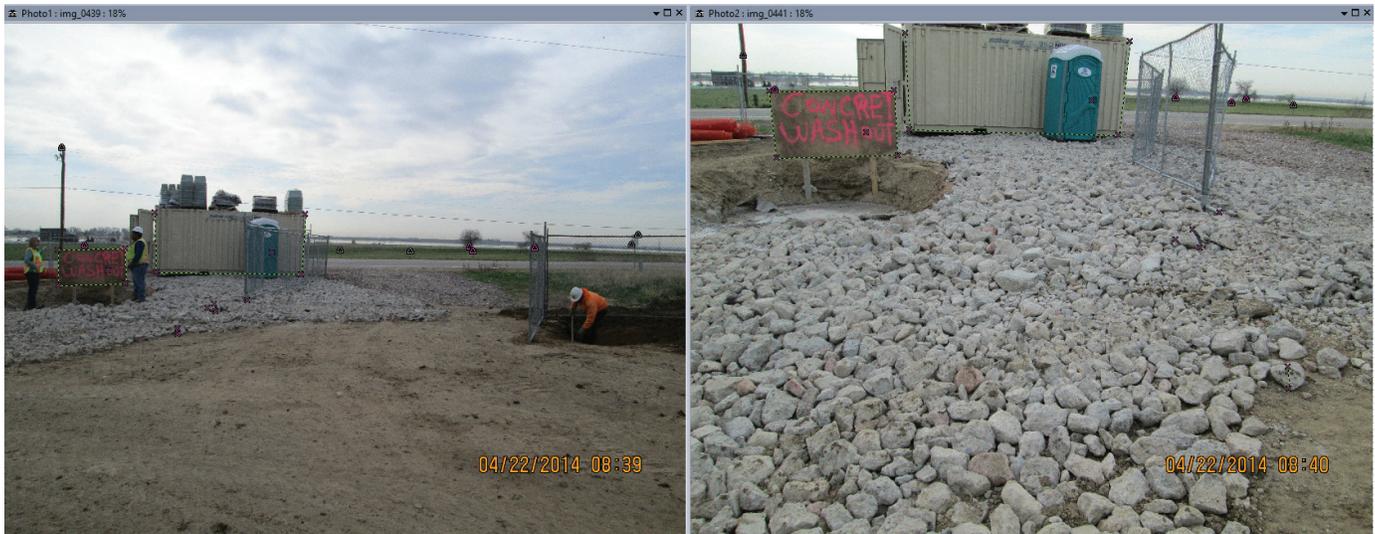
**Figure 9**

Control points between the two photographs and reference points used to solve for the cameras with the point cloud of the scene.

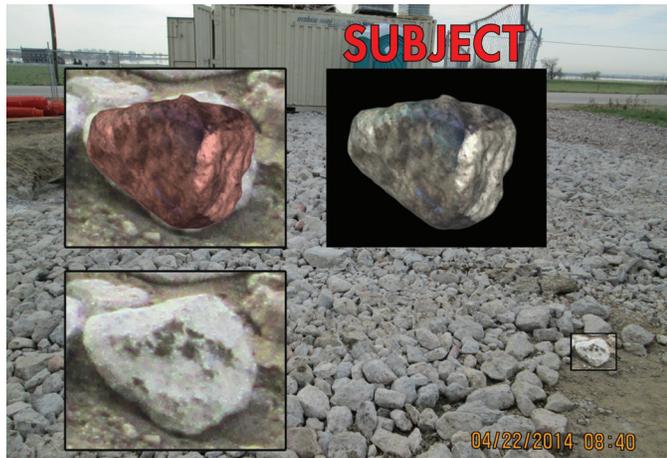
**Figure 10**

The virtual concrete projectile overlaid (to-scale) on the photographs is shown in **Figures 10 and 11**. The Figures show that concrete projectile was similar in both size and shape to the recycled concrete installed on the VTC prior to the incident.

Projectile concrete overlay (to-scale) on photograph.

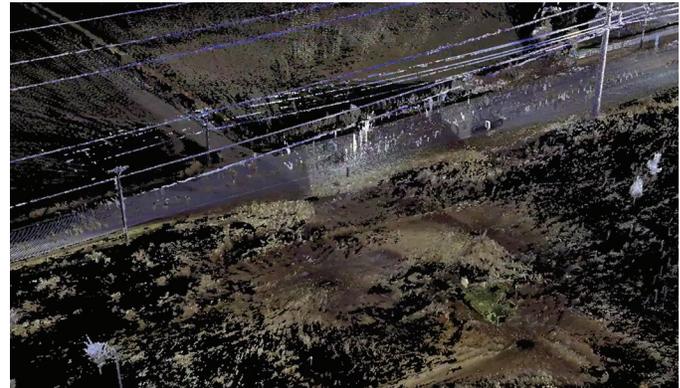
During the park inspection, the previous construction entrance was documented using photography and HD scanning. Seven high-definition scans were taken near the entrance. **Figure 12** shows the HD scan of the park.

High-definition scanning of the park.

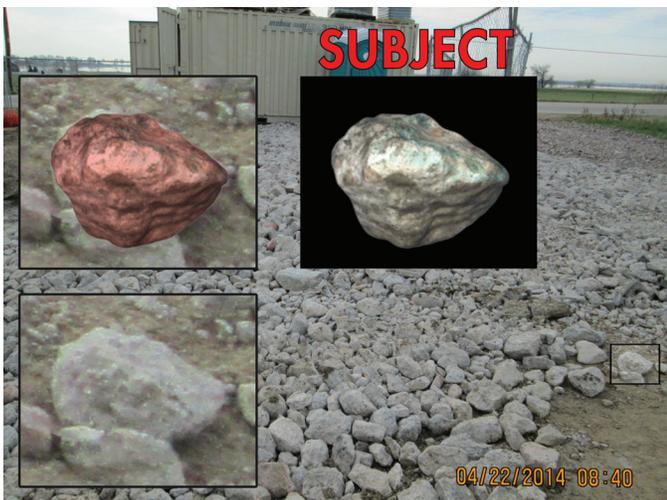
**Figure 11**

Projectile concrete overlay (to-scale) on photograph.

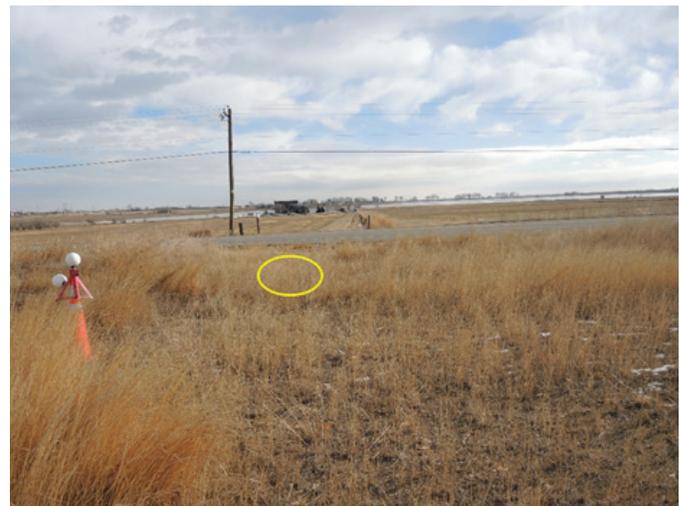
**Figure 13**

The construction project had long been completed prior to the inspection, and the vehicle tracking pad was no longer in place. The recycled concrete that had been spread over the VTC during the construction project had been removed prior to the inspection, and most of the inspection area was covered in grass (**Figure 13**).

The area where VTC was previously installed is shown here.  
The circle represents general area that sample concrete was collected during inspection.

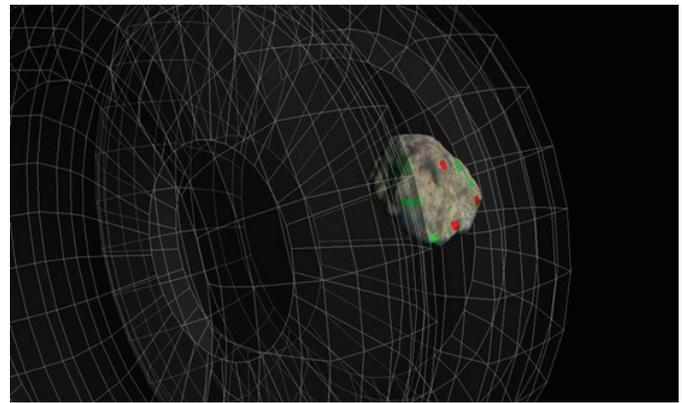
Figure 16

Geometrical analysis with a virtual model of the trailer tires and concrete projectile was done to determine how the projectile concrete would have fit within the set of dual tires, matching the areas where the black material was observed on the concrete with where the concrete made contact with the tires (Figure 16 and Figure 17). The analysis also showed how the concrete would have been pressed fit into the set of dual tires (Figure 18).

Graphic showing a scaled model of the concrete wedged in scaled dual tires. (Green marks = locations of black material embedded; red marks = locations of soil.)

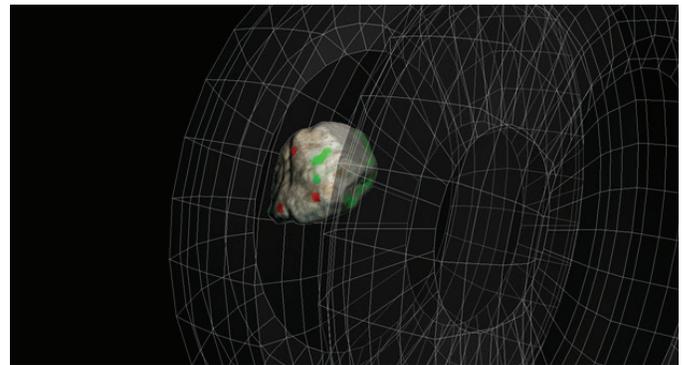
Figure 17

Graphic showing a scaled model of the concrete wedged in scaled dual tires from the other side. (Green marks = locations of black material embedded; red marks = locations of soil.)

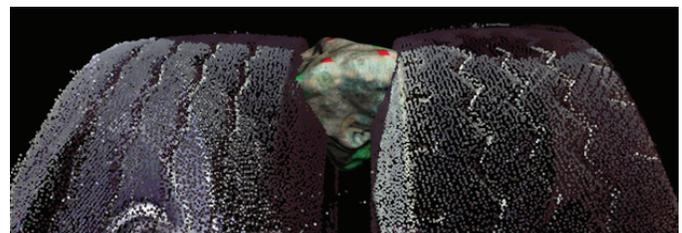
Figure 18

Visualization of the projectile concrete press-fit in HD scan of the dual tires.

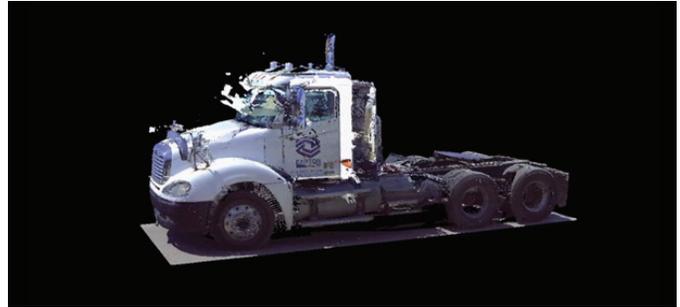
The plaintiff's truck was documented approximately two years after the damage had been repaired. During the inspection, the truck was documented using photography and HD scanning. **Figure 21** is the point cloud of the truck.

**Figure 21**  
Point cloud of the truck.

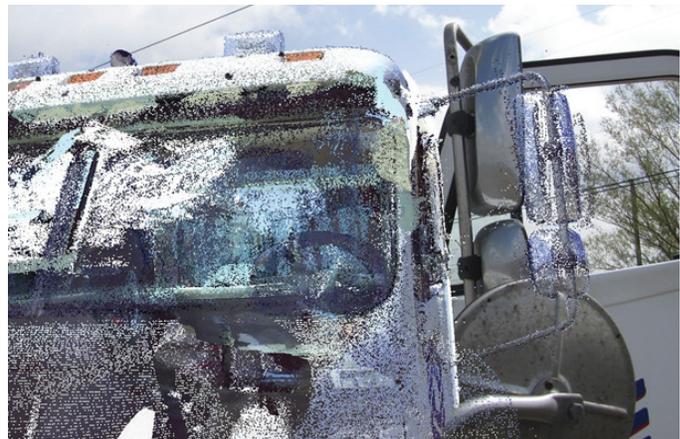
The HD scans and the process of photogrammetry were used to determine where the concrete entered the windshield, the approximate location of the plaintiff's head, and the location that the concrete hit the rear wall of the cab. As an example, **Figure 22** shows the point cloud of the truck overlaid on the scene image as a result of the

**Figure 22**  
Application of photogrammetry to scene photographs using HD scans to determine windshield damage location.

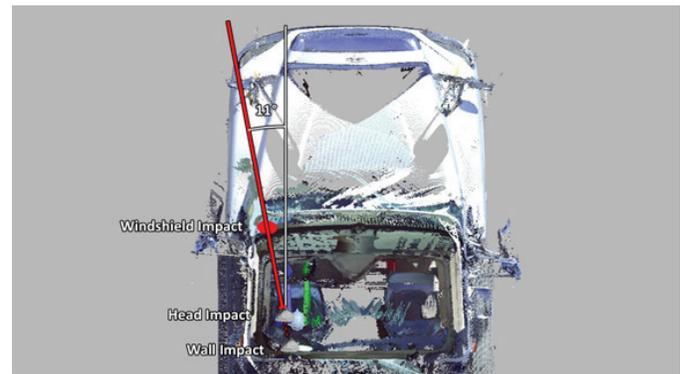
After identifying the location of the hole in the windshield, approximate seating location of the plaintiff, and the location of the dent in the rear of the cab, the trajectory of the concrete projectile through the windshield was determined (**Figure 23**). The projectile entered the windshield at a height of approximately 96.6 in. The trajectory shows that the projectile entered from the left (driver's)

**Figure 23**  
Trajectory of the projectile concrete through the cab top view.

side and traveled both rearward and right relative to the truck. This lateral (left-to-right) trajectory is consistent with the projectile originating in the northbound lane of the county line road, in contrast to coming from the southbound lane of the county line road from a leading vehicle.

- The horizontal trajectory of the concrete from the windshield to the plaintiff and to the rear of the truck's cab. This lateral (left-to-right) trajectory was consistent with the concrete projectile originating in the northbound lane (**Figure 23**). Therefore, the horizontal trajectory of the projectile concrete through the windshield showed the projectile did not come from the southbound lane, but rather the northbound lane.

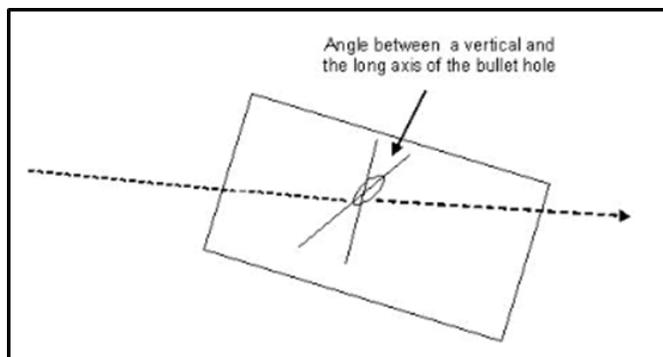
Figure 25

Projectile bullet hole produced in a windshield. The angle of the oval indicates direction bullet is shot. Graphic courtesy of Consolidated Consultant Co.

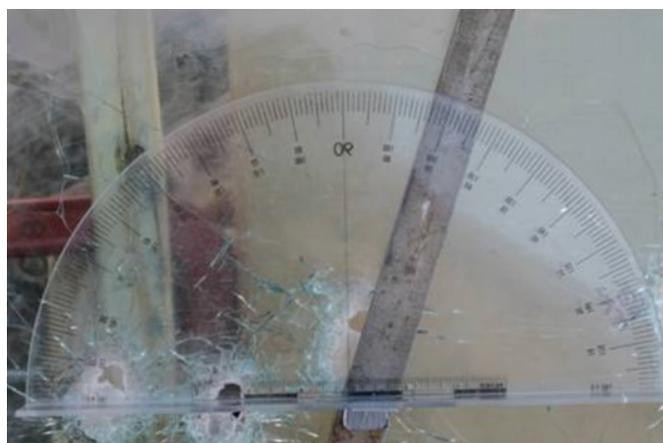
Figure 26

Example of measurement to determine lateral angle. Graphic courtesy of Consolidated Consultant Co.

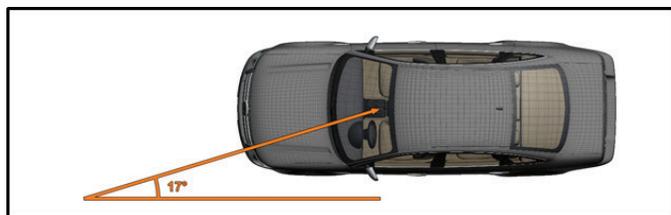
Figure 27

the interior of the vehicle. The bullet hole forms an elongated oval shape. The protractor is aligned with the base parallel to the plane of the front of the vehicle. The angle of the long axis of the elongated oval is approximately 17 degrees to the right, which is consistent with the projectile bullet traveling at a lateral angle of 17 degrees from left to right (Figure 27).

Example of bullet lateral angle through windshield of 17 degrees.  
Demonstrative graphic created by the authors.

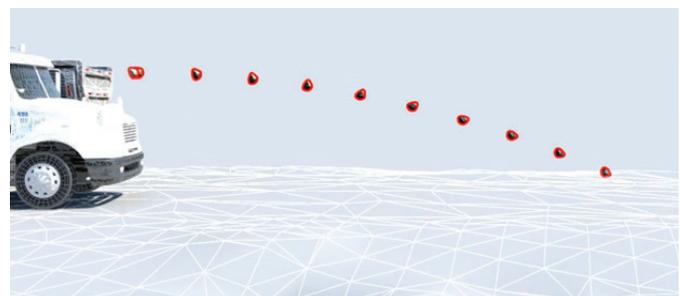
After calculating the trajectory of the concrete projectile and simulating the motions of both vehicles, scientific visualizations were created. One of the scientific visualizations included showing the trajectory of concrete projectile ejecting from the northbound dump truck and striking the windshield of the southbound truck (**Figure 30**).

**Figure 30**  
Still frame from scientific visualization  
showing trajectory of the concrete projectile.

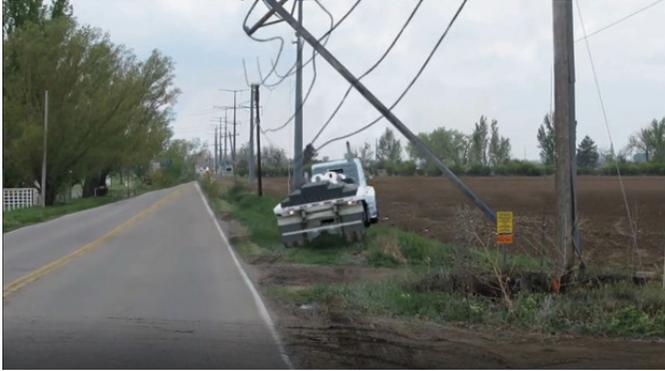
**Figure 31**

A photorealistic scientific visualization showing the northbound dump truck picking up the concrete projectile, driving northbound, the ejection of the concrete projectile into the windshield of the southbound truck, and the southbound truck traveling off the roadway into the field to the west of the roadway was also created using aerial imagery and scene photographs (**Figure 31**).

Still frame from photorealistic scientific visualization of accident.

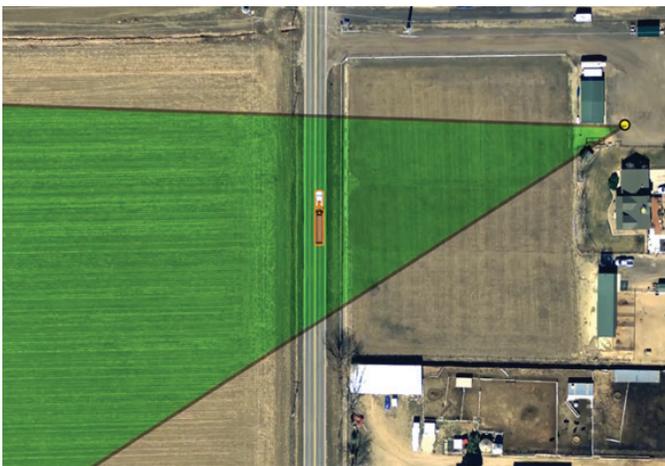
**Figure 32**

A scientific visualization was created, showing the field of view of the witness (**Figure 32**). The scientific visualization showed that approximately 11 seconds after the witness first observed the northbound white rear-dump truck making a thumping sound, the southbound

Scientific visualization showing the field of view of the witness.
