Journal of the
National
Academy OF
Forensic
Engineers[®]

Forensic Engineering Investigation and Analysis of Crack Formation in Acetal Resin Nuts Used for Water Supply Lines

By Edward S. George, PE (NAFE 621M), Donald J. Fournier, Jr., PE (NAFE 626S), Paul Eason, PhD, PE, and Charles R. King

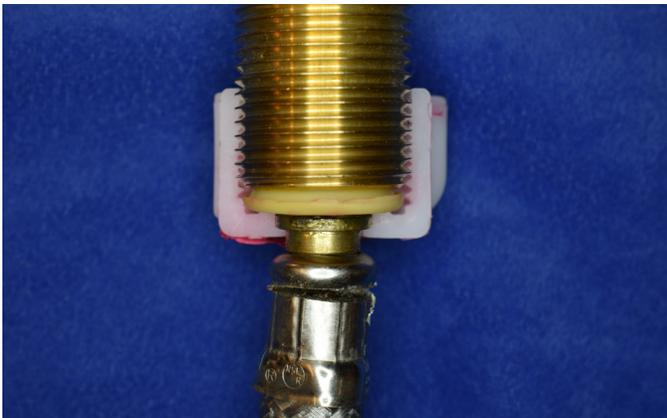
Figure 2
Cross-section showing connection to male-threaded fitting at base of toilet tank.

In use, the toilet connector threads onto a male pipe at the bottom of the toilet tank, compressing a rubber gasket between the interior surface of the connector and the end of the male pipe to prevent water leakage (**Figures 2 and 3**). The contact between the end of the male pipe and the connector creates an outward-directed longitudinal force on the interior surface of the connector. This force creates a shear stress and bending moment within the wall of the connector, with the highest stress located at the interior surface at the bottom of the wall (as shown in **Figure 4**). In addition, the threaded wall of the cap is subjected to a

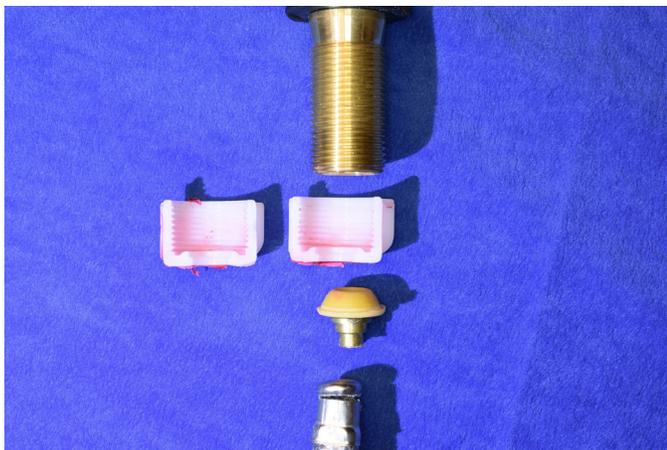
Figure 3
Exploded view of cross-section of connector components.

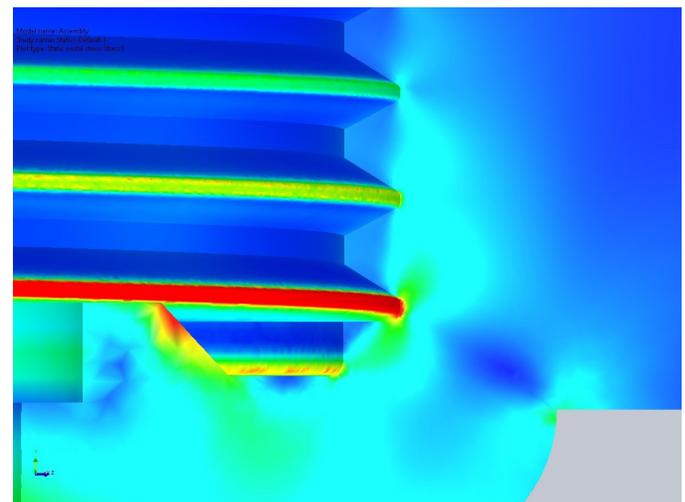
Figure 7

FEA analysis was performed using a standard simulation software. The geometry of the fitting was based on measurements of a cross-section. Material properties were obtained from material datasheets. A tensile force was applied to the base of the fitting. The goal was not to determine stress values but to identify the most probable location for stress risers in this type of loading. The static simulation performed on the resulting model revealed a stress riser in the root of the base thread of the nut (**Figure 7**), consistent with both the physical findings and predictions based on engineering mechanics.

Qualitative FEA image, showing peak stress at root of base thread in red.

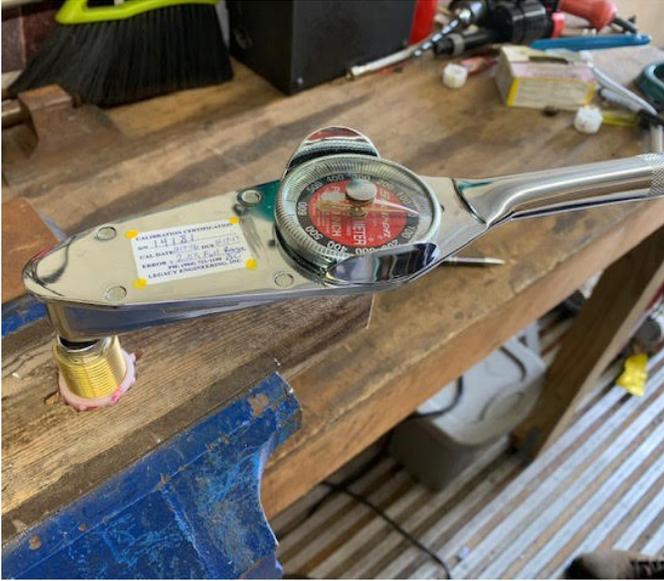
After the resolution of the legal cases, the authors decided to continue the investigation. The initial approach was modified by developing a method to expose the fracture surface. To do so, a hole in the shape of the nut was machined into a block of wood, and the male thread from a toilet fixture was attached to the socket of a torque wrench with epoxy. Using a calibrated torque meter, 0 to 600 inch-pounds, each nut was torqued to failure,

Figure 10
Torque wrench and nut in wood block.

and the load required to do so was recorded (**Figures 10 through 12**). The required torque to cause the part to fracture ranged from 14 to 22 nanometers (nm) 125 to 200 inch-pounds, consistent with data reported by Timpanaro, Shcerzer, Keifer and Eason⁴, who reported torque values of 16.9 to 26.8 nm (150 to 237 inch-pounds).

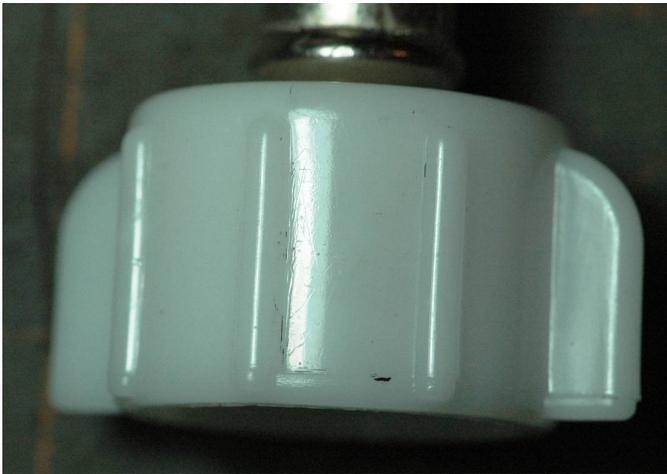
Figure 11
Before torque to failure — no tool marks.

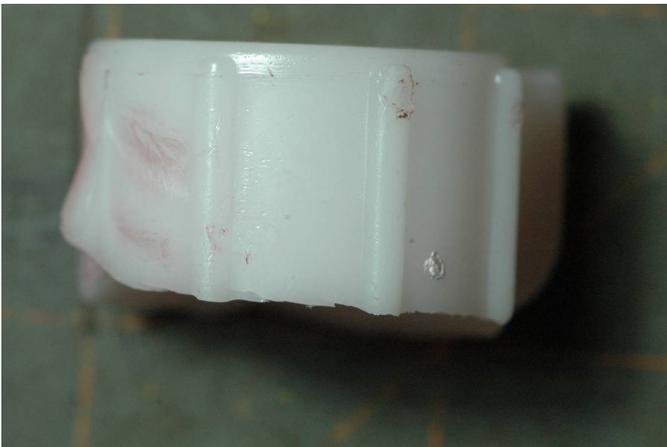
Figure 12
Torqued to failure.

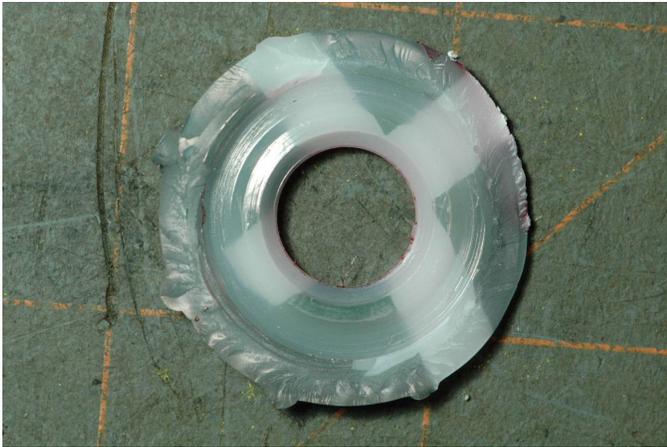
Figure 15
Sample #17, sputter coated.

analytical SEM. The fracture surface was imaged in an uncoated state, using a 5kV accelerating voltage, and spot size of between 96 and 117 nm with the average spot size of 100 nm with a resulting absorption current of 0.58 pascals, to avoid sample charging. After imaging the fracture surface at multiple magnifications, the sample was removed and coated with gold, using a vacuum sputtering system (**Figure 15**). The sample was placed back in the analytical SEM, and the series of fractographs was replicated with respect to location and magnification, at 5kV accelerating voltage, and slightly higher absorption current to illustrate the ability of gold coating to permit higher quality imaging (without changing the features and morphology of the fracture surface). Note that at 20,000 times magnification, the gold coating is invisible

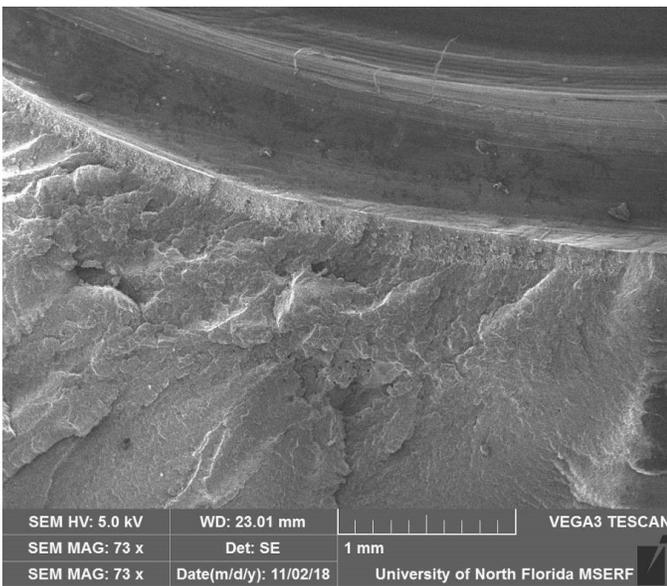
The SEM images after gold coating clearly show two different types of fracture morphologies present in the surface of the same sample. One has plate-like fracture zones corresponding to a fast overload fracture achieved with the torque wrench, while the other (crack that visually showed as red in color) has a tufted appearance associated with sustained loading over time, resulting in creep rupture morphology. See **Figures 16** through **20**. Under sustained

Figure 16
Medium magnification, Sample #17.

loading, this material undergoes slow, stable crack extension, resulting in the development of a tufted fracture surface appearance. These tufts represent fibril extension and subsequent rupture in various polymers⁹.
