Electrocutions and Downed Powerlines: a Forensic Electrical Engineering Analysis of Causes, Reasons, and Effects

By Helmut G. Brosz, PEng (NAFE 1029C)

Abstract

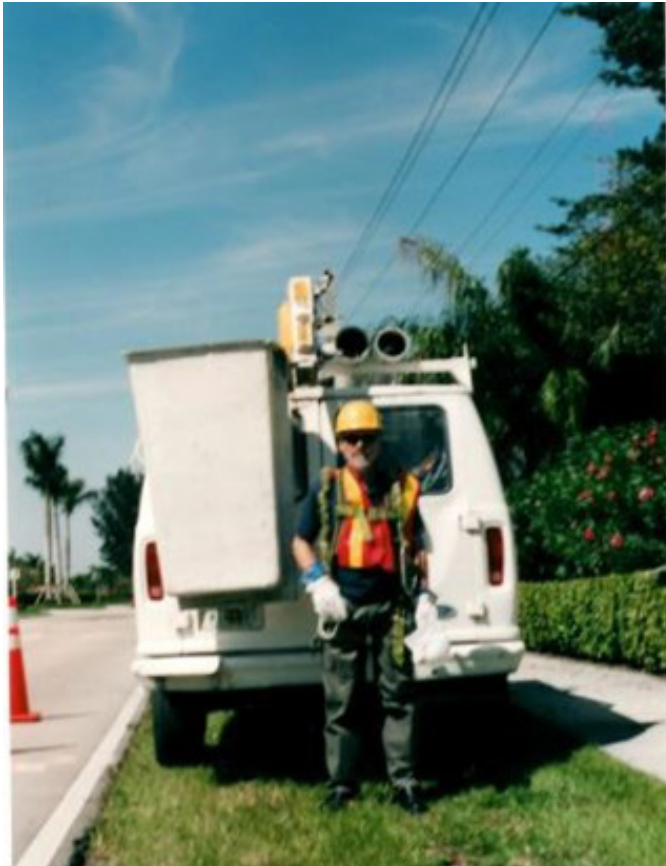
Figure 8

Forensic Engineer and Professor Helmut Brosz at the bucket truck to inspect the conductors close-up.

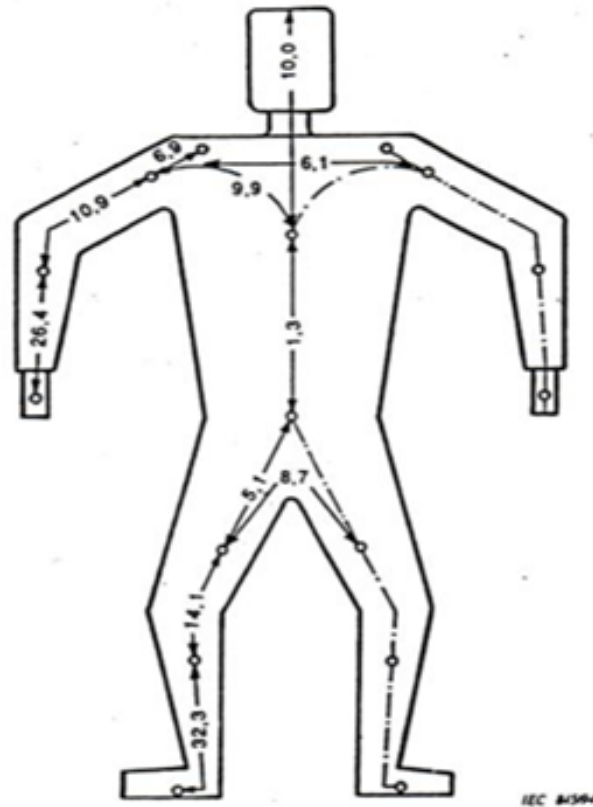
Figure 15

of water. The voltage between their feet, also known as “step potential,” was of an approximate magnitude to exceed 85VAC. The impedance between wet foot to foot based on the I.E.C. Standard 479-1-1994 (Figure 14) is indicated to be 100% of the wet hand to foot impedance of 850 ohms (for 50% of population) at about 500V (Figure 15).

Total body impedance for a current path hand to hand.
