Vol. 36 No. 1 June 2019

# Forensic Engineering Investigation of a Furnace Oil Supply Line Fitting Leak

By Daniel P. Couture, PEng (NAFE 951M)

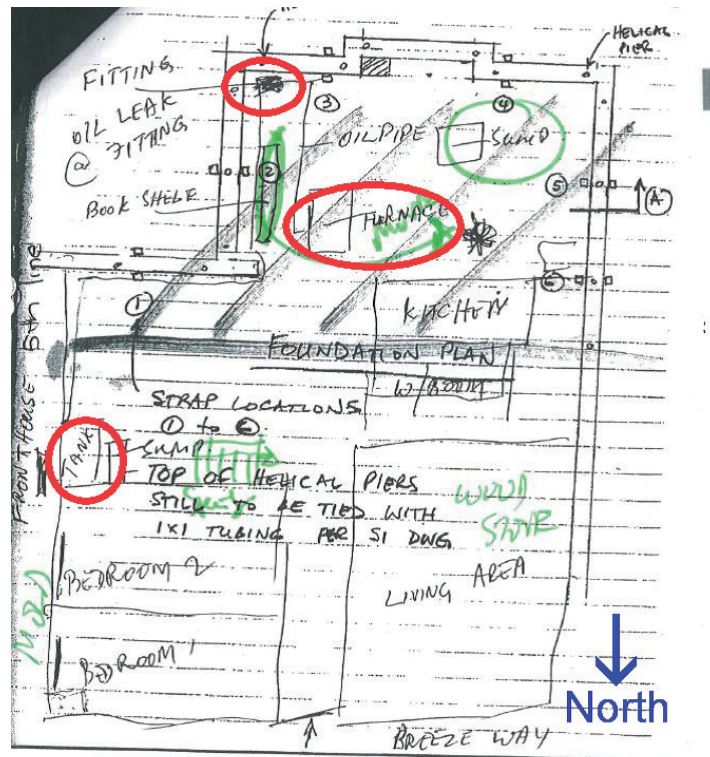
The home was built in the 1970s (**Figure 1** on page 2), and its basement area measured approximately 35 feet by 75 feet (11 meters by 23 meters), and was comprised of two bedrooms, a living area with woodstove heater, laundry room, and utility area. Within this utility area was a furnace, a 240-gallon (910-liter) fuel oil tank with a copper supply line attached to the cement slab floor, and two sump pits. The fuel line was located by the perimeter wall and had a single union a few feet away from the point where it supplied the furnace. There were some furniture items (such as bookshelves and boxes of books) in the furnace area. These site details are found in an unscaled sketch reproduced as **Figure 2** (on page 2), with the tank, fitting, and furnace highlighted in red ovals.

Figure 2  
Scanned sketch of the basement configuration by others.

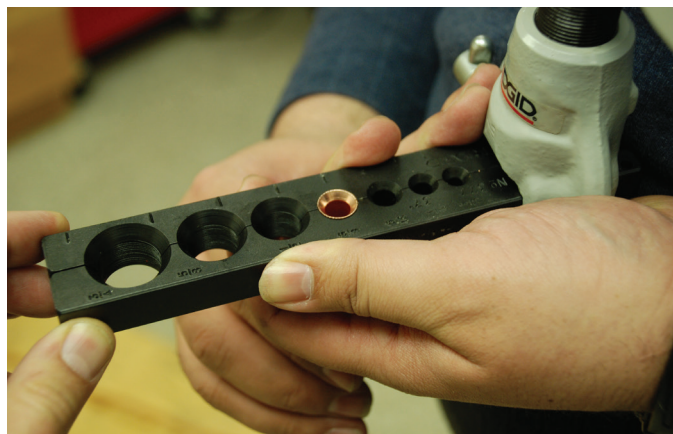
**Figure 7**

The flaring tool used on the copper lines.

The tubing was flared with a professional quality swaging tool (**Figure 7**) similar to that used by BURSCO's employees, and both correct and short flares were made (**Figure 8** and **Figure 9**). The nuts (**Figure 10**) were

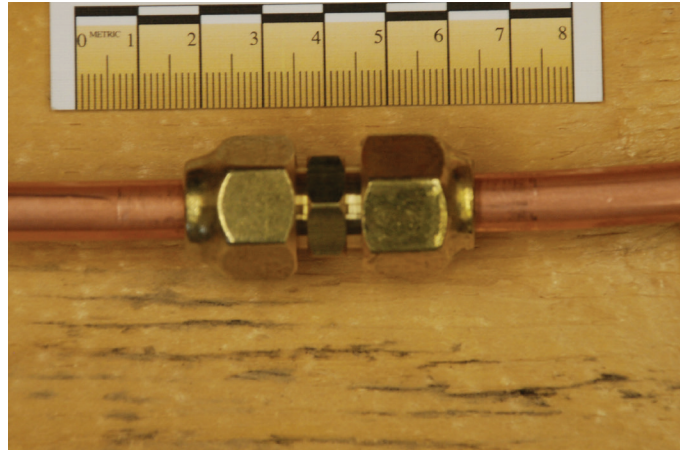
**Figure 11**  
The union as assembled for testing.

tightened with a  $\frac{7}{8}$ -inch wrench, while the union hex face was tightened with a  $\frac{5}{8}$  wrench, and the joint was ready for testing (**Figure 11**).

The experiment included an attempt to disrupt a tool-tightened union fitting by repeatedly kicking by a workboot worn by a 250-lb technician with the strike force directed at pushing the nut, over a period of 3 minutes. We also considered whether the burner pump vibration, from a distance of 8 feet away, could have had an effect, but it was presumed to be insignificant. These actions were unable to dislodge the fitting or tubing to create a leak. The same actions were performed on a finger-tight union fitting, but these actions could only move the nut 1 millimeter, as seen in **Figure 12**. No droplets were formed from the fitting after this interaction.

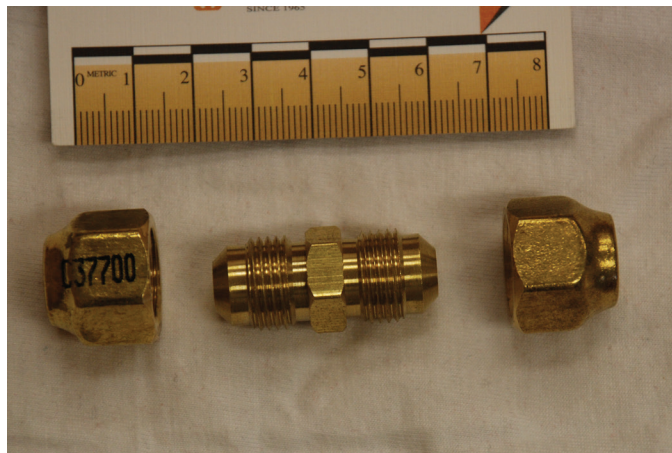
**Figure 10**  
The exemplar SAE 37° union fitting and nuts.
