Vol. 39 No. 1 June 2022

FE Use of Arc Mapping/Arc Fault Circuit Analysis in a Residential Kitchen Fire Investigation

By Jason McPherson, PE (NAFE 852M)

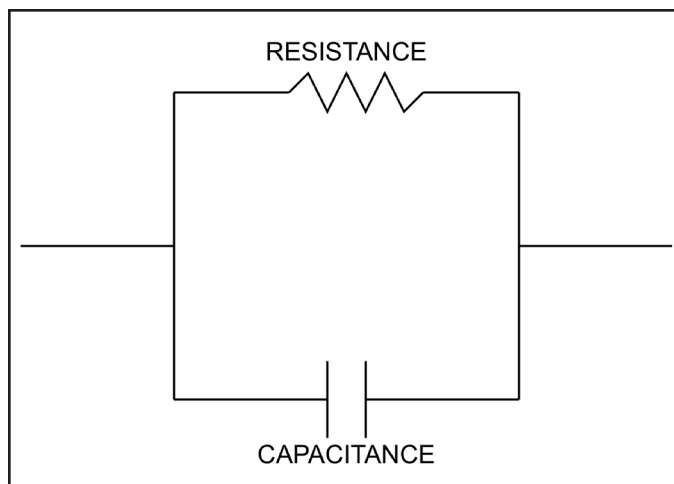
The intent of electrical insulation, when placed between conductors at different potentials, is to permit only a "small or negligible current to flow through it."⁵ Electrical insulation can be considered a combination of resistors and capacitors. The basic circuit representation of electrical insulation is shown in **Figure 3**. When exposed to heat from fire of sufficient time and magnitude, the insulation can go through a decomposition process that results in the insulation no longer functioning as intended.

Figure 3
Basic circuit representation of electrical insulation.
