Vol. 36 No. 1 June 2019

Forensic Engineering Investigation into Factors Contributing to Explosion of Consumer-Grade Tabletop Torch

By Jahan Rasty, PhD, PE (NAFE 768S)

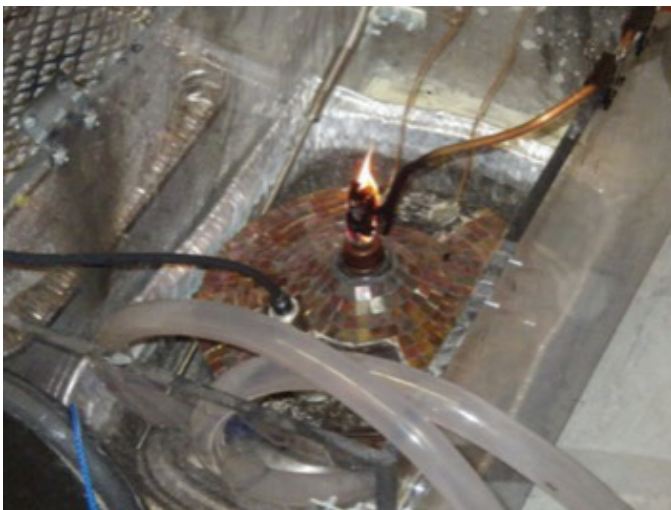
Figure 4

An exemplar tabletop torch was instrumented for data acquisition by removing small sections of mosaic tiles and creating small openings on the top surface of the torch for a pressure transducer, an oxygen sensor, and two thermocouples for monitoring the temperature of both the liquid and vapor phases of the fuel. Threaded nubs were manufactured and epoxied over each hole, into which a pressure transducer and an oxygen sensor were placed. Additionally, the two smaller holes were used to route the two thermocouples into the torch. Each thermocouple hole was then epoxied to create a “water-tight” (sealed) region, as shown in **Figure 4**.

Exemplar torch instrumented with pressure gauge, oxygen sensor, and thermocouples to monitor pressure and temperature of vapor during operation of torch.

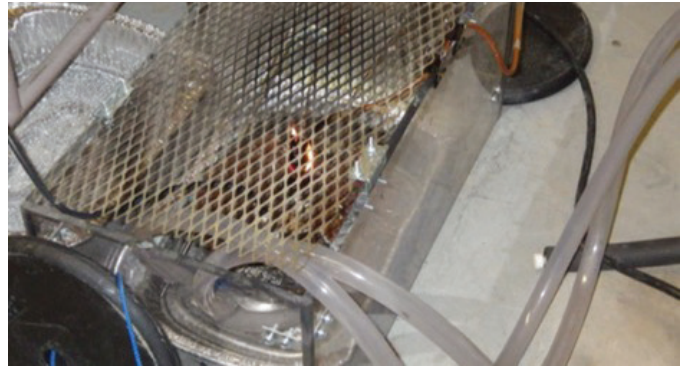
Figure 5

Instrumented exemplar torch placed inside a safety cage designed to guard against potential explosions during testing.

temperature, recirculating water bath. The height of the water bath was approximately 1 inch below the “lid” of the torch (location where the top and bottom of the torch are mechanically joined). The torch and water bath were then placed inside an enclosure designed to contain fuel and fire emission in the event of a torch explosion, as shown in **Figure 5**. The following instruments were used in this experimentation:

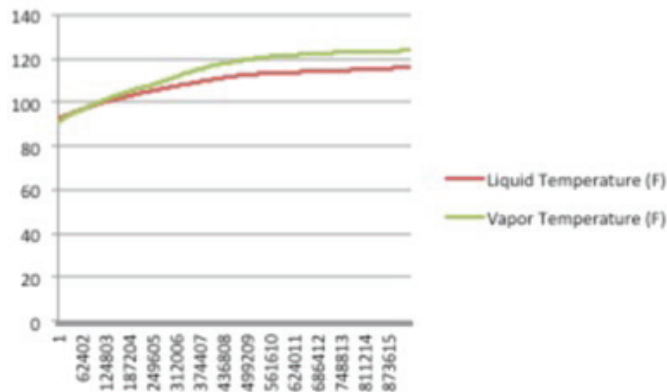
Figure 6

The temperature data was analyzed in an attempt to discover how the temperatures of both the liquid and vapor phases of the fuel inside the torch changed as a function of time after the torch was lit. The results, as depicted in the temperature-time plot of **Figure 6**, show that the flash point temperature of the fuel was exceeded within 3 minutes of lighting the torch. Repeated experiments showed that the vapor temperature would exceed 105°F within two to three minutes of operation, and within 20 minutes the temperature would stabilize at around 120°F. This demonstrates that the fuel vapor within the torch is capable of reaching its ignitable flash point of 104°F after only a short period of operation. This explains how, as it did in the subject incident, an explosion could happen within minutes of lighting the torch when the ambient temperature is near 90°F and accumulation of radiant heating can cause the

Internal liquid and vapor fuel temperature rise with elapsed time post lighting of torch — liquid fuel (bottom, red curve), vapor fuel (top, green curve).

fuel temperature to reach the fuel’s flash point within minutes. Therefore, the results clearly indicate that explosions can occur within normal operating conditions of this torch, as it did in the subject event.

data) and liquid fuel (red data) show an expected time lag following the explosion that occurs due to the finite time constant of the 24 gauge thermocouples. As depicted in **Figure 6**, following the explosion, the gas/vapor temperature reached above 236°F, while the liquid fuel temperature reached ~161°F. The results of the testing show that the air/fuel ratio within the torch, which is normally fuel rich and above the upper explosive limit (UEL), can be bought into the explosive range and ignited by the introduction of air into and around the torch cap.

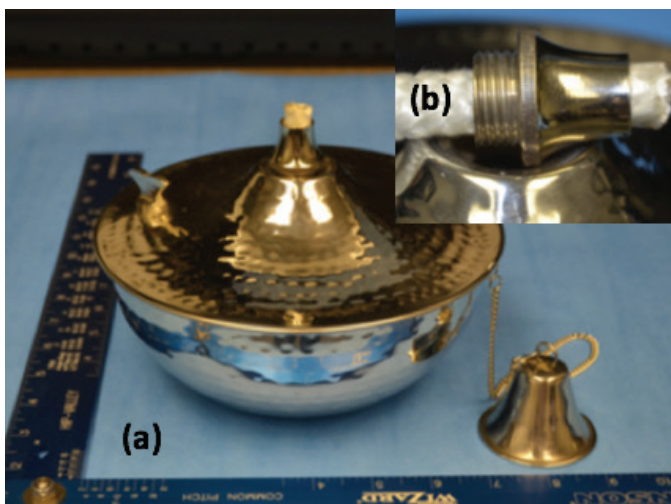
Figure 10

Alternative design of an exemplar tabletop torch (a) showing appropriate length of wick holder section to hold and contain the wick (b) to separate the flame from volatile fuel vapors below the cap.

Comparison of the different torch models in **Figures 10** through **13** reveals that each of the exemplar torches utilize a cap with a wick holder that conforms tightly to the wick for at least a centimeter before allowing it to be exposed through the opposite side, thereby preventing the flame from coming in contact with the fuel vapor below. However, there is no such wick holder present on the subject model torch as shown in **Figure 8**; the wick passes through an unrestricted cap opening that is no more than 1 mm in thickness, with excess space between the metal cap and the wick itself. This excess space provides the vapor a means of reaching the flame and igniting the rest of the fuel within the chamber below.

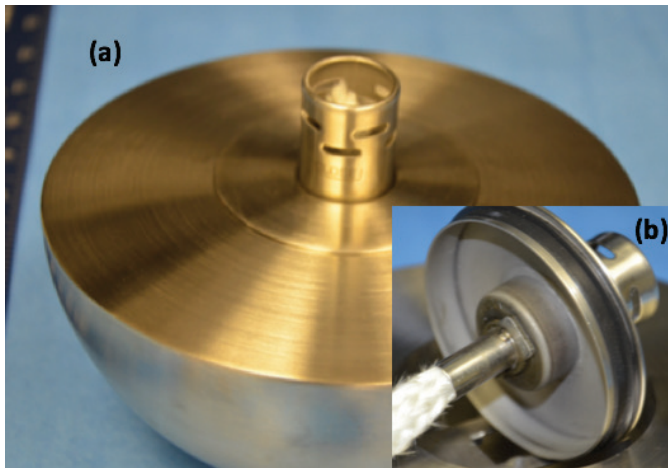
Figure 11

Alternative design of an exemplar tabletop torch (a) showing appropriate length of wick holder section to hold and contain the wick (b) in order to separate the flame from volatile fuel vapors below the cap.

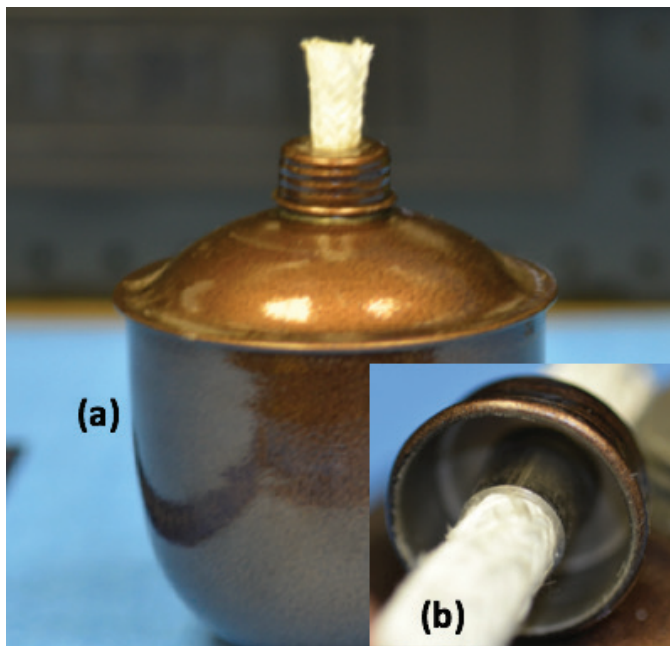
Figure 12

Alternative design of an exemplar tabletop torch (a) showing appropriate length of wick holder section to hold and contain the wick (b) to separate the flame from volatile fuel vapors below the cap.

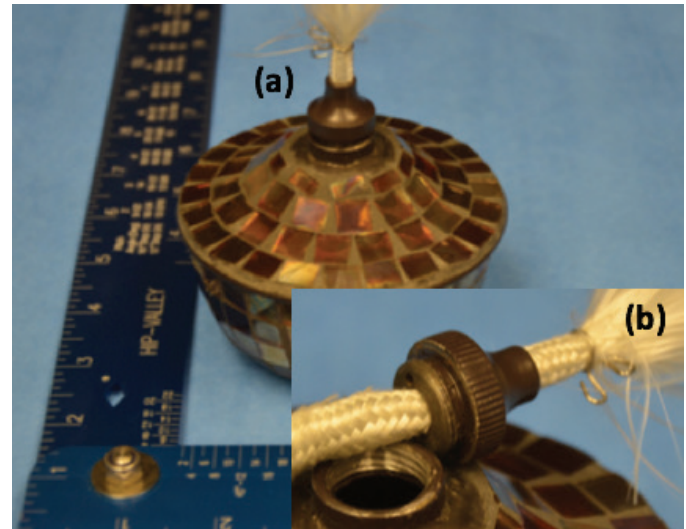
Figure 13

Alternative earlier model torch (a) designed and manufactured by the same designer involved in the design of the subject torch, showing appropriate length of wick holder section (b) to hold and contain the wick to separate the flame from volatile fuel vapors below the cap.
