Forensic Evaluations of Built-Up Roofing Storm Damage Claims and the Appraisal Process

By Todd Springer, P.E. (NAFE 422C)

Case Study #1 – Large Commercial Strip Mall

Case Study #2 – Five Building Hotel Complex

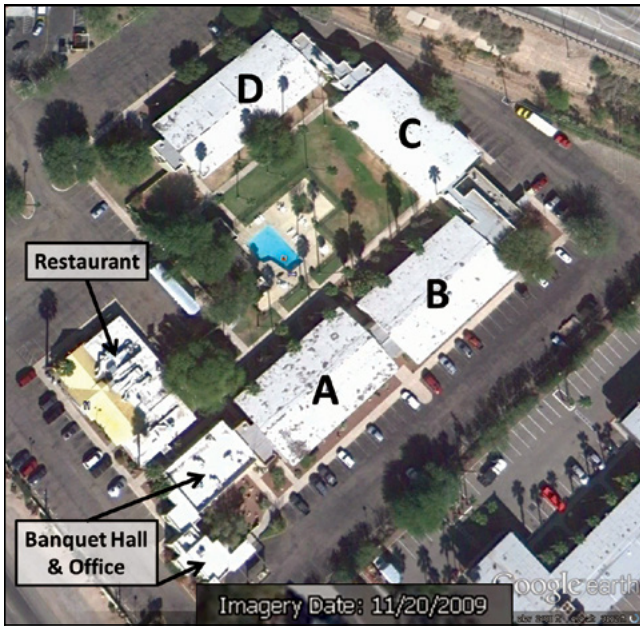
Figure 4

Image of roof from Nov. 20, 2009.

After review of these documents, the property was researched. Information provided through the county assessor revealed the buildings were originally constructed 44 years prior. Historical aerial images obtained from Google Earth showed the roofs in a deteriorated condition in 2009 — two and a half years prior to the reported date-of-loss. **Figure 4** provides a portion of this image. The date has been magnified in **Figure 4**. The darker areas of the roof are locations where the ballast material is displaced or removed, and the underlying roofing is exposed.
