Vol. 38 No. 1 June 2021

Forensic Issues from the Investigation of a Marine Shaft Failure

By Stephen R. Jenkins, CPEng (NAFE 11)

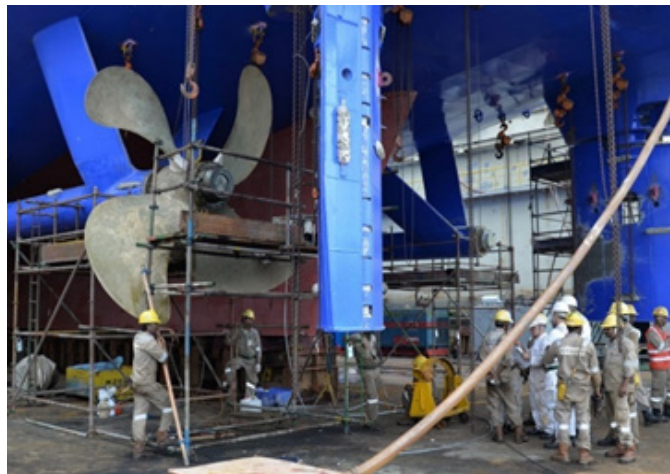
Figure 2

The port side arrangement is similar. In this photo, the new high-efficiency propeller is in place and rudder is inclined toward the camera.

The general arrangement (**Figures 1 and 2**) of the stern equipment was symmetrical with each propeller followed by an in-line rudder. This close up (**Figure 3**) shows the area between the aft end of the stern tube and the hub of the propeller. **Figure 3** is the port side, which was undamaged; the starboard side was similar.

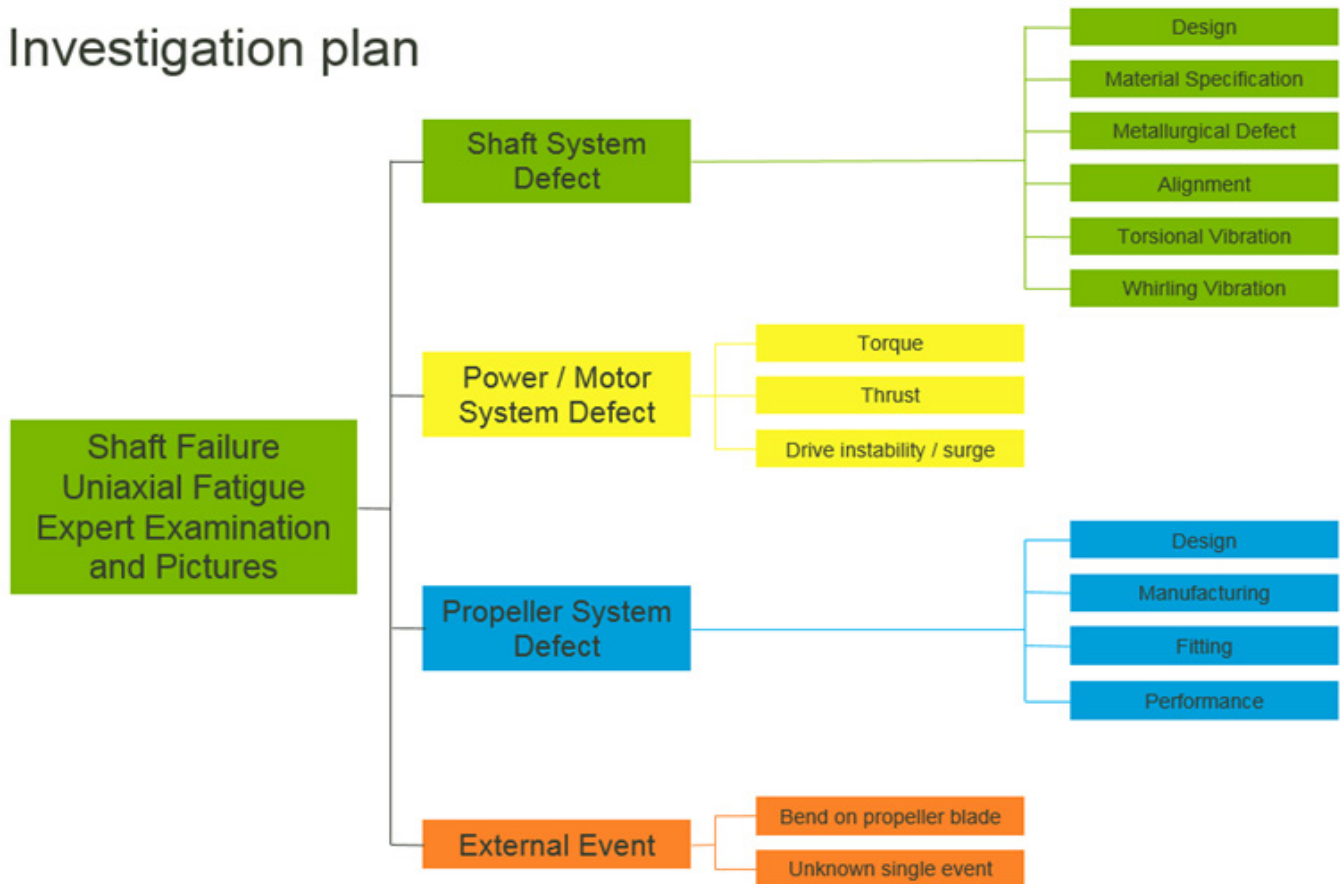
Figure 14
Detailed investigation plan.

To provide some structure, the system was analyzed and divided into four primary systems based on operational elements of the propulsion system. These were the propeller, shaft, power and motor system, and an external event (**Figure 14**). Observations were accumulated under each heading and potential causes evaluated with a view to confirming or eliminating their possible contribution.

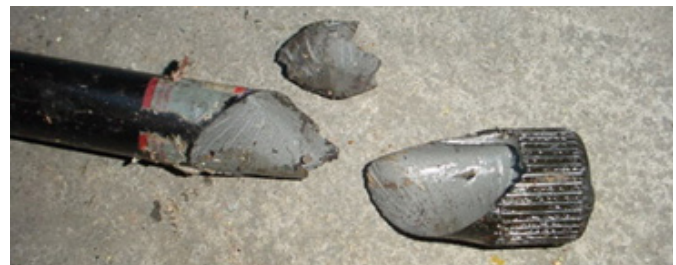
Figure 15
A typical torque failure.

In addition, a torque failure produces a characteristic fracture that runs at 45° to the main axis of the shaft (**Figure 15**), and is completely different from the uniaxial

fatigue failure observed on the starboard shaft. On this basis, a failure related to torque can be positively ruled out.

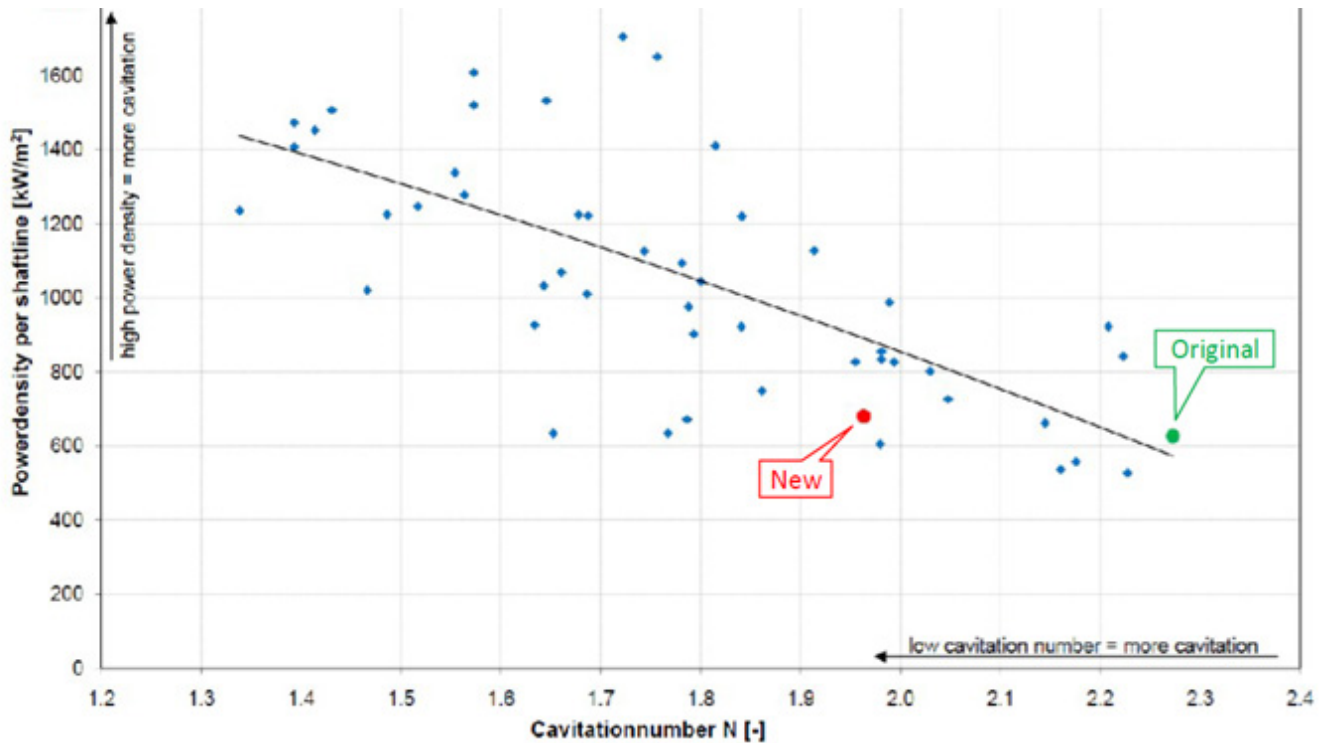
Figure 16
Power density and cavitation number for the design and the ferry reference set.

The new propellers had a slightly higher power density in kilowatts per square meter of blade area than ships of similar design and service. The propeller improvement report noted that the new high-efficiency propellers would be slightly closer to cavitating in service. A diagram included in that report showed that, as designed, the propellers were within accepted service parameters (**Figure 16**), although the sensitivity to cavitation had increased. Therefore, damage or surface defects became more likely to initiate cavitation.

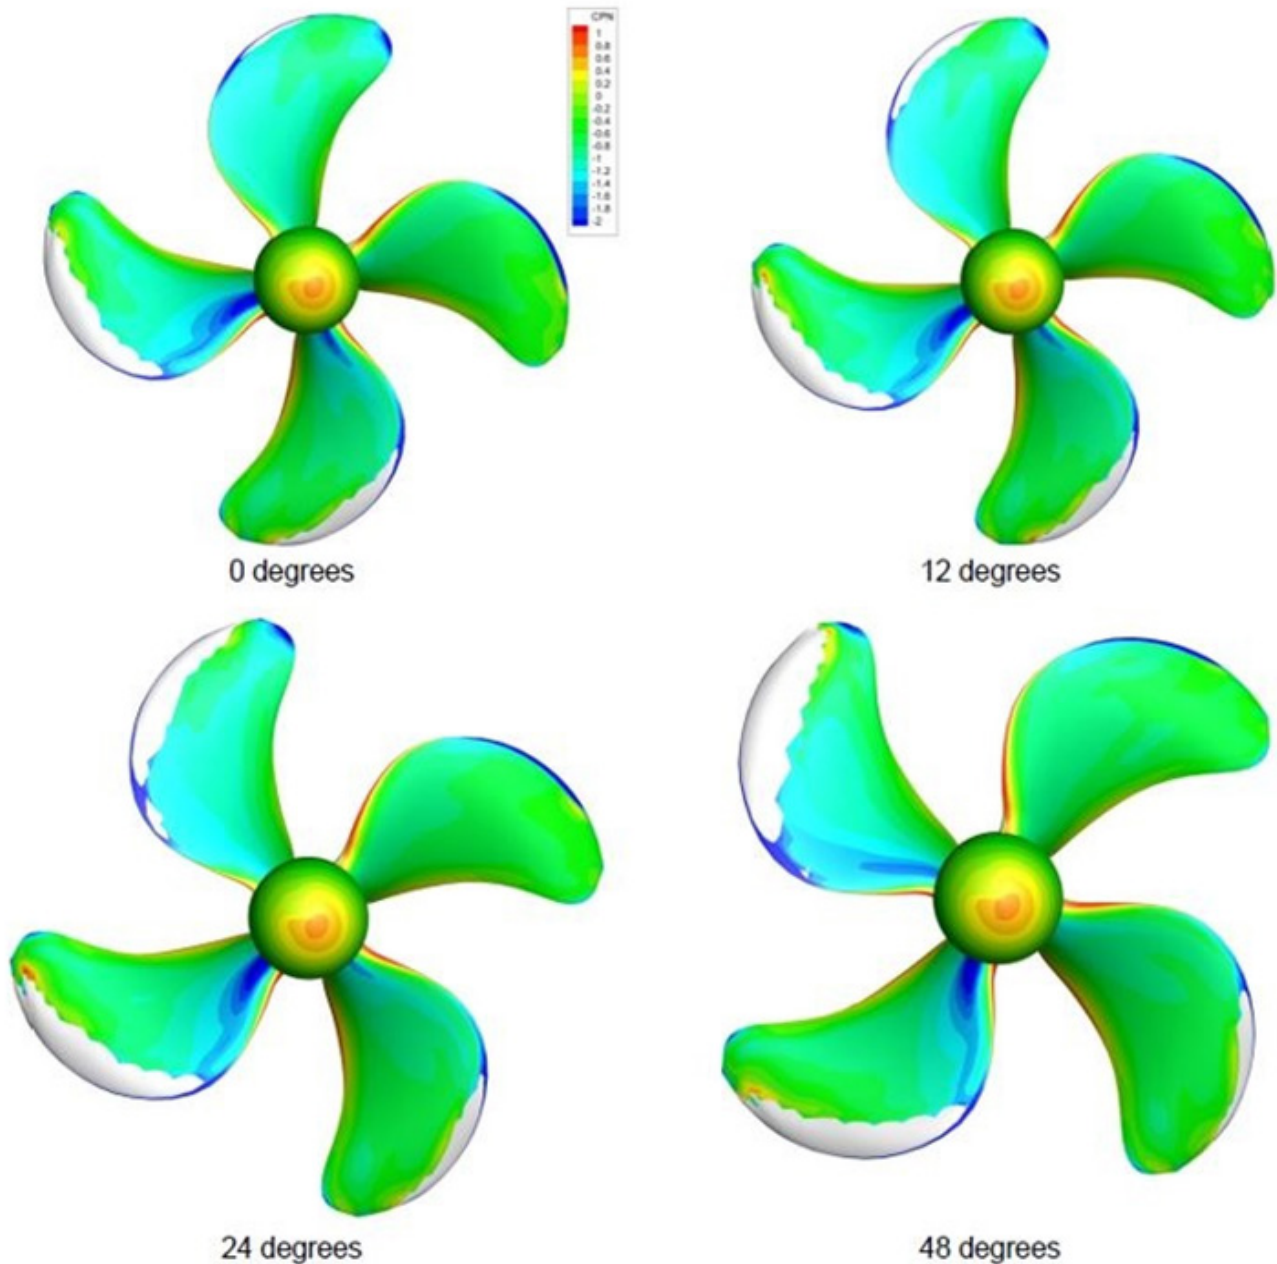
Figure 21

While it was disappointing that the modeling did not generate results that matched the cavitation patterns on the propeller surfaces, this was explained by the limits of the software and in computational capacity. (Note: This was in 2015, and both have developed significantly since then.) They were, however, able to provide maps of the propensity of the propellers to cavitate through the calculation of a standard measure called the cavitation number. This showed that, according to their calculations, the scanned shape of the propellers operated at a cavitation number much closer to the critical level than the number proposed in the original investigation reports to determine the benefits of the new propellers. White areas in **Figure 21** are cavitating.

These results supported cavitation as a significant factor for consideration, but the uncertainty in the results meant that the physical evidence became the most reliable indicator of any performance problems with the propellers.

Pressure distribution (CPN) and sheet cavitation pattern for starboard propeller (shown mirrored, overloaded condition, 150 RPM, PD = 5,148 kW). Edge effects only, surface deformities could not be modeled.
