Forensic Engineering Investigation of PVC Piping Failure in a Multistory Condominium Building

By John Certuse, PE (NAFE 708F)

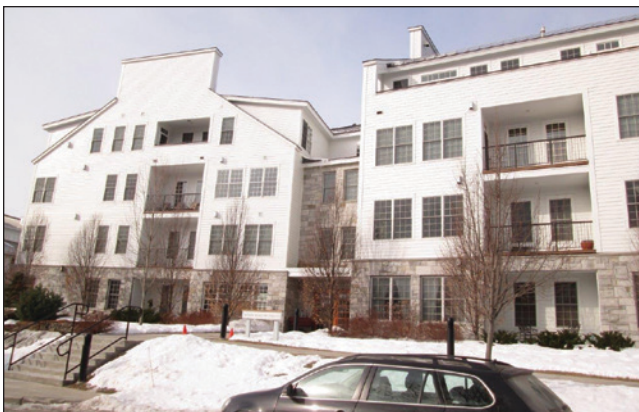
Figure 1
Property as seen.

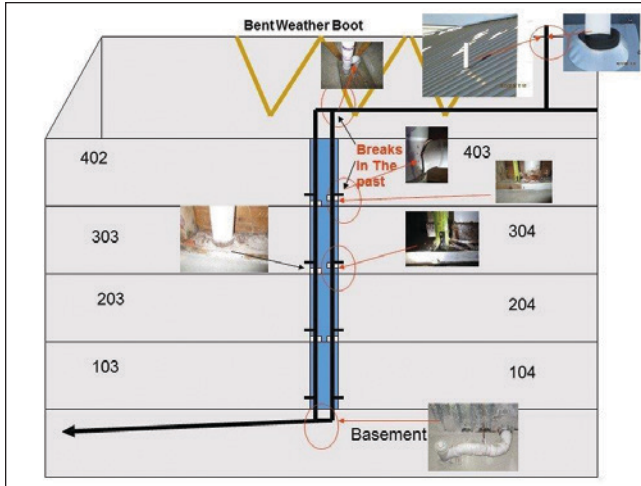
In the fall/winter of 2013-2014, seven years after construction was completed, four pairs of horizontally adjacent and vertically aligned (see **Figure 2**) condominium units were found to be damaged by long-term exposure to moisture and subsequent mold growth.

Figure 2
Diagram of building piping system.
