Vol. XVII No. 2 December 2000

Deposition & Court: Quotes That Altered the Engineering Case

by Michael Kravitz, P.E. (NAFE 451S)

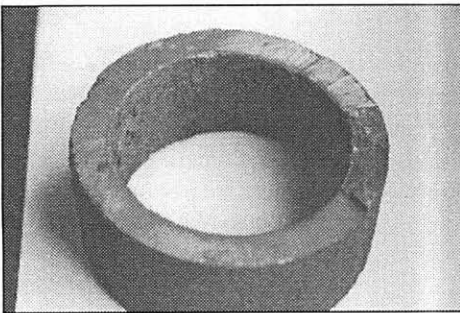
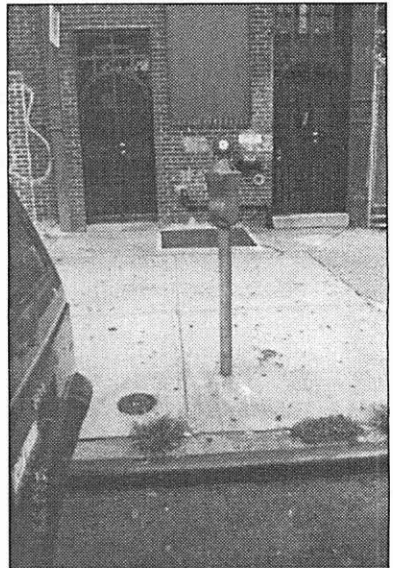
The first piece of evidence that was shown to the writer was a two inch (2") section of 4" diameter steel pipe that was cut from the sprinkler feed leading into

the building. The pipe was cut on both sides. On one side the cut was continuous which indicated that it was done with a pipe cutter in one continuous cut. The other side was not a continuous cut and at one section approximately one-eighth of the circumference was jagged which indicated that the pipe was probably snapped at that point. (See photograph.) The pipe showed no sign of fracture in bending, nor did it show any sign of fracture in shear. The next photograph showed the exterior of the building including the water valve within the sidewalk and the vault cellar doors flush with the sidewalk. It was claimed that water was gushing through the vault door. At the time of the event there was no sidewalk in place. The sidewalk was being constructed and that the subgrade was exposed.

There were four possible scenarios on how the water entered the cellar. The first was that the water pipe was caused to be broken. However, that would have allowed very large amounts of water to enter the cellar and probably would have filled the cellar beyond the two foot level that had been measured by the plaintiff's inspector. The second possibility was that because of the hurricane large volumes of water might have filled the sidewalk subgrade area in front of the building and then entered the cellar through the sidewalk cellar doors as indicated by the inspection firm. The third possibility was that the cellar floor slab was cracked by age or hydrostatic uplift and that ground water entered through the slab. Finally, the fourth possibility was that water entered through the sewer trap in the cellar floor. It should be noted at this point, that this section of the City had a combined sewer system. Storm water and sewerage are collected through the same pipe.

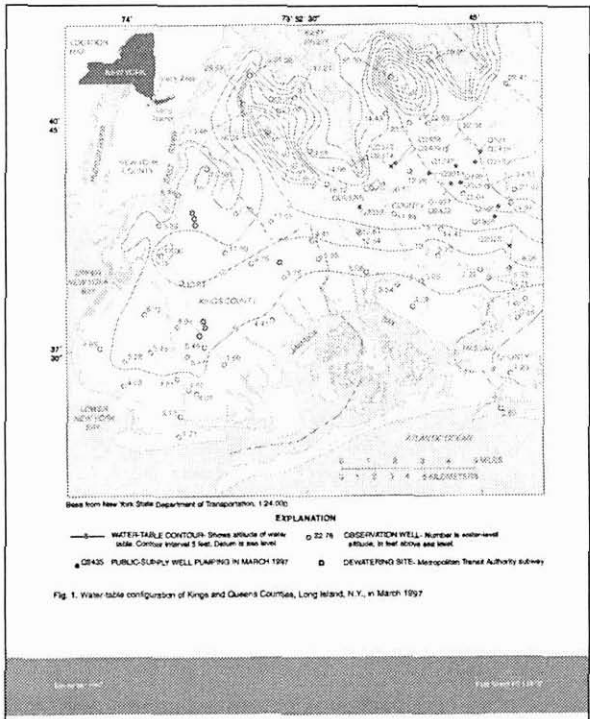
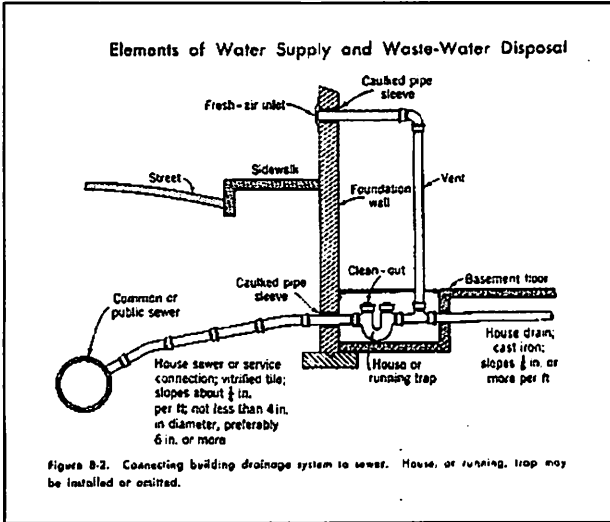
This question and answer told us that the water was not pumped out. The water drained out by itself. This was an indication to the author that the major part of water had not entered through the sidewalk vault doors, although some water probably might have entered through the vault doors as indicated by the earth stains that were on the wall near the cellar vault doors. We also concluded that the sprinkler pipe was not the cause of the flooding since if the sprinkler pipe had broken then the water would have probably filled the entire cellar. The cellar slab could have been cracked and ground water certainly could have entered through the cracked slab because the hurricane probably contributed to the rise of the ground water table. The ground water table obtained from United States Geological Survey (USGS)⁴ indicated the elevation of ground water in that area as approximately five feet (5') in this area of the city. In the end, we concluded that the most probable explanation of the infiltration of water was that the combined sewer had backed up due to the large volume of storm water and sewerage that then entered the cellar through the sewer trap as indicated by the diagram of a typical sewer connection.⁵ The chart in the appendix of the paper showed the calculations at various pressures and the time it would have taken to fill

the cellar floor to a level of two feet (2'). There was no explanation as to why the sprinkler pipe water might have stopped flowing after achieving a level of only two feet (2') above the floor.

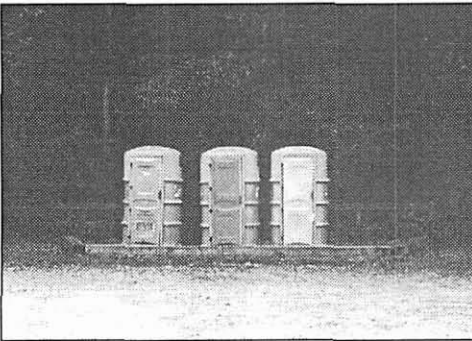
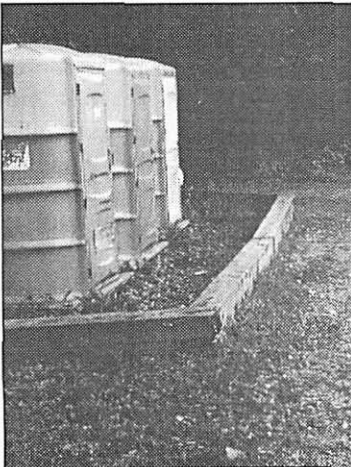
The defendant town had installed railroad ties around three (3) portable toilets in the town park because vandals had been driving their vehicles into the park and crashing into the toilets and knocking them over. The town installed

railroad ties to act as a barrier to protect the portable toilets. The plaintiff tripped and fell while she attempted to step over the railroad ties that were surrounding the three (3) portable toilets. The plaintiff incurred injuries and entered suit against the town. The writer was retained on behalf of the plaintiff and reviewed five (5) color laser photographs of the configuration of

the three (3) portable toilets, reviewed the deposition of the Director of Recreation for the town park and the deposition of the plaintiff. The writer was not authorized by the plaintiff's attorney to visit the site. The author reviewed regulations regarding amusement devices and temporary structures along with architectural standards and issued an opinion that the means of ingress and egress to and from the portable toilets was in violation of the standards. The defendant's position was that the means of ingress and egress was appropriate and safe. The photographs had been provided to us by the plaintiff's counsel. The first photograph showed the general area of the portable toilets.
