STRUCTURAL FAILURE REVIEW

Forensic Engineering Structural Failure Review By Finite Element Analysis

by W. T. Yaxley, CSP, P.E. (NAFE 270F) W. Bracken, P.E. (NAFE 605M)

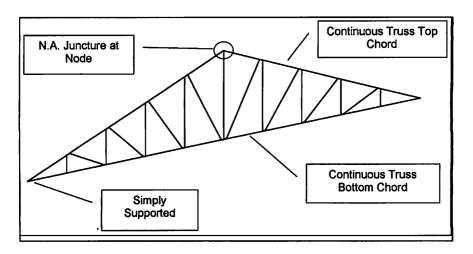
the revised end condition. The condition, shown in Figure 3, was the revised condition erected at the home. The original simple truss consisted of common triangles but was modified at one end heel connection by adding some indeterminate elements that seriously challenged the critical heel connection.
