Vol. XX No. 1 June 2003

Anatomy of a Forensic Engineering Case

by Michael Kravitz, P.E., (NAFE 451S)

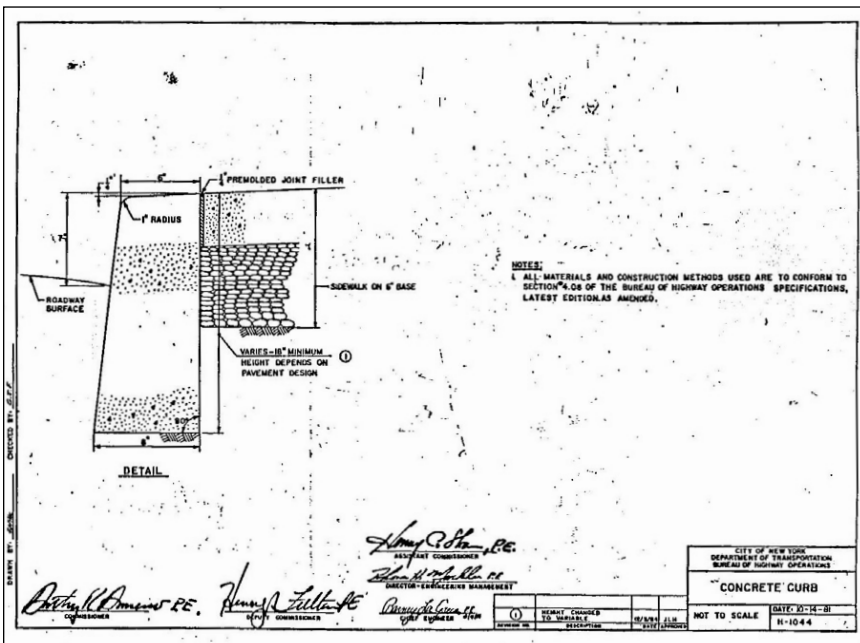
The Plaintiff's expert also relied on the AIA Architectural Standard Graphics to support his opinion that the minimum height of a concrete curb above pavement should be 6" and that precast concrete parking bumpers 6" high

should have been installed. The AIA standards are used by highway design engineers and architects as a guide. In fact, when curbs are constructed their heights are generally between six inches (6") and seven inches (7") not 8" as opposing expert opined.
