Forensic Engineering Report: Finite Element Analysis of a Flex-Fan Blade Failure

by John Marcosky, P.E. (NAFE 205F)

Abstract

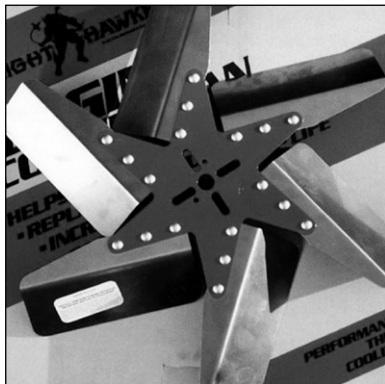
Photo 8

An exemplar fan, Photo #8, was obtained which had six 0.027-inch-thick stainless steel blades, each fastened between two painted steel spiders (that formed the hub) by three aluminum rivets. The hub assembly (two spiders and the blade thickness) was about 0.103 inches thick. These stainless steel blades were moderately magnetic, indicating that they had been cold worked: their hardness was Rockwell 15N 77.4 (equivalent to an ultimate tensile strength of approximately 152,000 psi). The convex side of one blade bore a notice that this side was to be installed toward the radiator.

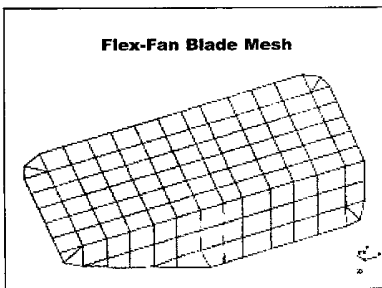
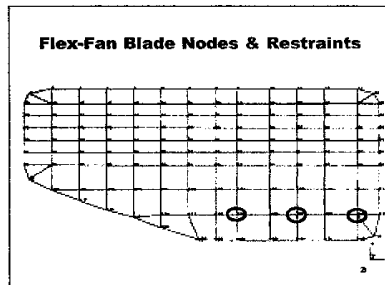
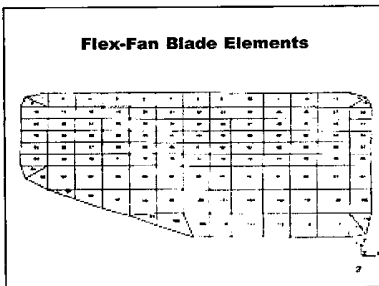
In the finite element method of structural analysis, the part or structure is broken down into a series of discrete or “finite” volumes of the part material. These are called elements, and they may be rectangular or triangular for 2-D analysis or polyhedrons for 3-D models. The geometric points defining the element corner points are called nodes. Behavior of the finite element model will converge to the behavior of the real structure if proper modeling and analysis techniques are used. The part loading is simulated by applying proper force magnitude to the nodes. Restraints to the part are also imposed at specified nodal points. Celestial Software Inc., Images 3D Finite Element Analysis program and Interactive Microcomputer Analysis & Graphics of Engineering Systems were used for this analysis. Blade mesh, element and node identifications are shown in Figure #1, #2 and #3.
