Forensic Engineering Analysis of Falling Merchandise in a Retail Warehouse

by *Wilbur T. Yaxley, P.E., C.S.P. (NAFE 270F)*

Jeffrey D. Armstrong, P.E. (NAFE 644S)

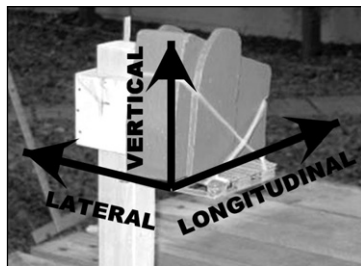
The forklift pallet was a standard 40-inch by 48-inch pallet. The height of a standard pallet is six (6) inches. There are gaps of undetermined widths between the boards on the top of the pallet. An exemplar pallet weighed 64 pounds. Figure 2 illustrates the length of a single lounge chair in comparison to a pallet. Figure 3 shows a scale model representation of the chairs on the pallet, with arrows

defining lateral, longitudinal, and vertical directions as referenced in this paper.

The irregular shaped stack of lounge chairs was held together by wrapping the entire stack with stretch wrap. The positioning frame sat on top of the pallet. The chairs rested on the positioning frame. The chairs were placed on the pallet so that the length of the chairs was parallel to the 48-inch side of the pallet. When the frame and stack of chairs were placed on the pallet, only the two center wheels rested on the pallet. With the casters at the corners of the frame being approximately 66 inches apart, these corner casters hung over the edge of the pallet. The center wheels may have rested directly on the surface of the pallet, which would have caused the frame and the stack of chairs to wobble, or the wheels may have rested between adjacent boards on the pallet with the frame itself resting directly on the pallet. This would help prevent the load from shifting on the pallet in the longitudinal direction, but would not keep it from shifting in the lateral direction. The composite stack of chairs overhangs the pallet by approximately 20 inches at both the front and the back. The width of the positioning frame and the stack of chairs (measured at the arm rests) is 28 inches. The width of the pallet is 40 inches. When the chairs are centered on the pallet each side of the stack is six (6) inches from the side of the pallet. Therefore, there is an irregular shaped stack of chairs that is longer than the pallet in one direction, and narrower than the pallet in the other direction sitting on a wheeled positioning frame that does not rest flat across the surface of the pallet.
