# Forensic Engineering Analysis of Dynamic Wheel Tire Impact Ejection of Manhole Covers

by Jon O. Jacobson, Ph.D., P.E. (NAFE 401F)

Michael Kravitz, P.E. (NAFE 451F)

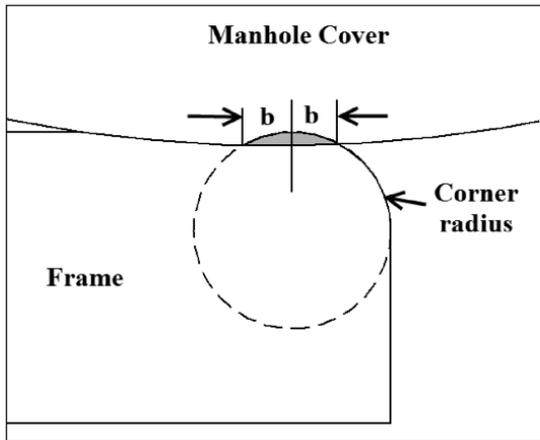
The local stress resulting from the manhole cover being supported on one small raised edge has been analyzed utilizing the Hertz Contact Stress analysis with the extension by Thomas and Hoersch who solved the three-dimensional stress field beneath the contact surface. The formulation of the analysis initially gives the local width of the deformed contact surface. The half-width “b” is calculated according to the diagram:

Where D is the corner radius and F is the load on the edge.

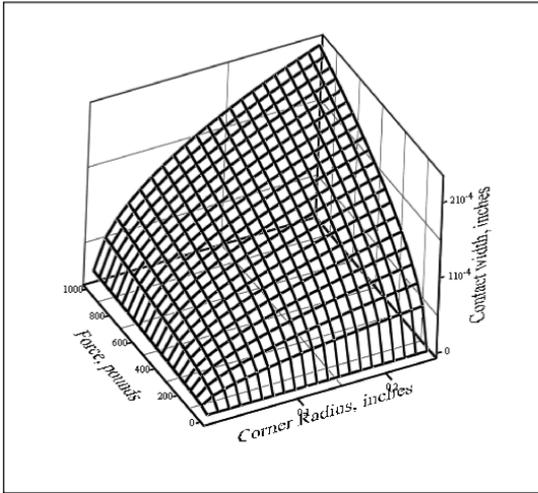
In graphical form, this is seen to depend on the corner radius and load as seen:
