Vol. 37 No. 1 December 2020

Forensic Engineering Investigation of a Pipe Joint Tester Explosion

By William Keefe, PE, (NAFE 481M)

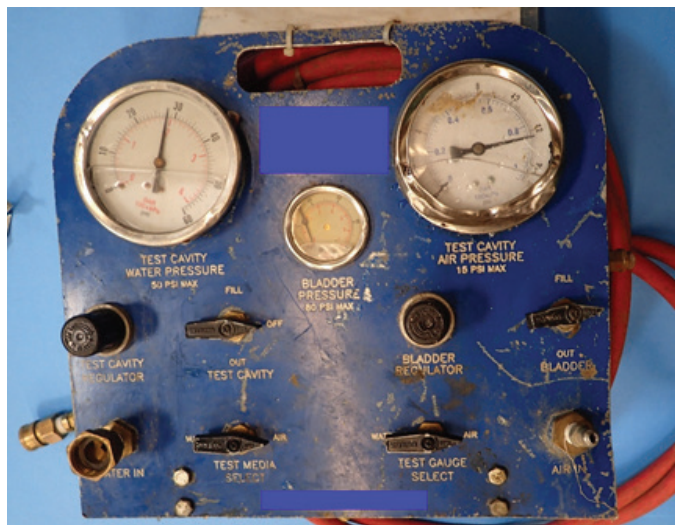
Figure 4
Control panel.

The joint tester was operated from a portable control panel assembly (**Figure 4**), which contained separate control circuits for the bladder and test cavity. The bladder control circuit included a bladder air pressure regulator, an adjustable pressure relief valve, a three-way control valve (fill/off/out), and a bladder air pressure gauge. The test cavity control circuit included a test cavity air pressure regulator, a three-way control valve (fill/off/out), and a test cavity air pressure gauge. The test cavity control circuit did not contain a pressure relief valve. The test cavity circuit also contained controls utilized for the water testing.

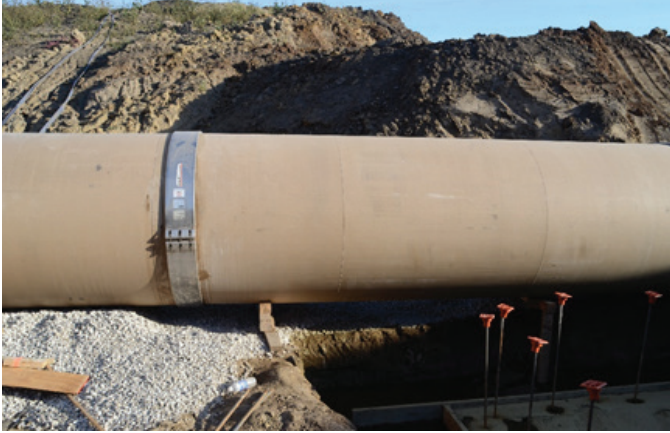
Figure 9
Pipe with external coupler.

The pipe involved was fiberglass reinforced polymer mortar pipe meeting ASTM D3262-14. When installed, the pipe joints were sealed with external compression couplings. The couplings contained an elastomer seal and a two-piece stainless steel clamp secured with external bolts. The pipe involved in the incident was 54 in. in diameter (**Figure 9**). The project specifications required testing of the pipe joints.

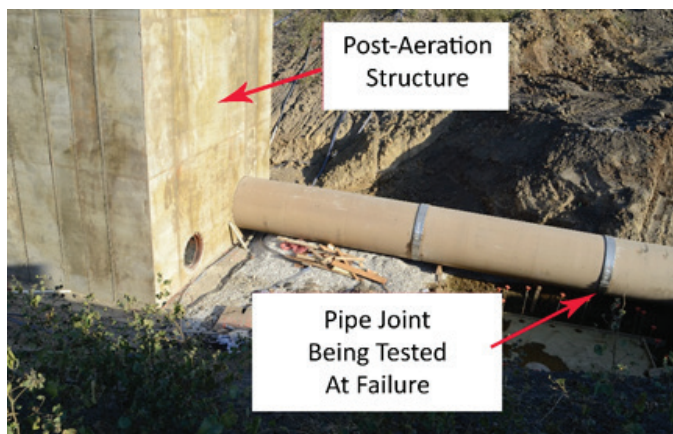
Figure 10

The incident occurred in a section of 54-in. pipe near a concrete post-aeration structure. The pipe joint being tested was the second joint away from the structure (**Figure 10**). The operator (Laborer 2) and the engineer were positioned on the side of the joint tester closer to the aeration structure. Laborer 1 was positioned 10 to 12 ft from

Incident location.

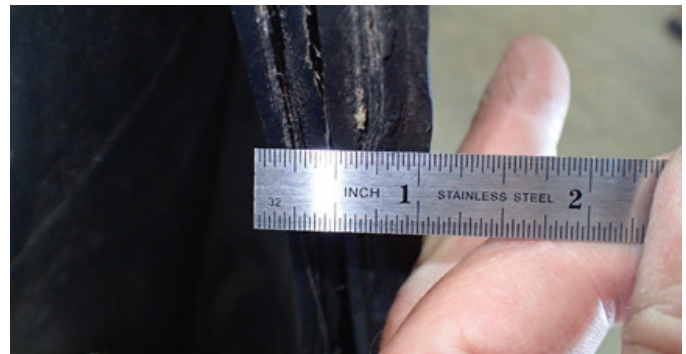
Figure 16

Bladder cross-section.

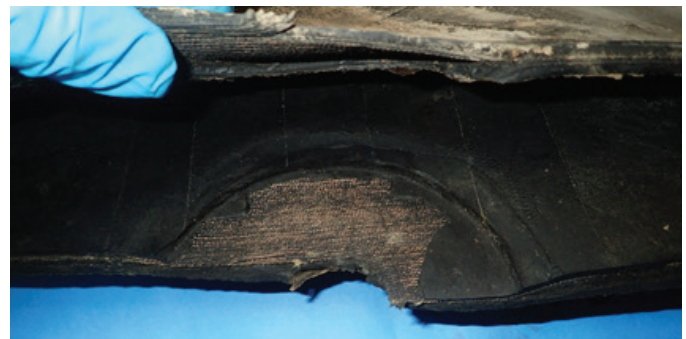
Figure 17

Bladder reinforcing cords.

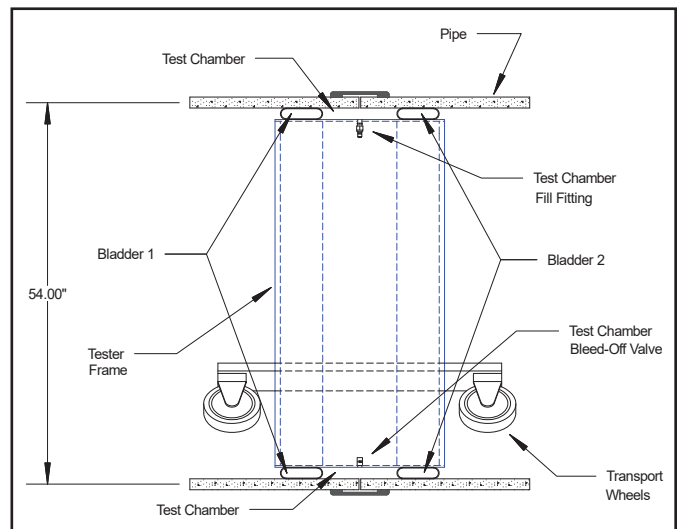
Figure 29

Side view of two-bladder joint tester in 54-in. pipe.

walls (**Figure 29**). The failure on the incident unit occurred at this connection and the manufacturer previously determined that this connection was a source of bladder failures.

- Reduce the compressed air volume and stored energy by using a two-bladder system on the pipe joint tester. The volume of both bladders combined would be less than the single bladder. In the event of bladder failure, it is unlikely that both bladders would fail at the same time (**Figure 29**).
- Reduce the compressed air volume and corresponding stored energy by designing the tester to fit a single size of pipe more closely matched to the pipe joint tester diameter. In addition, the clearances with a single size tester would not permit the tester frame to rotate within the pipe.
