**Vol. XXV No. 2 December 2008**

# Forensic Engineering Investigation of Pyrite's Expansive Forces and Impact on Long-Term Building Failure

by Paul G. Carr, Ph.D., P.E. (NAFE 664S)

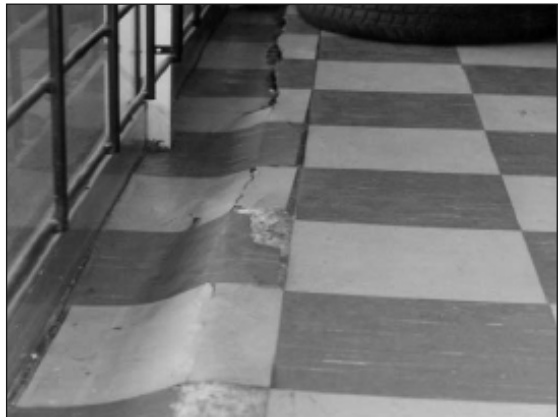
**Figure 8**  
(Bryant 2003)

The following Figure 8 is from a reference study where pyrite was the agent that caused expansion. This photo can be compared to the situation at the case study elementary school, Figure 9.

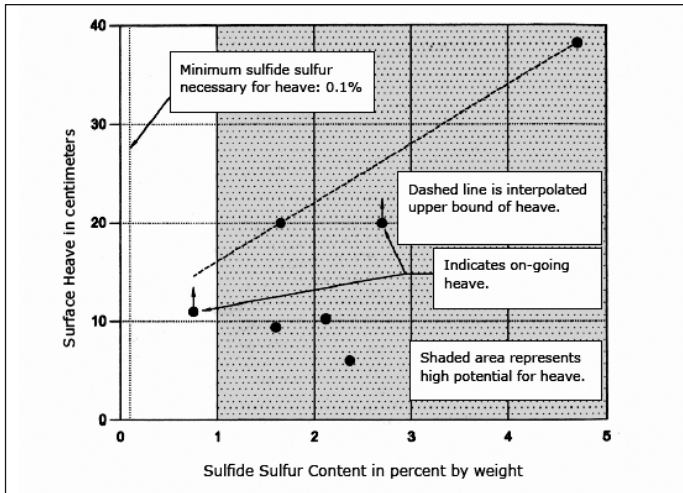
**Figure 12**  
Potential For Expansion (Bryant 2003)

Accepting that the material collected in the middle school crawl space is representative of the elementary school fill material the test results show that with 0.32% sulfur there was an adequate amount of sulfur present to initiate the reaction for heave. The Figure 12 shows the potential for heave given various levels of sulfur. Of course this is a generic graph, which only provides a limited understanding of the potential for heave at the elementary school, however it is somewhat informative, and agrees with our movement thus far. The overall potential for swell suggests that upwards of 5 inches of movement might be expected.

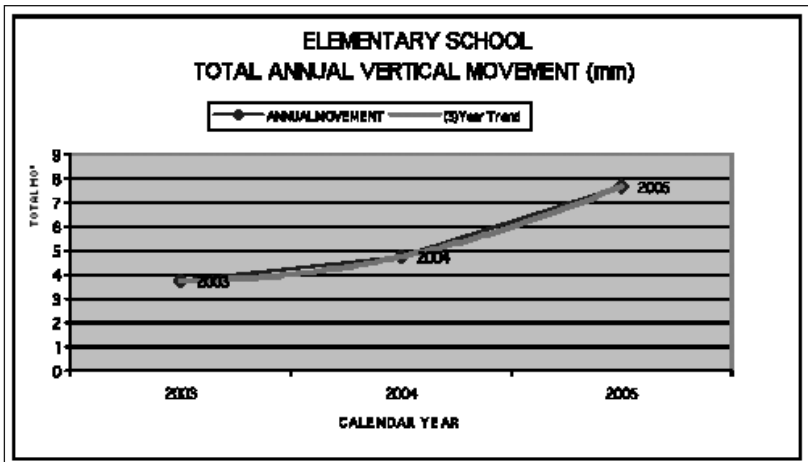
Once the oxidation process has begun, the ability to halt its action is essentially non-existent. The rate of movement, and building failure may be expected to increase with time. This is supported by the tracking of building rate of movement over time as presented in Figure 13

The solution to the problem at the elementary school will likely be dramatic. While the recently installed footing drains will remove water from the space adjacent to the foundation wall, and will allow the soils within the foundation to dry out, the long-term implications of the pyrite expansion are not good.
