Vol. XXV No. 2 December 2008

Forensic Engineering Analysis of Excessive Iron Corrosion in a Class of Automobile Engines

by Michael D. Leshner, P.E. (NAFE 559F)

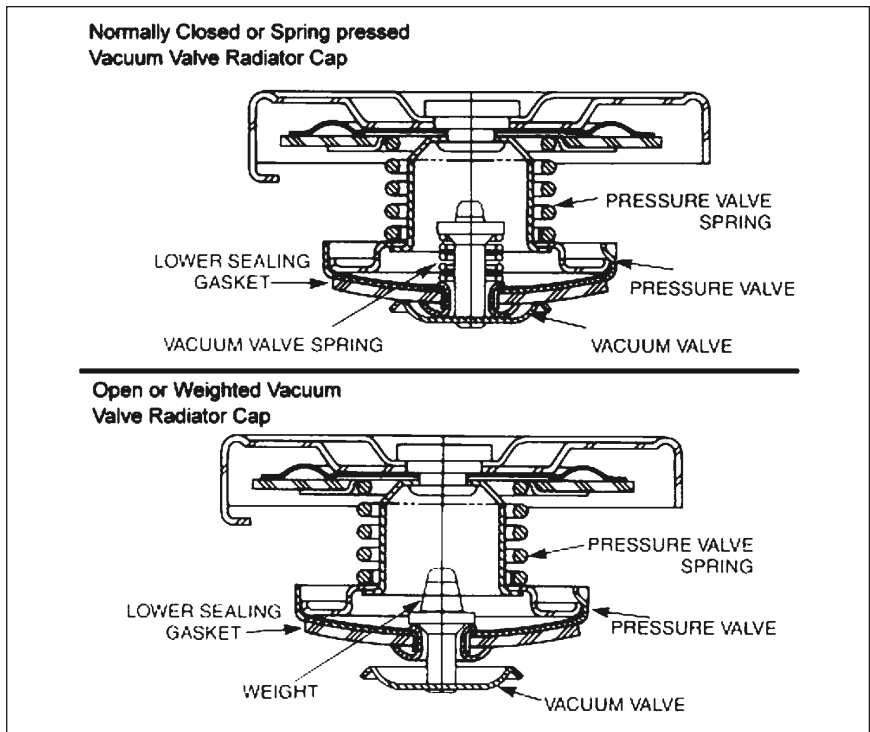
Figure 3

To find the actual cause of low coolant, the author observed his own affected vehicle. After filling the cooling system and reservoir properly, the recovery bottle needed re-filling about every sixty days of use. Upon closer observation, it was clear that coolant was lost whenever the recovery bottle became over-filled, spilling coolant onto the ground. To understand the actual cause of the problem, one must consider all the functions of a standard radiator cap. Two different types of cap are shown in figure 3. Both have a spring-loaded

pressure relief valve to limit system pressure, and both have an upper seal to maintain a closed passage to the coolant recovery reservoir. At the bottom, both have a vacuum valve. The upper diagram has a spring-loaded vacuum valve and the lower diagram has a weighted vacuum valve.

Vacuum valve leakage tends to over-fill the coolant recovery reservoir, resulting in coolant loss.
