# Forensic Engineering Investigation of Side Glazing Failure in Rollover Collisions

By Stephen A. Batzer, Ph.D., P.E. (NAFE 677M)

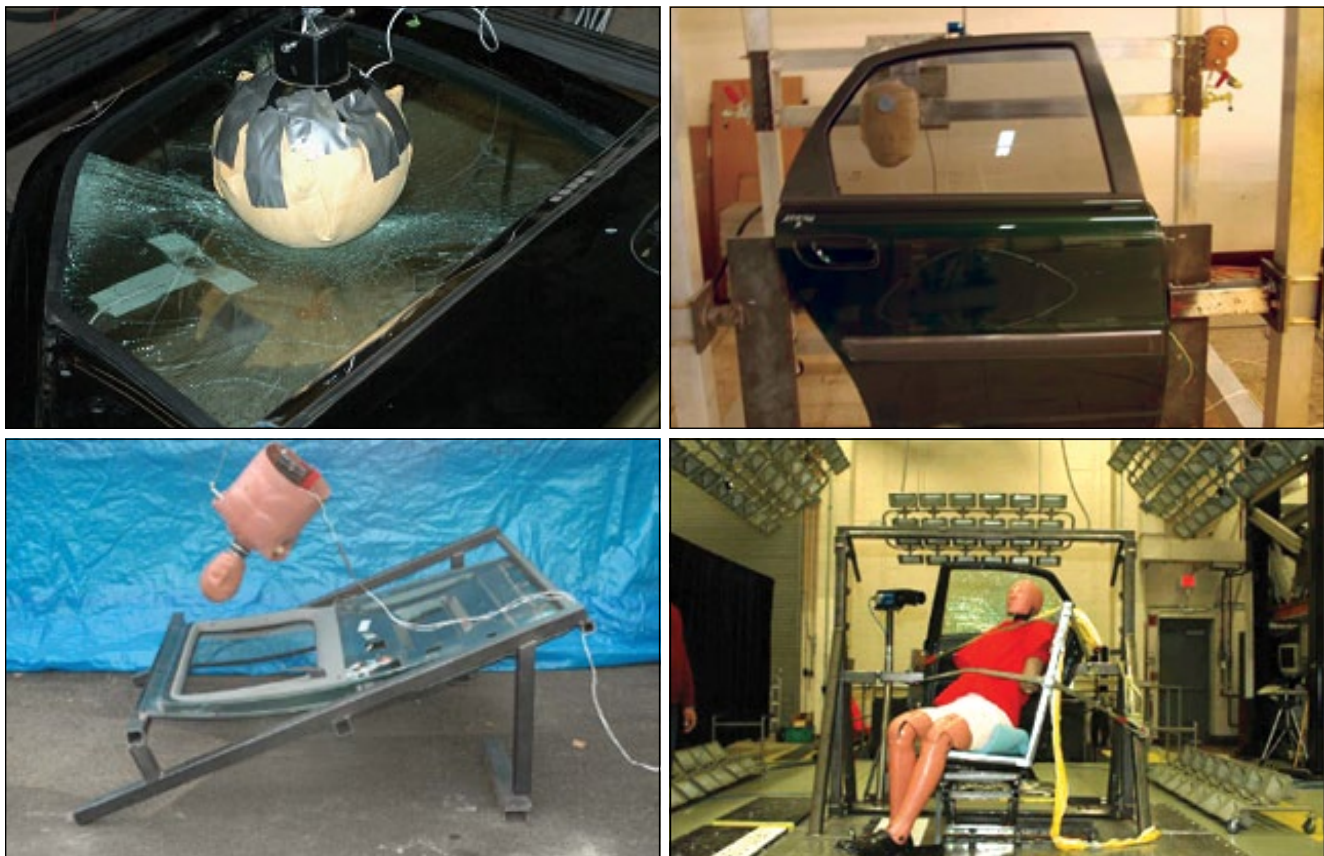
**Figure 2**

Laminated side glass laboratory testing montage<sup>10-13</sup>.

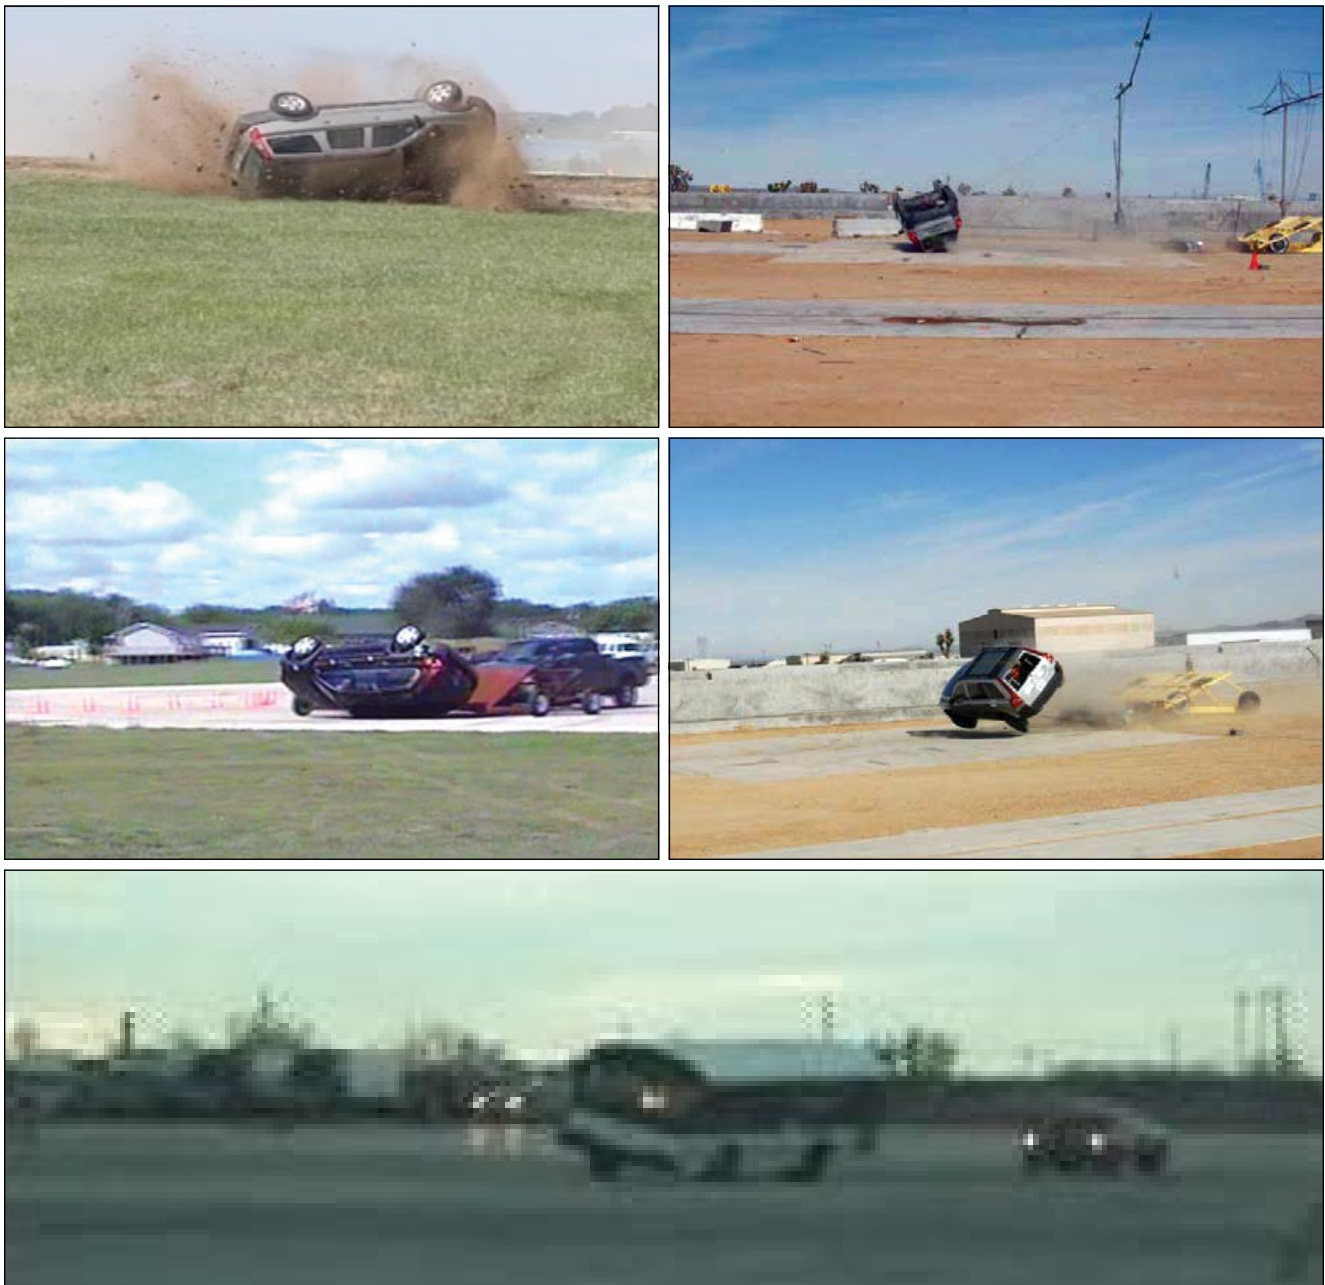
**Figure 3**

Occupant retention glazing design testing validating using robotic steering (1 roll, upper left); dolly (2.75 rolls, upper right); sled (4 rolls, lower left); sled (5.5 rolls, lower right); robotic steering (1/4 roll, bottom).

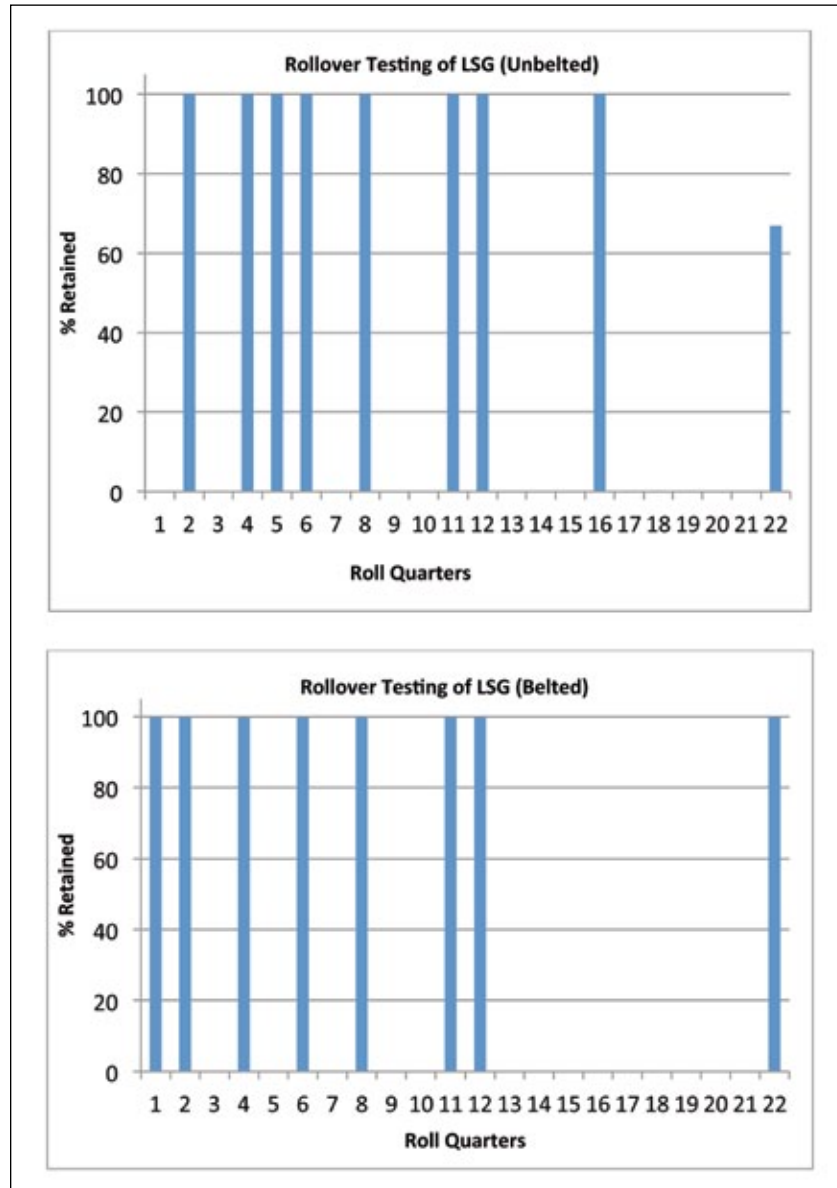
**Figure 4**

NHTSA and other organizations have run various tests of this sort. An illustration of how well this testing has gone is shown in Figure 4 below. Each vertical line represents one test condition (some with replicates), and the success rate in retaining unbelted occupants (top) and belted occupants (bottom). These charts give evidence that properly supported laminated side glass is sufficient to completely retain both belted and unbelted occupants in over 95% of turnovers.

Testing success rate of laminated glass used to retain occupants in rollover collisions.  
These two charts are based upon the data given in Table 1 below.
