Forensic Engineering Investigation of a Long Span Wooden Truss Failure During Erection

By E. Ross Curtis, P.E. (NAFE 571S)

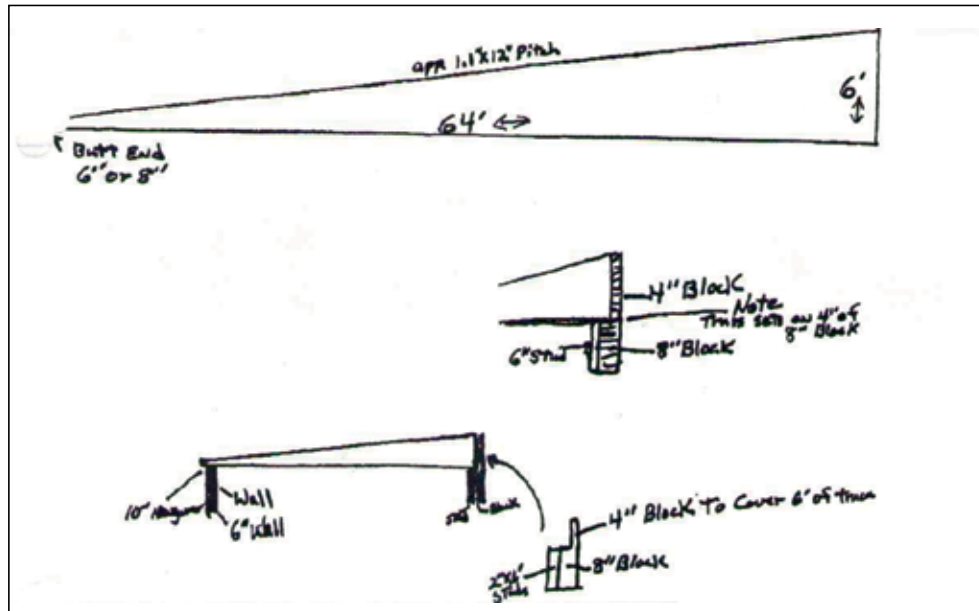
Roof Cross-Section and Details

With the assistance of the wood truss supplier, the contractor prepared a sketch of the roof cross section. The supplier used that sketch to order the wood roof trusses from the manufacturer who designed, manufactured and shipped them to the construction site. See the contractor's sketch of the roof cross-section below.
