Journal of the
National
Academy OF
Forensic
Engineers[®]

Forensic Engineering Investigation of Lumber Temporary Guardrails

By John P. Leffler, P.E. (NAFE 709S) and

James H. Robinson, Jr., P.E., S.E. (NAFE 741S)

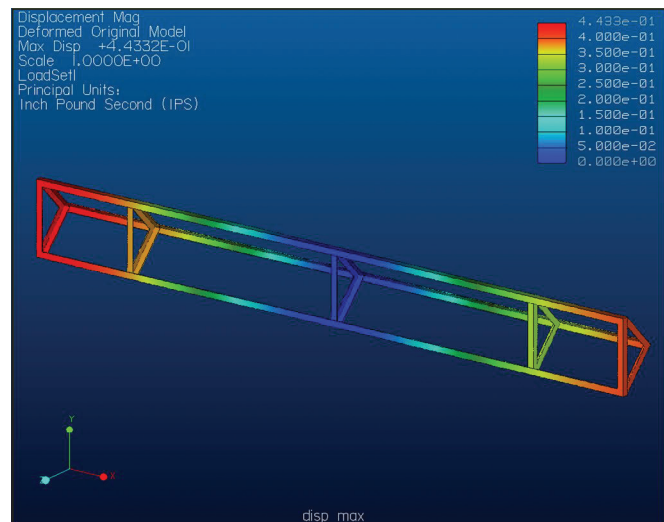
One of the authors designed a framework using 3D CAD, and also used finite element analysis to predict deformation under the testing loads. The CAD model confirmed that the design would not experience undue deflection, and the framework was fabricated by the designer. See Figures 1 & 2.

Figure 1
finite element analysis of CAD design

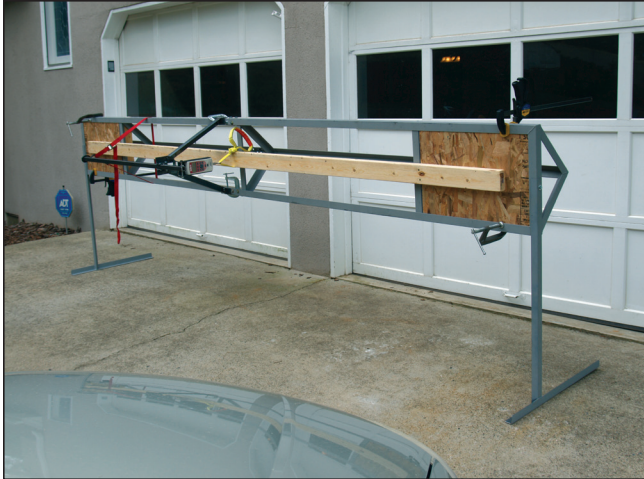
Figure 2
assembled test jig

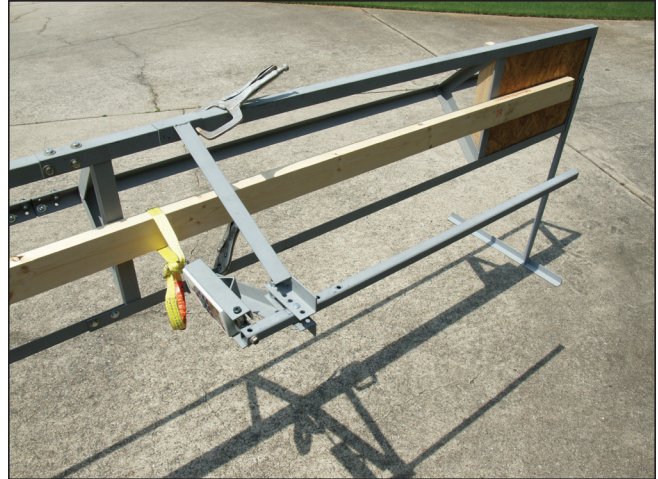
The framework design features lever-based mechanisms that work through a digital force gauge to apply horizontal, vertical, and 45 degree angled loading to the lumber guardrail at any point along its 9 foot long unsupported span. See Figures 3 through 5. The digital force gauge was

Figure 3
horizontal loading linkage

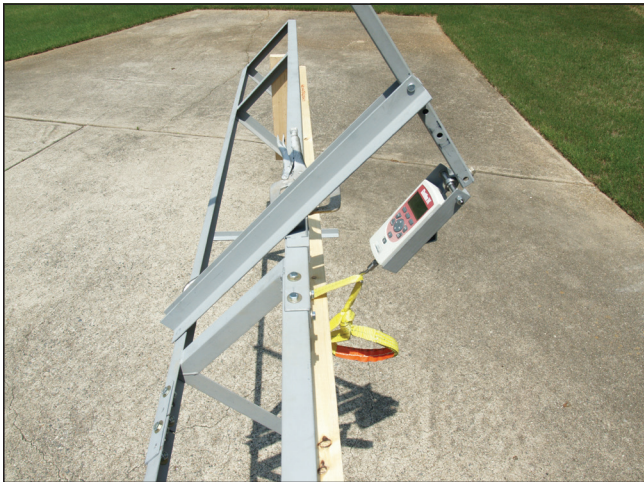
Figure 4
45° angled loading linkage

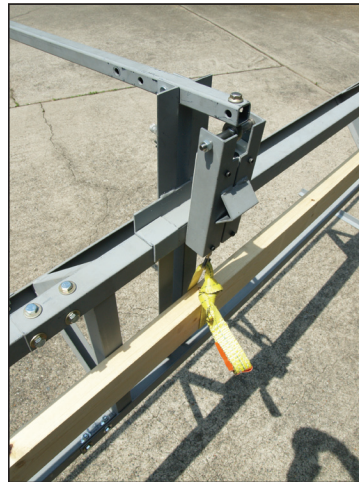
Figure 5
vertical loading linkage

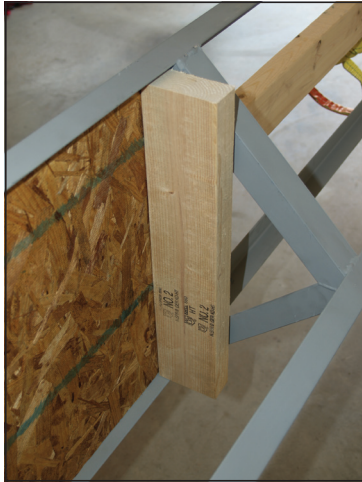
The OSB panels were mounted in the framework. A 2x4 board was centered vertically and horizontally across the 9 foot wide opening in the framework. The board was nailed through the OSB panels and into 2x4 blocking meant to represent building framing. Two nails were installed in each end and were adjacent to the 9 foot wide opening – see Figures 6 and 7.

Figure 6
OSB panel with 2x4 blocking

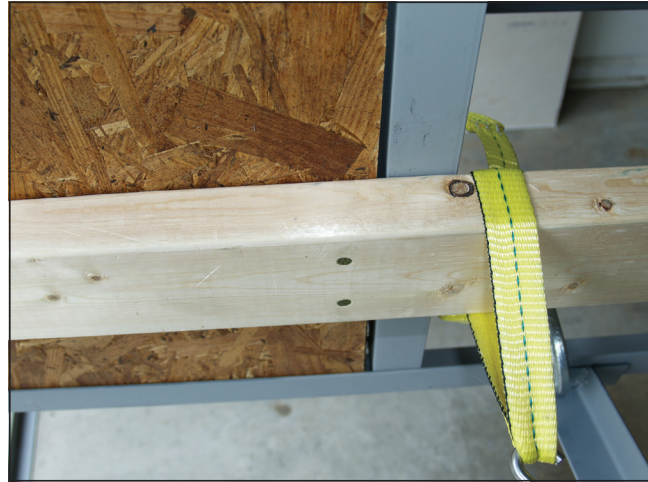
Figure 7
nailed installation of guardrail

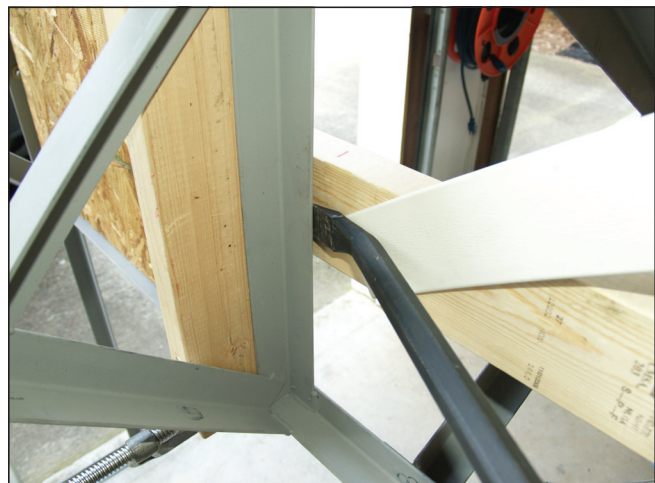
In this testing, the horizontal pull test was applied with an approximate load of 260 pounds, which represents a 30% “safety factor” over the OSHA-prescribed 200 pound loading. The load was maintained for one minute, and then the guardrail was pried away from the wall panels using a crowbar centered on the “inside” surface of the guardrail – see Figure 8.

Figure 8
crowbar removal of guardrail
