Journal of the
National

Forensic Engineering Investigation of Vehicle Hub Separations

by John Leffler, P.E. (NAFE 709S)

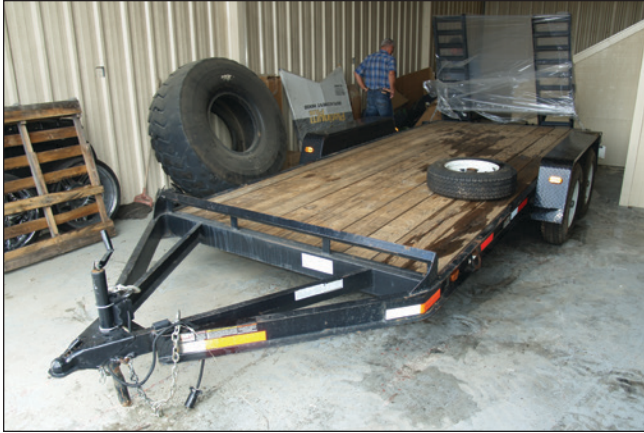
Case facts: A contractor purchased a 2007 dual-axle flatbed utility trailer from a dealer, in October 2007, intending it for use in carrying his 8,000 pound wheeled skidsteer construction vehicle. See Figure 8. The trailer had been manufactured about 100 miles away from the dealer, and was picked up from the manufacturer by the dealer. Four months after purchase, the trailer was being used to haul the skidsteer vehicle from a worksite to the owner's residence. While traveling on an Interstate highway, the right rear hub/wheel/tire assembly separated from the trailer. The assembly ended up striking a motorcyclist

Figure 8
Subject utility trailer

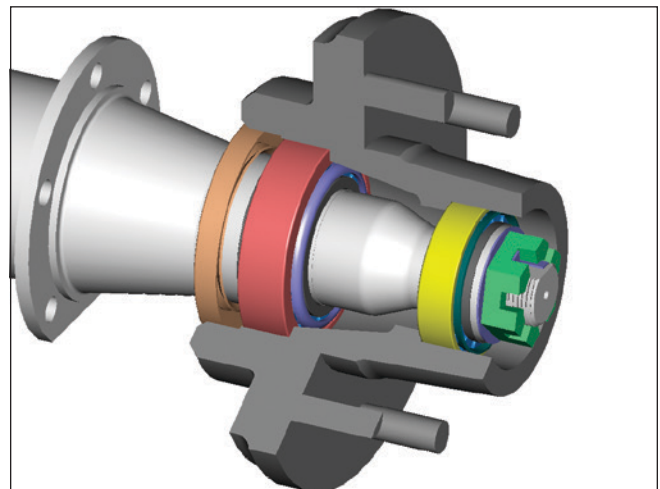
Figure 16
Idler axle cutaway

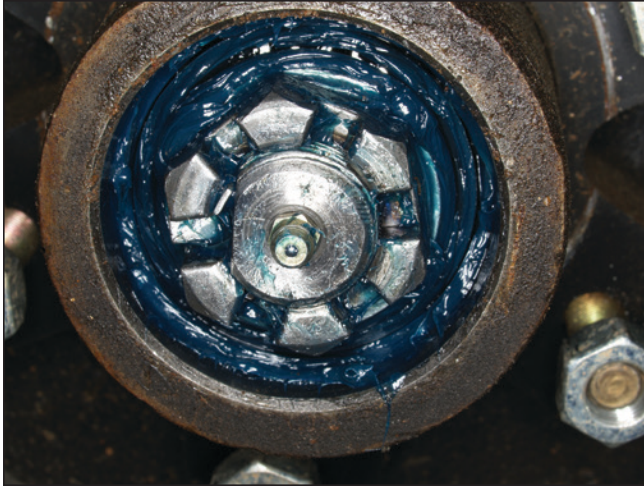
Figure 20

Assembled Delta axle hub showing ~1/8" of threads protruding from nut

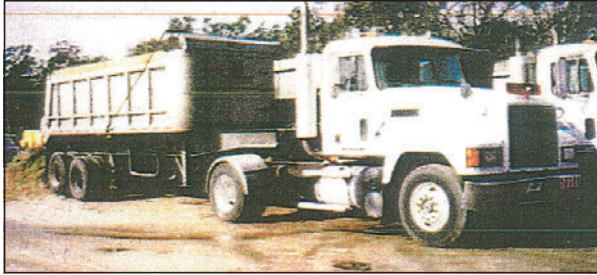
Case facts: A trucking company had a fleet of dozens of gravel trailers, which their drivers would use in supplying gravel for construction projects. The trailers have dual rear axles with cast spoke wheel hubs and drum brakes. The hubs use oil-bath tapered roller bearings. In January 2004, a truck tractor and a model year 2000 gravel trailer were carrying the first load of the day, and were traveling at approximately 40-45 mph approaching a traffic light on a two-lane rural highway. The left rear trailer hub separated, carrying with it the drum, two rims, and two tires. The assembly sideswiped a pickup truck traveling in the other direction. Both the axle end and the separated hub assembly were observed to be on fire, due to burning hub oil. The outboard tire blew off the hub/wheel assembly. Following the hub separation, the subject trailer was towed back to the company’s facility, the axle replaced, and the trailer used for several years prior to the author’s involvement in the case. See Figures 22 - 25.

Figure 22
Subject tractor and gravel trailer after incident

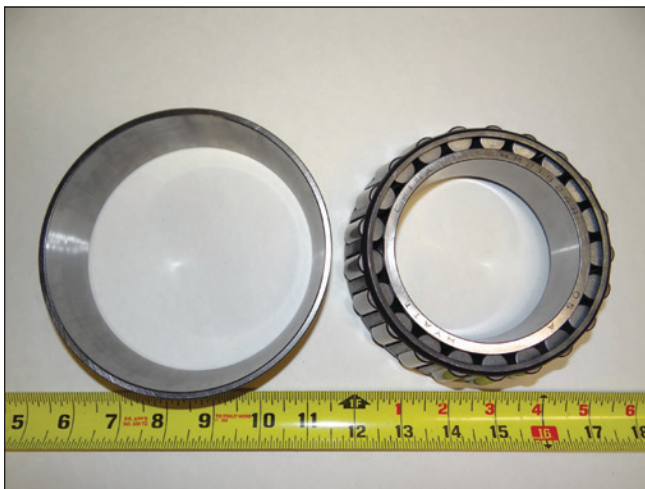
Figure 26

- Service invoices dated 4/21/2003 and 9/5/2003 documented that one hub set of wheel bearings (with seal) had been replaced.
 - Standard tapered roller bearings are a refined product and may last for hundreds of thousands of miles, depending upon service conditions. The axle manufacturer recommends wheel bearing inspection whenever the lubricant is replaced. Bearings may be affected by inadequate lubrication, impact damage during hub removal/replacement, excessive adjustment freeplay or preload, and other issues discussed previously. The wheel bearing series used for this trailer is shown in Figures 26 & 27.

HM218248 bearing style used on subject axle

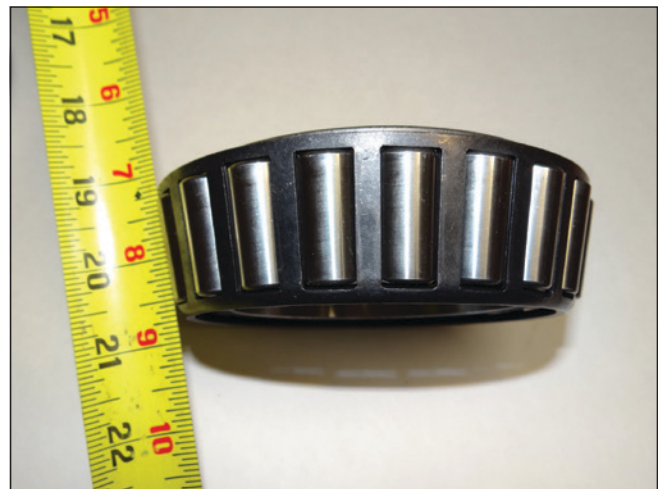
Figure 27

HM218248 bearing style used on subject axle

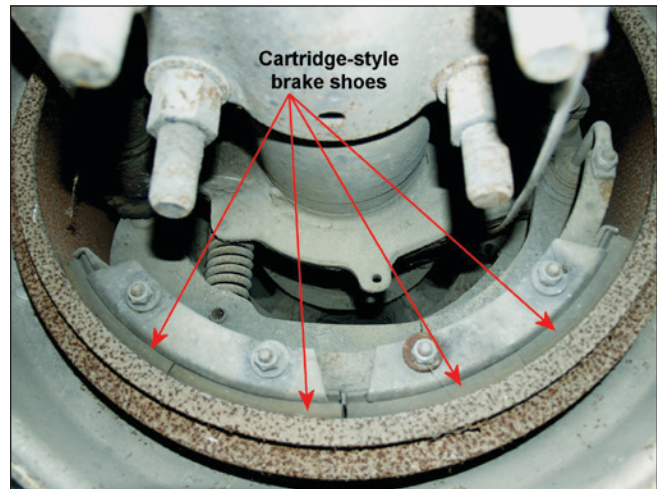
Figure 28

- Typically the replacement of brake shoes on this type of hub requires removal of the hub, which again provides the opportunity to inspect bearings, inspect the oil seal, and refresh the hub oil. However, this particular trailer was fitted with an unusual type of “cartridge” brake shoe that can be removed and replaced without removing the hub and exposing the bearings and seal. See Figure 28.

Cartridge-style brake shoes on subject trailer axle.
