Vol. XXVIII No. 2 December 2011

Forensic Engineering Determination of Who Was Driving

by Jeffrey D. Armstrong, P.E. (NAFE 644F)

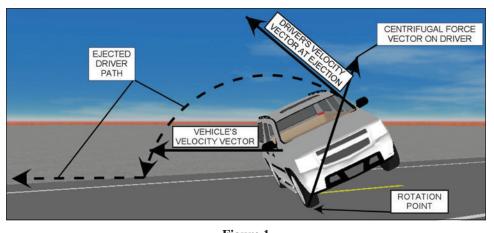
Figure 1 illustrates the forces to which a driver would be subjected during a vehicle rollover, and the subsequent path an ejected driver would take. The forward motion of the vehicle results in a forward velocity vector. The centrifugal force created by the rolling of the vehicle points away from the center of rotation. This centrifugal force will tend to pull an un-belted driver out of his/her seat, and can potentially be strong enough to eject the driver through the side window. Once ejected, the resultant velocity vector created by

the forward motion of the vehicle and the rolling of the vehicle will throw the driver up and over the top of the vehicle as indicated by the dashed line. Once the ejected occupant lands on the ground, their forward velocity will cause them to slide or tumble on the ground to a final rest position.

Figure 1 Diagram illustrating velocity vectors and force vectors present during a vehicle rollover and subsequent ejected occupant path.
