Vol. XXX No. 2 December 2013

Forensic Engineering Investigation of a Police Shooting

by John C. Laughlin, P.E. (NAFE 760S)

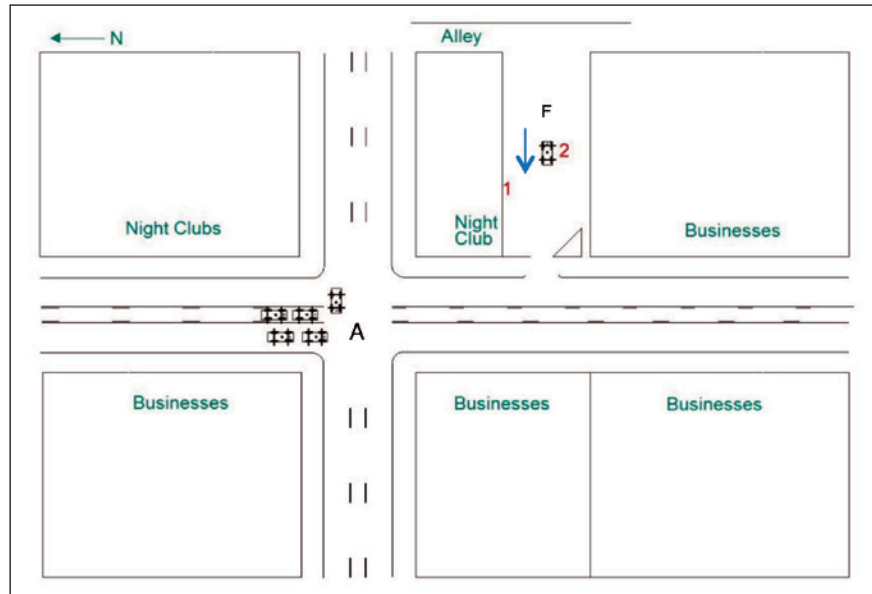
Figure 1

Depicts the initial locations of Officers 1 and 2 relative to the SUV prior to the shooting. The vehicles in the area, “A,” are parked police vehicles which point in the vicinity of the “A.” The “F” in the image corresponds to the front of the SUV and the arrow depicts the direction of travel.

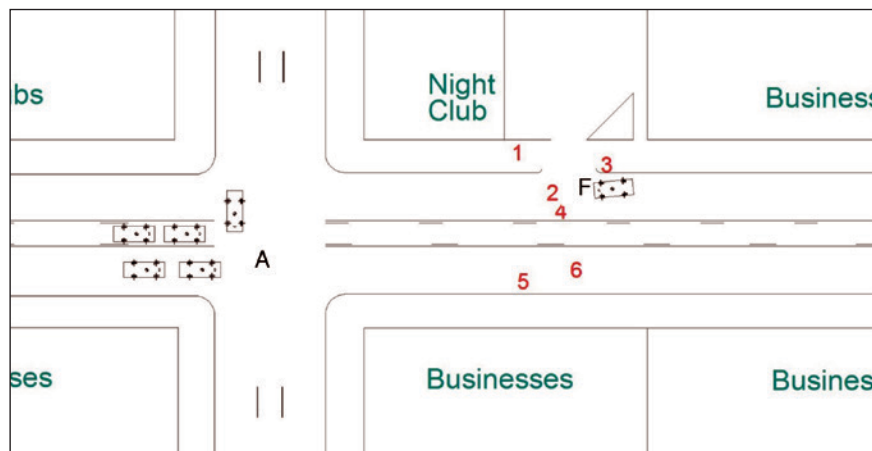
Depicts the relative locations of the officers and the SUV prior to shooting. It also shows the line of police cars blocking the roadway to the north. The SUV has backed out of the parking lot and is facing the police cars. The vehicles in the area, “A,” are parked police vehicles which point in the vicinity of the “A.” The “F” in the image corresponds to the front of the SUV. In this image, the SUV has backed out of the parking lot and stopped.

Officer 4 was in the roadway when the SUV pulled out of the parking lot and was reportedly almost struck. Officer 4 also believed the right rear window to have been shot out. All of the officers on the scene heard Officer 2 shout that the shooter was in the “Suburban,” so focus was given to the SUV. Figure 2 shows the approximate locations of each of the officers after the SUV came to a stop.

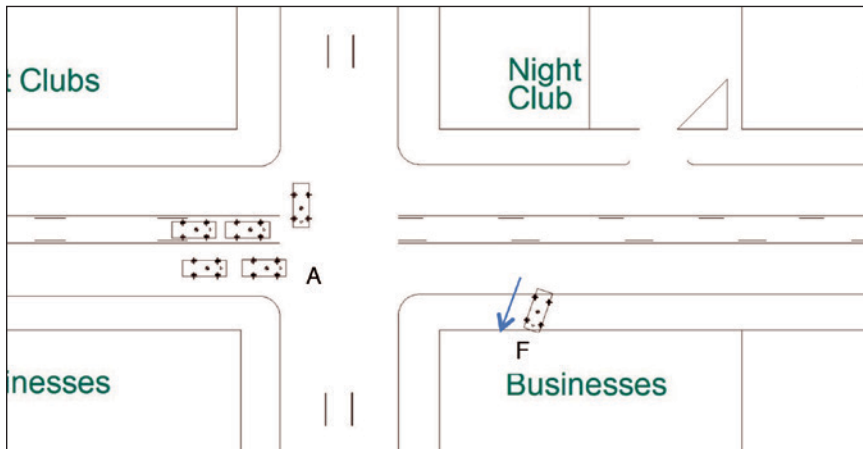
Depicts the final rest location of the SUV after it struck a building across the street. The front of the SUV actually struck a corner of a column in the storefront. The vehicles in the area, “A,” are parked police vehicles which point in the vicinity of the “A.” The “F” in the image corresponds to the front of the SUV and the arrow depicts the direction of travel.

As the SUV moved forward, the officers collectively fired 40 times. As the driver lost the ability to control the vehicle, it rolled westward across the street and impacted a column on the front of a building. Figure 3 shows the final rest location of the SUV. These events and officer locations were determined from official police investigation files and deposition transcripts of the officers at the scene.

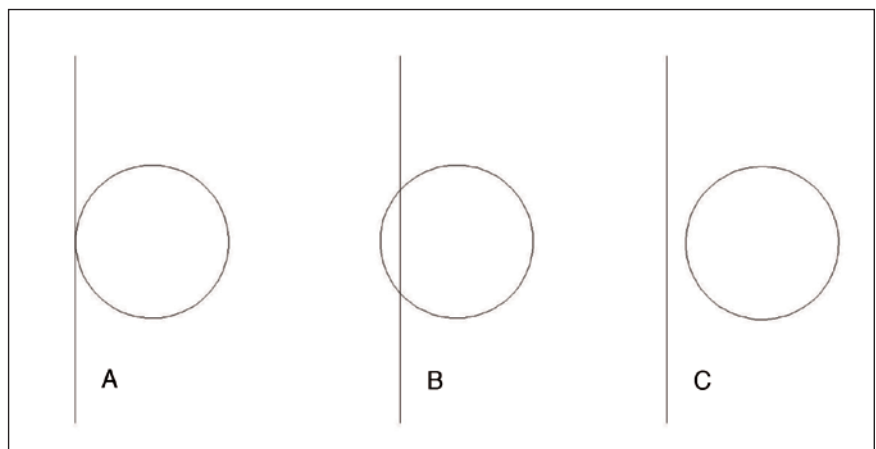
Figure 5

When detecting motion from video captured with a non-moving camera, place guides next to the object to be tracked. Example A shows a guide lined up next to an object to track. Examples B and C illustrate motion. This can be done with horizontal guides to detect vertical motion, as well.

Utilizing this technique, the SUV was determined to come to a stop at 133 frames past the reference point, indicating that the SUV came to rest 4.43 seconds after time zero. Utilizing the same methodology, a slight vertical pitch was detected at 221 frames, 7.37 seconds, after time zero. The impact with the column in front of the building across the street was determined to occur at 426 frames, 14.2 seconds after time zero.

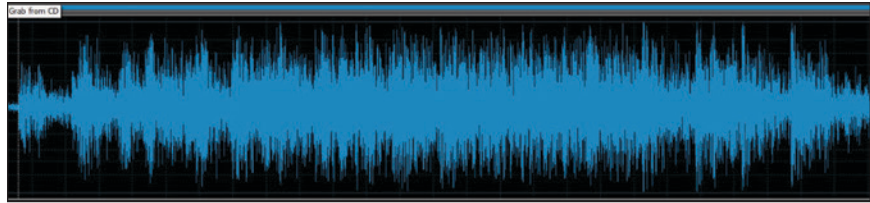
truncated at the start of the last shot. The temporal length of the remaining file is the duration of the gunfire, 4.62 seconds.

Figure 8
The audio waveform of the gunfire.

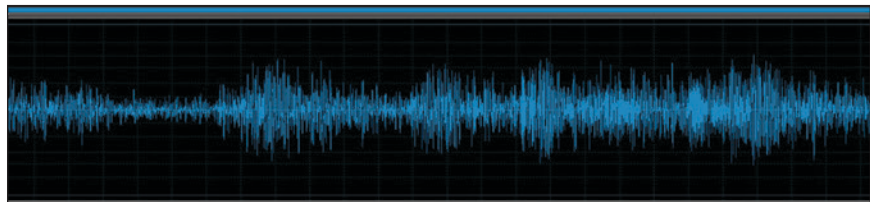
Figure 9
An enlarged section of the gunfire audio waveform to show separate shots.

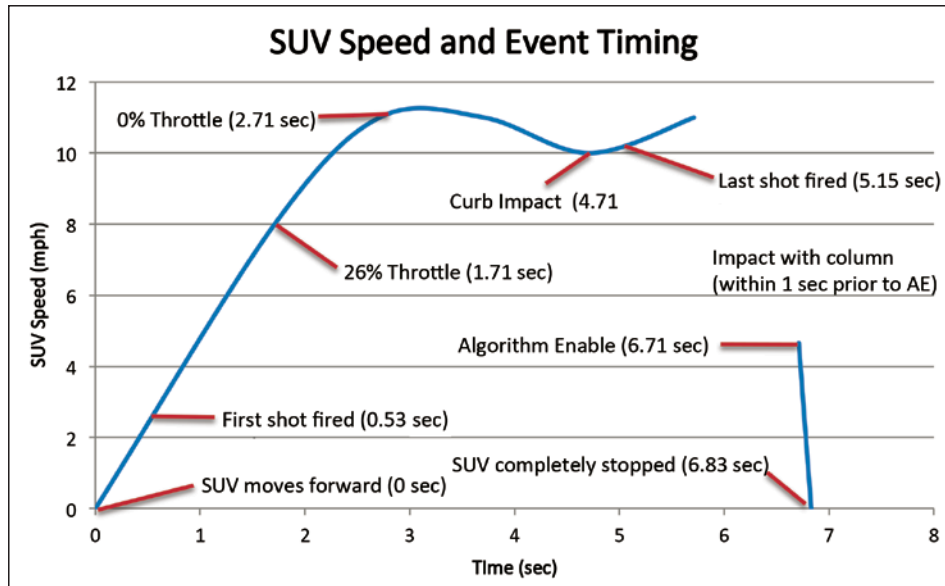
Figure 10 displays the results of the timing and speed analysis. While the analysis was performed with respect to a time zero which corresponded to a distinct event in the video, this chart uses the moment the SUV began moving forward as time zero to make it easier to understand. The chart is left blank during the column impact, because little was done to reconstruct the shape of that portion of the curve. The portion of the speed curve which corresponds to the calculated acceleration from the start was filled in, because a linear acceleration curve should be a good model, especially since not much speed was ever gained by the SUV. In fact, from the way the speed curve increases without throttle inputs and regains speed after the curb impact, it appears that the this SUV never reached its steady state idle speed prior to the driver

being shot. The timeline of speeds and events, as pieced together from the video and EDR data, did not support a theory that the driver of the SUV was attempting an aggressive “jack rabbit” start. An average acceleration of 6.9 fpps will cause a vehicle to accelerate from 0 to 60 mph in 12.8 seconds, which is very average performance.
