Vol. 39 No. 2 December 2022

Forensic Investigations of Propane-Related Food Truck Incidents

By John L. Schumacher, PE (NAFE 1052S), Charles R. Brown III, Zachary J. Jason, PE (NAFE 1053S), and Dennis E. Shelp, PE (NAFE 1058S)

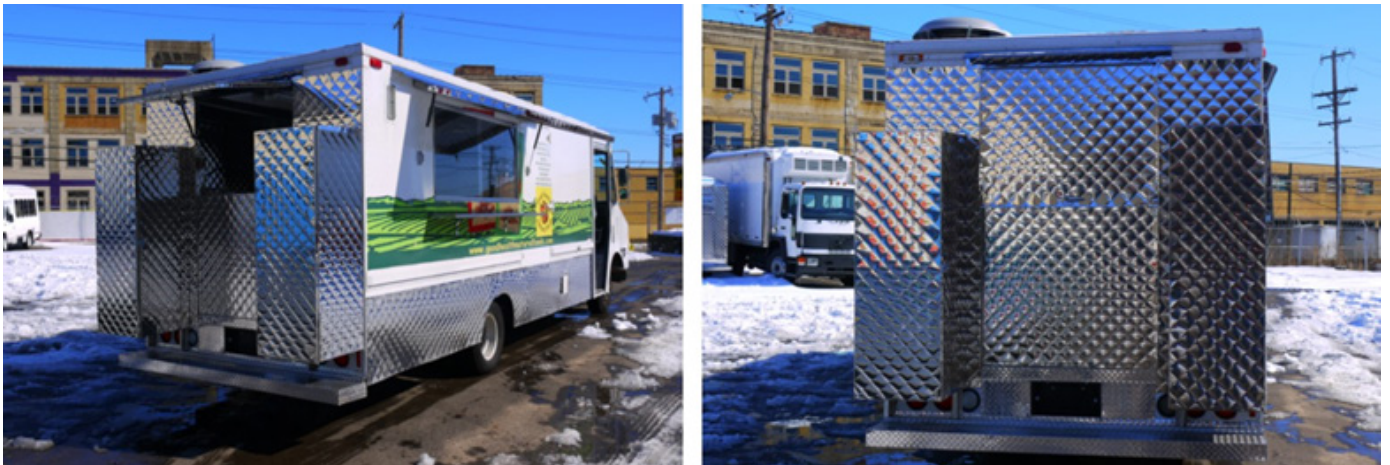
Figure 11

Pre-incident images of the rear of the food truck and the left and right propane cylinder cabinets.

Figure 10 shows the back of the food truck post-incident; the left cabinet and cylinder were both missing, but the right cylinder was still intact (and in place) inside the right cabinet. The right cylinder valve was closed after the incident by the fire department. As a comparison, pre-incident images of the food truck are illustrated in **Figure 11**.

The subject food truck was equipped with six propane-fired appliances fueled by the two 100-pound propane cylinders. The left and right cylinders were originally located inside of bottomless diamond plate metal cabinets — one on either side of the rear door above the bumper cover/step, as illustrated in **Figure 11**.

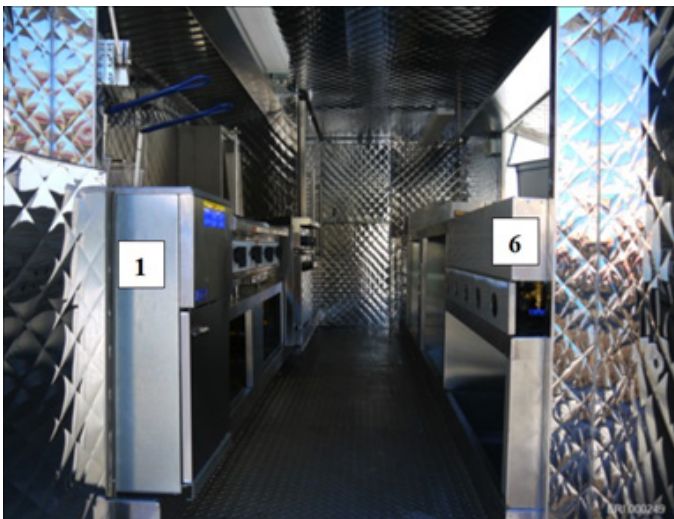
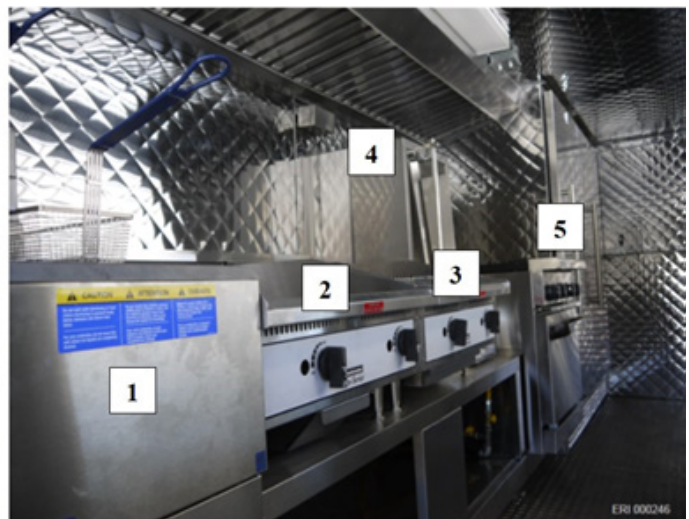
Figure 17

As shown in **Figure 17** prior to the incident, the five gas-fired appliances on the left side of the food truck (from rear-to-front) consisted of a deep fat fryer (1), flat-top griddle (2), charbroiler (3), vertical broiler (4), and range (5). A refrigerator and freezer were adjacent to and forward of the range. An exhaust hood and fan were installed above the five appliances. The exhaust hood did not have a restaurant hood fire suppression system or automatic fuel shutoff valve. A steam table (6) was located on the right side at the rear.

Six gas appliances inside the food truck.

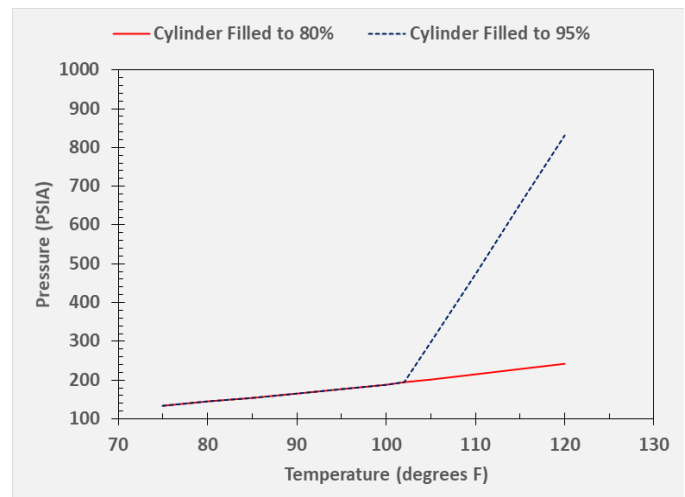
Figure 23, which was created using NIST Reference Fluid Thermodynamic and Transport Properties Database (REFPROP), illustrates the pressure versus temperature relationship for pure propane under two different scenarios⁹. The solid red line in **Figure 23** depicts the scenario where a cylinder is filled to 80% at 75°F, allowing 20% vapor headspace. The liquid propane is allowed to expand into the headspace of the cylinder and maintain the saturated vapor pressure versus temperature relationship. On the other hand, the dashed blue line in **Figure 23** depicts the scenario where a cylinder is filled to 95% at 75°F, leaving only 5% vapor headspace. The propane is allowed to expand until the 5% vapor headspace becomes occupied by the liquid, which occurs at about 102°F (a temperature differential of 27°F). At that point, the pressure inside the cylinder rapidly increases with an increase in temperature

In the unusual situations where the vapor pressure is abnormally high (e.g., in a fire condition) or the cylinder becomes liquid full (e.g., overfill), the relief valve is designed to release the excess pressure at a specified setting, typically 375 PSIG, or well below the failure point of the vessel. However, the left cylinder did not have a pressure relief valve, either as part of the cylinder valve or as a separate add-on appurtenance. The lack of bleeder and relief valves on the left cylinder contributed to the incident, as outlined in the following causation scenario:

1. The cylinder was filled without the use of a fixed maximum liquid level gauge or a scale.
2. The cylinder was overfilled.
3. The temperature of the liquid propane inside the cylinder increased due to an increase in the ambient temperature, solar radiation, and/or external heating sources, which caused the cylinder to become liquid-full.
4. The internal pressure increased to the point of vessel failure because the cylinder was not equipped with a pressure relief valve.
5. Once the cylinder began to fail, the sudden reduction to ambient pressure resulted in rapid flashing of the liquid propane to vapor, splitting open of the cylinder, and projecting the cylinder across

Figure 23
Pressure versus temperature relationship for pure propane under two different scenarios.
