Vol. 39 No. 2 December 2022

# Forensic Engineering Investigation of Factors Contributing to the Explosion of an International Natural Gas Pipeline

By Jahan Rasty, PhD, PE (NAFE 768S), Olin Parker, and Mathew Mills, PE (NAFE 1199C)

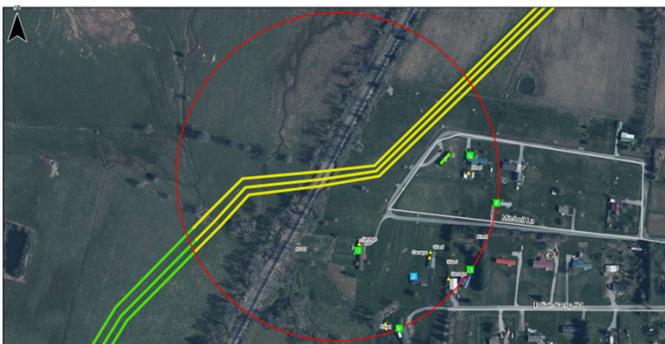
**Figure 2**

An incident occurred involving a section of a vintage natural gas pipeline in the United States that unexpectedly ruptured, resulting in one fatality, destruction of 30 acres of the surrounding area, hospitalization of six people, and the evacuation of more than 75 residents (**Figure 2** and **Figure 3**). The families of those affected filed suit against the owners of the pipeline, pursuing legal theories of recovery based on negligence and gross negligence.

Aerial photograph of the mobile home park with location of the pipeline highlighted<sup>4</sup>.
